# Retrofit conditions potentially complicating air-sealing and exterior insulation

A brief street-view survey of residential housing in  
Portland, Oregon (Glenfair, Glendoveer, Rockwood nhds)

20 April 2021

Graham S. Wright

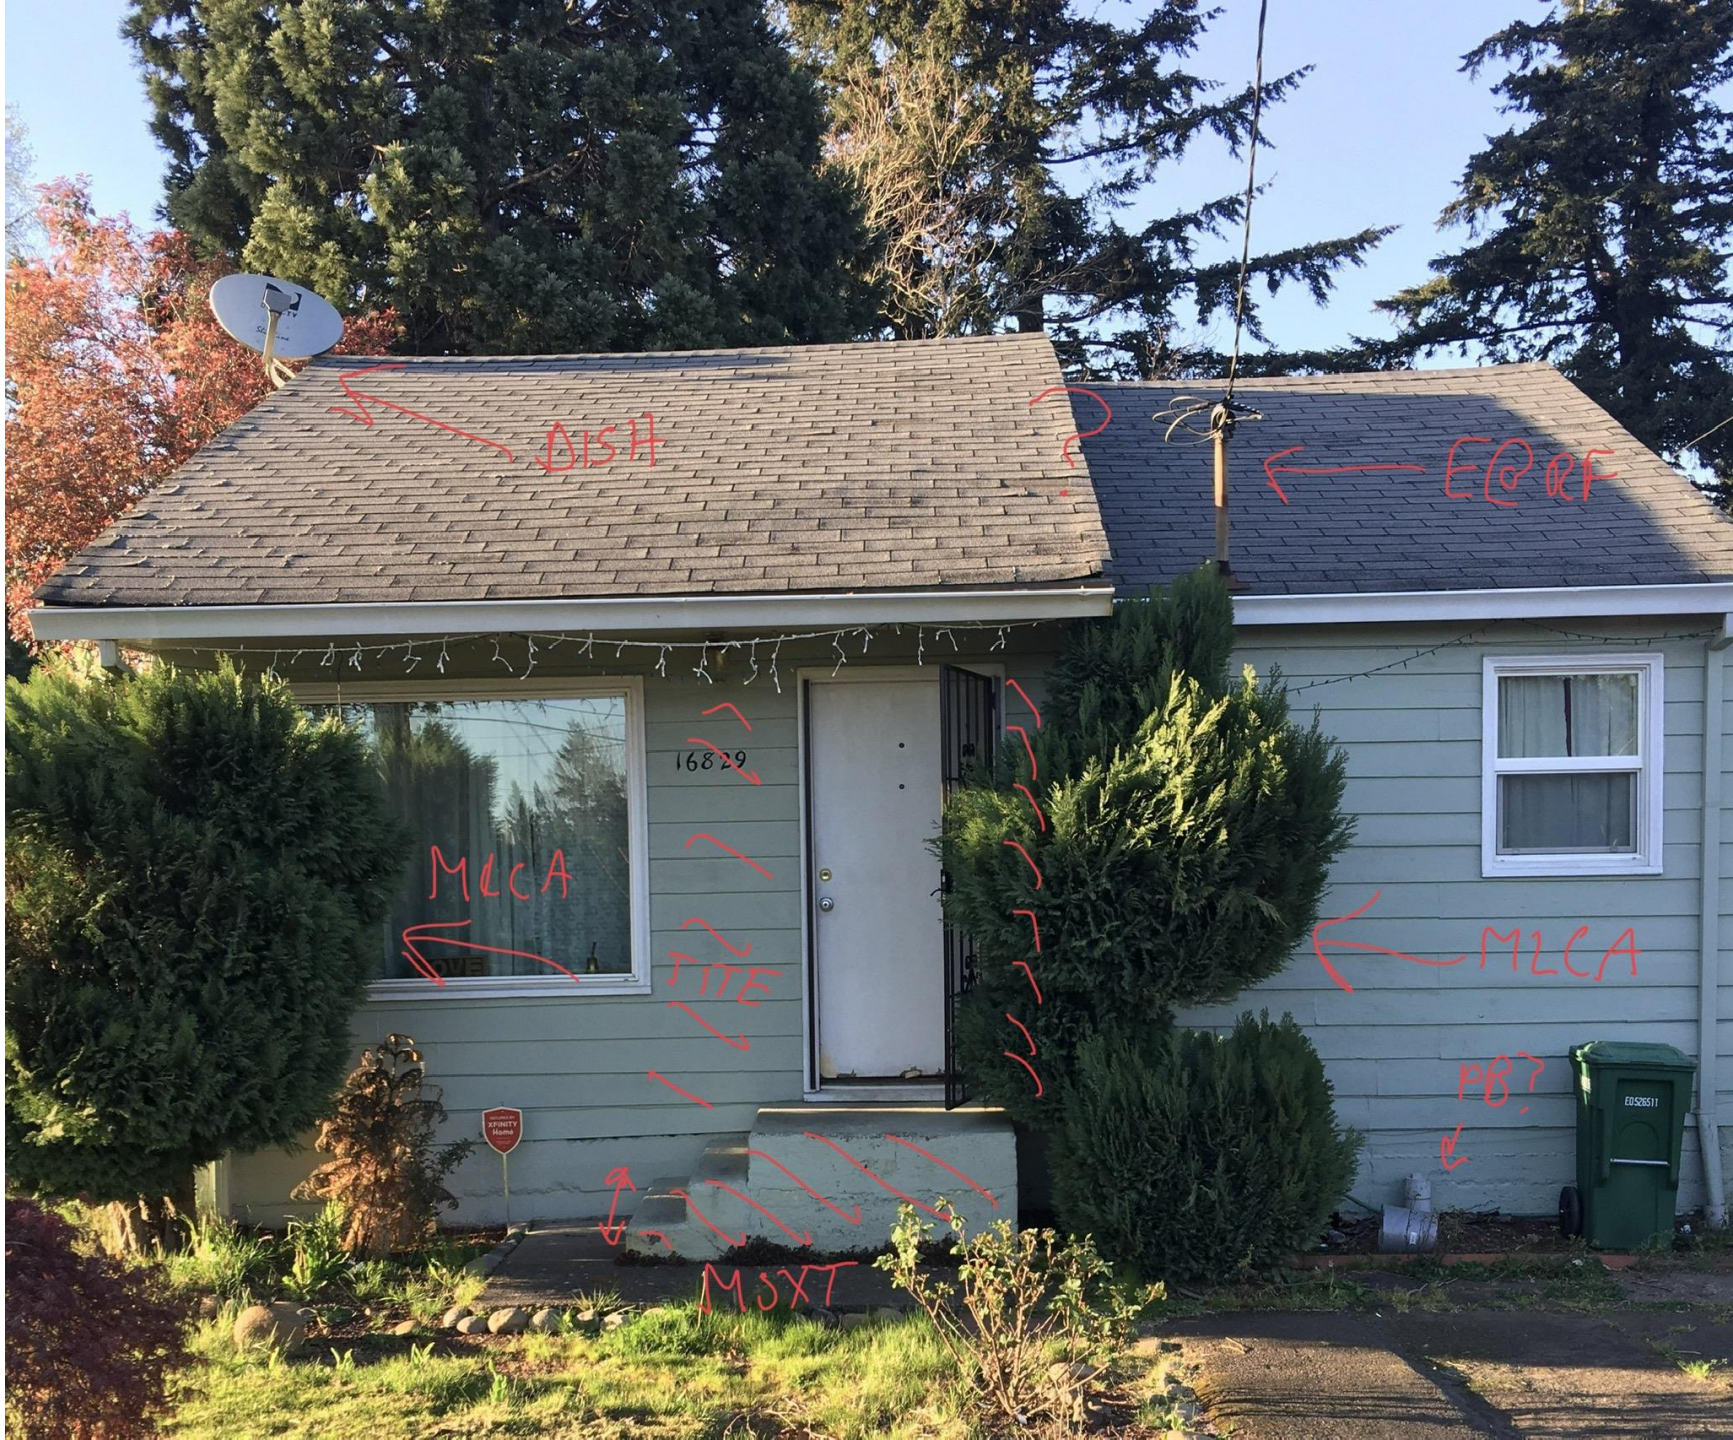
DISH

EQ RF

MLCA

TITE

MSXT

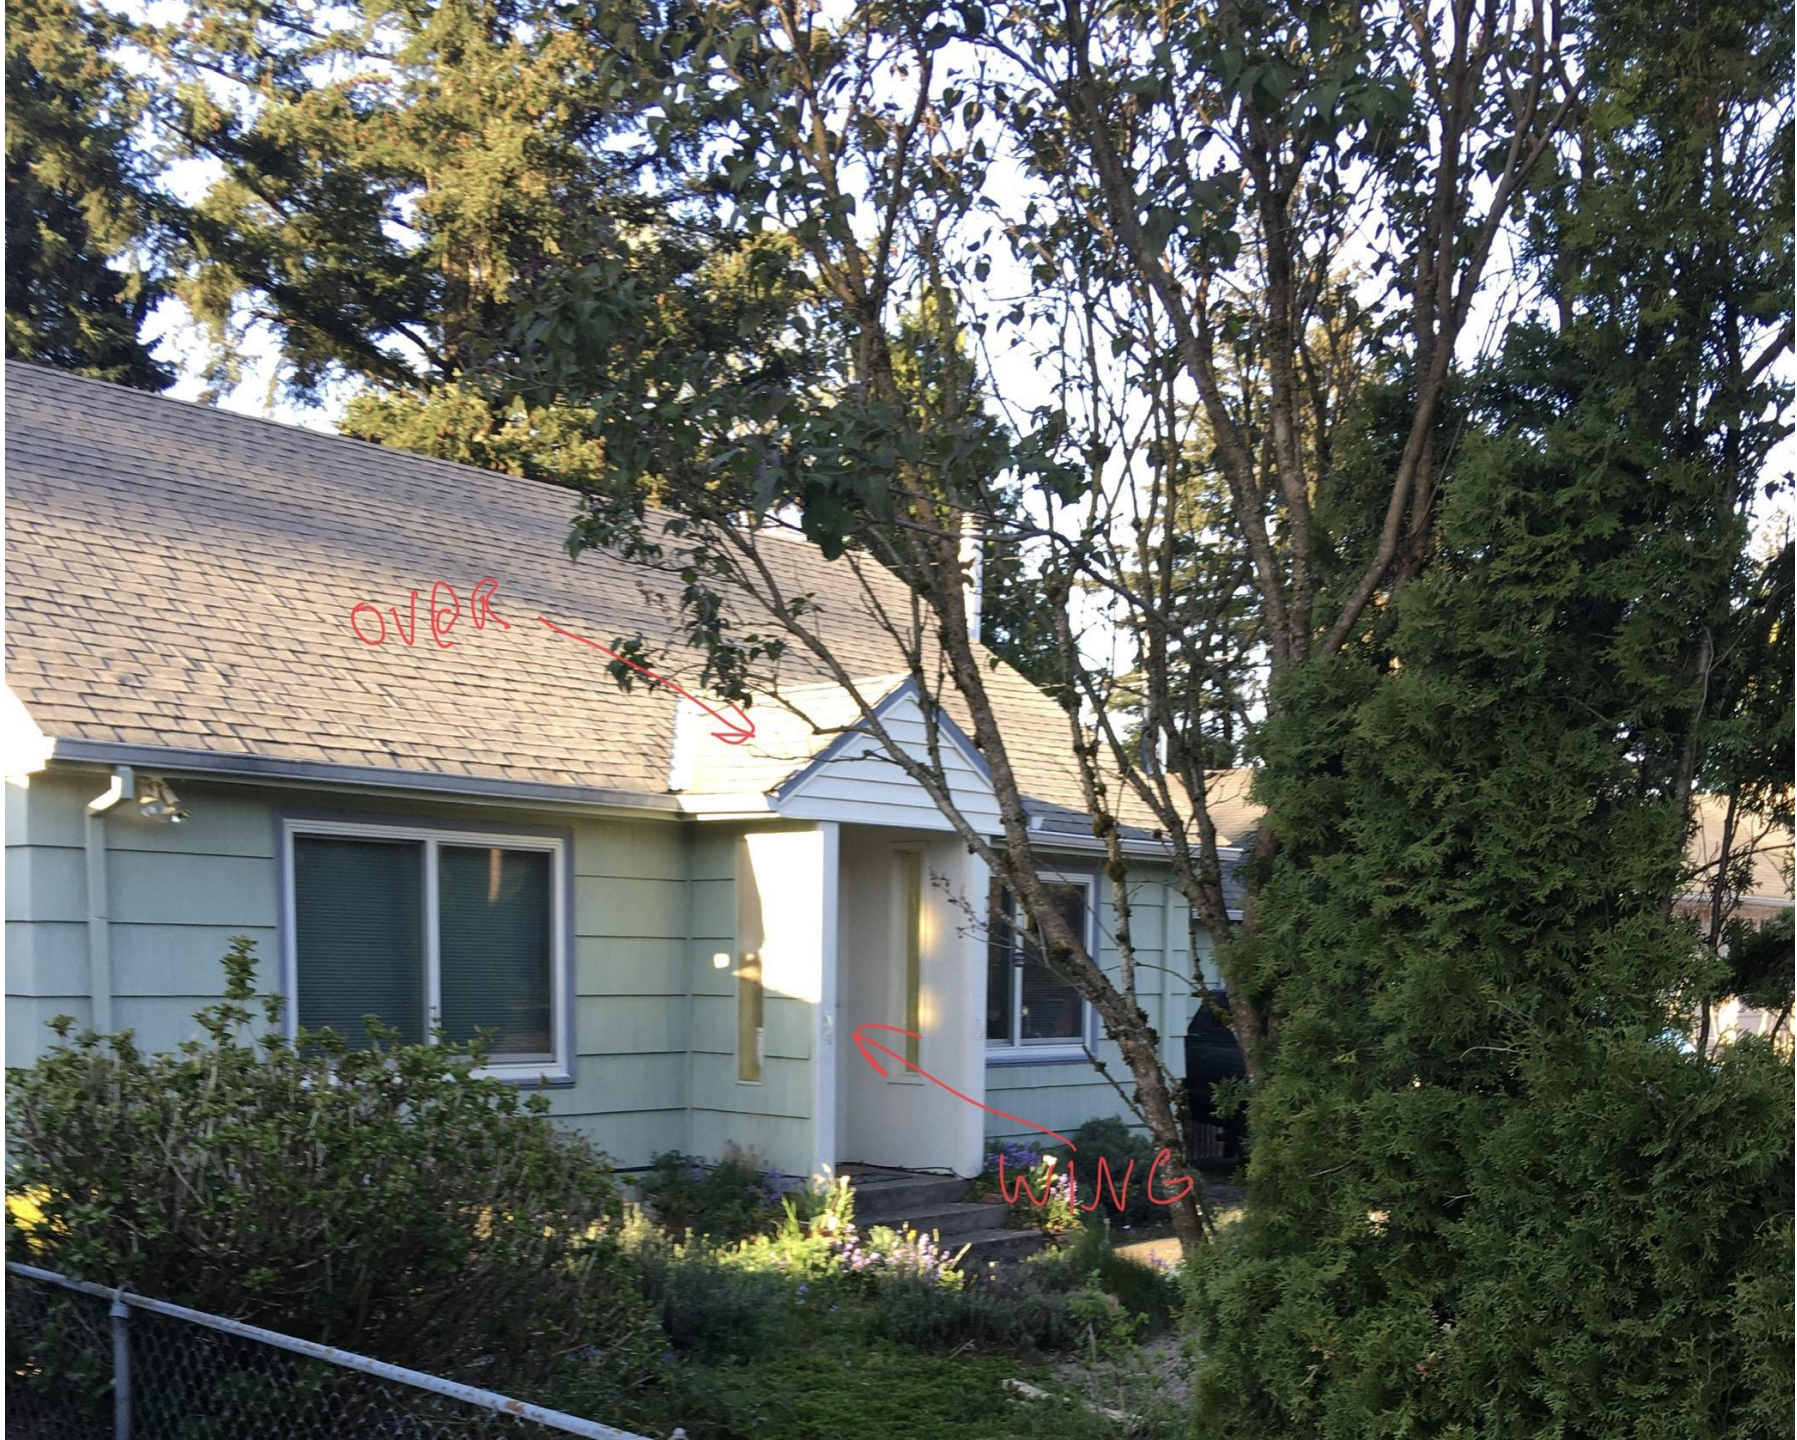
OVER

WING

← ov@w

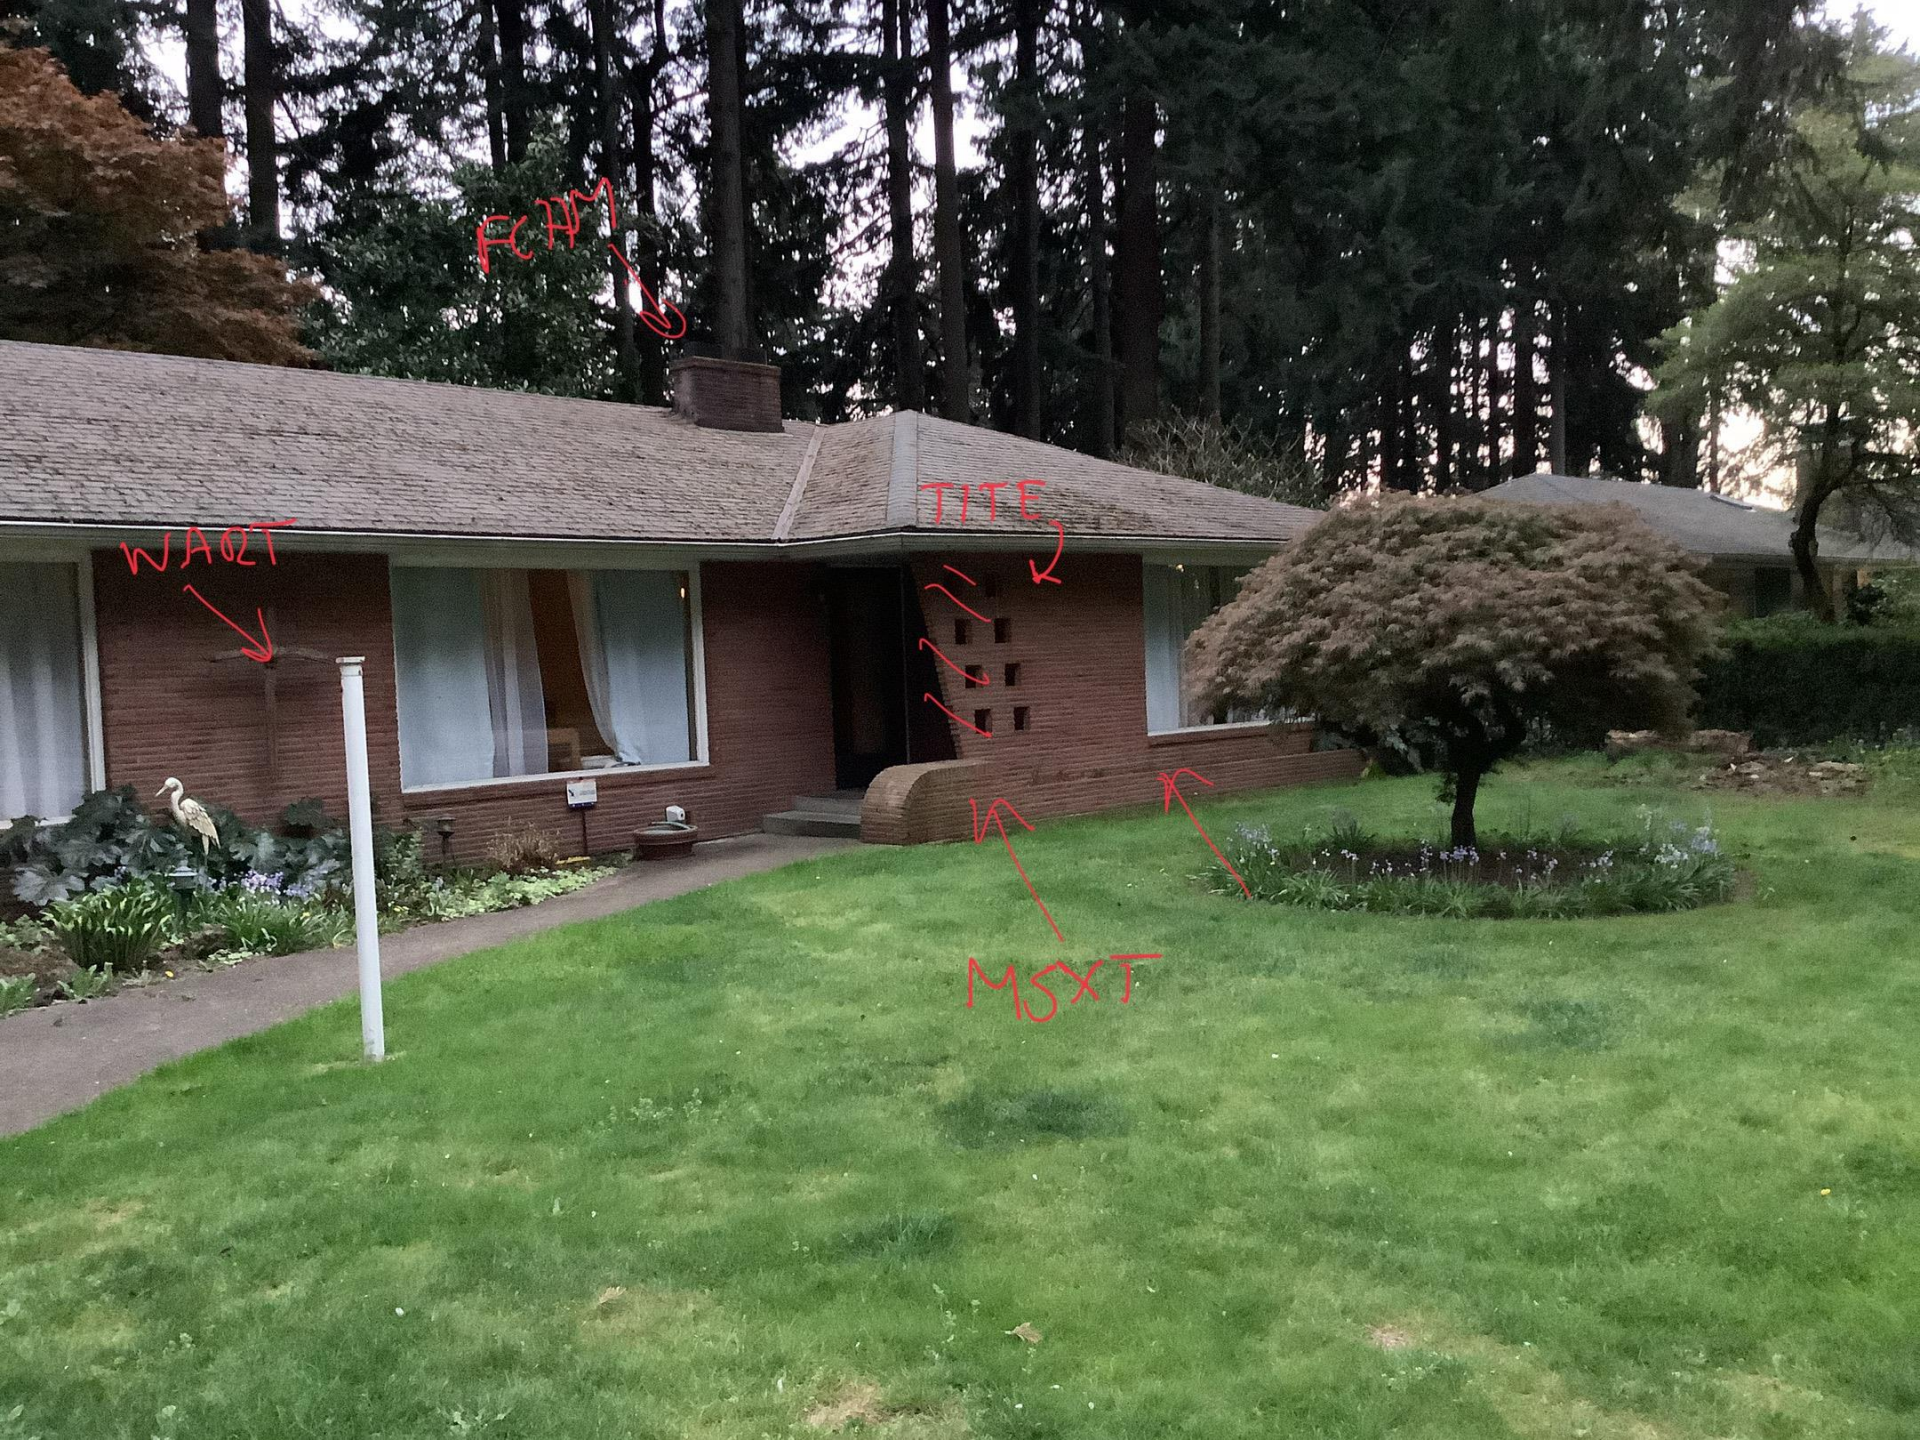
FCHM

WAQT

TITE

MSXT

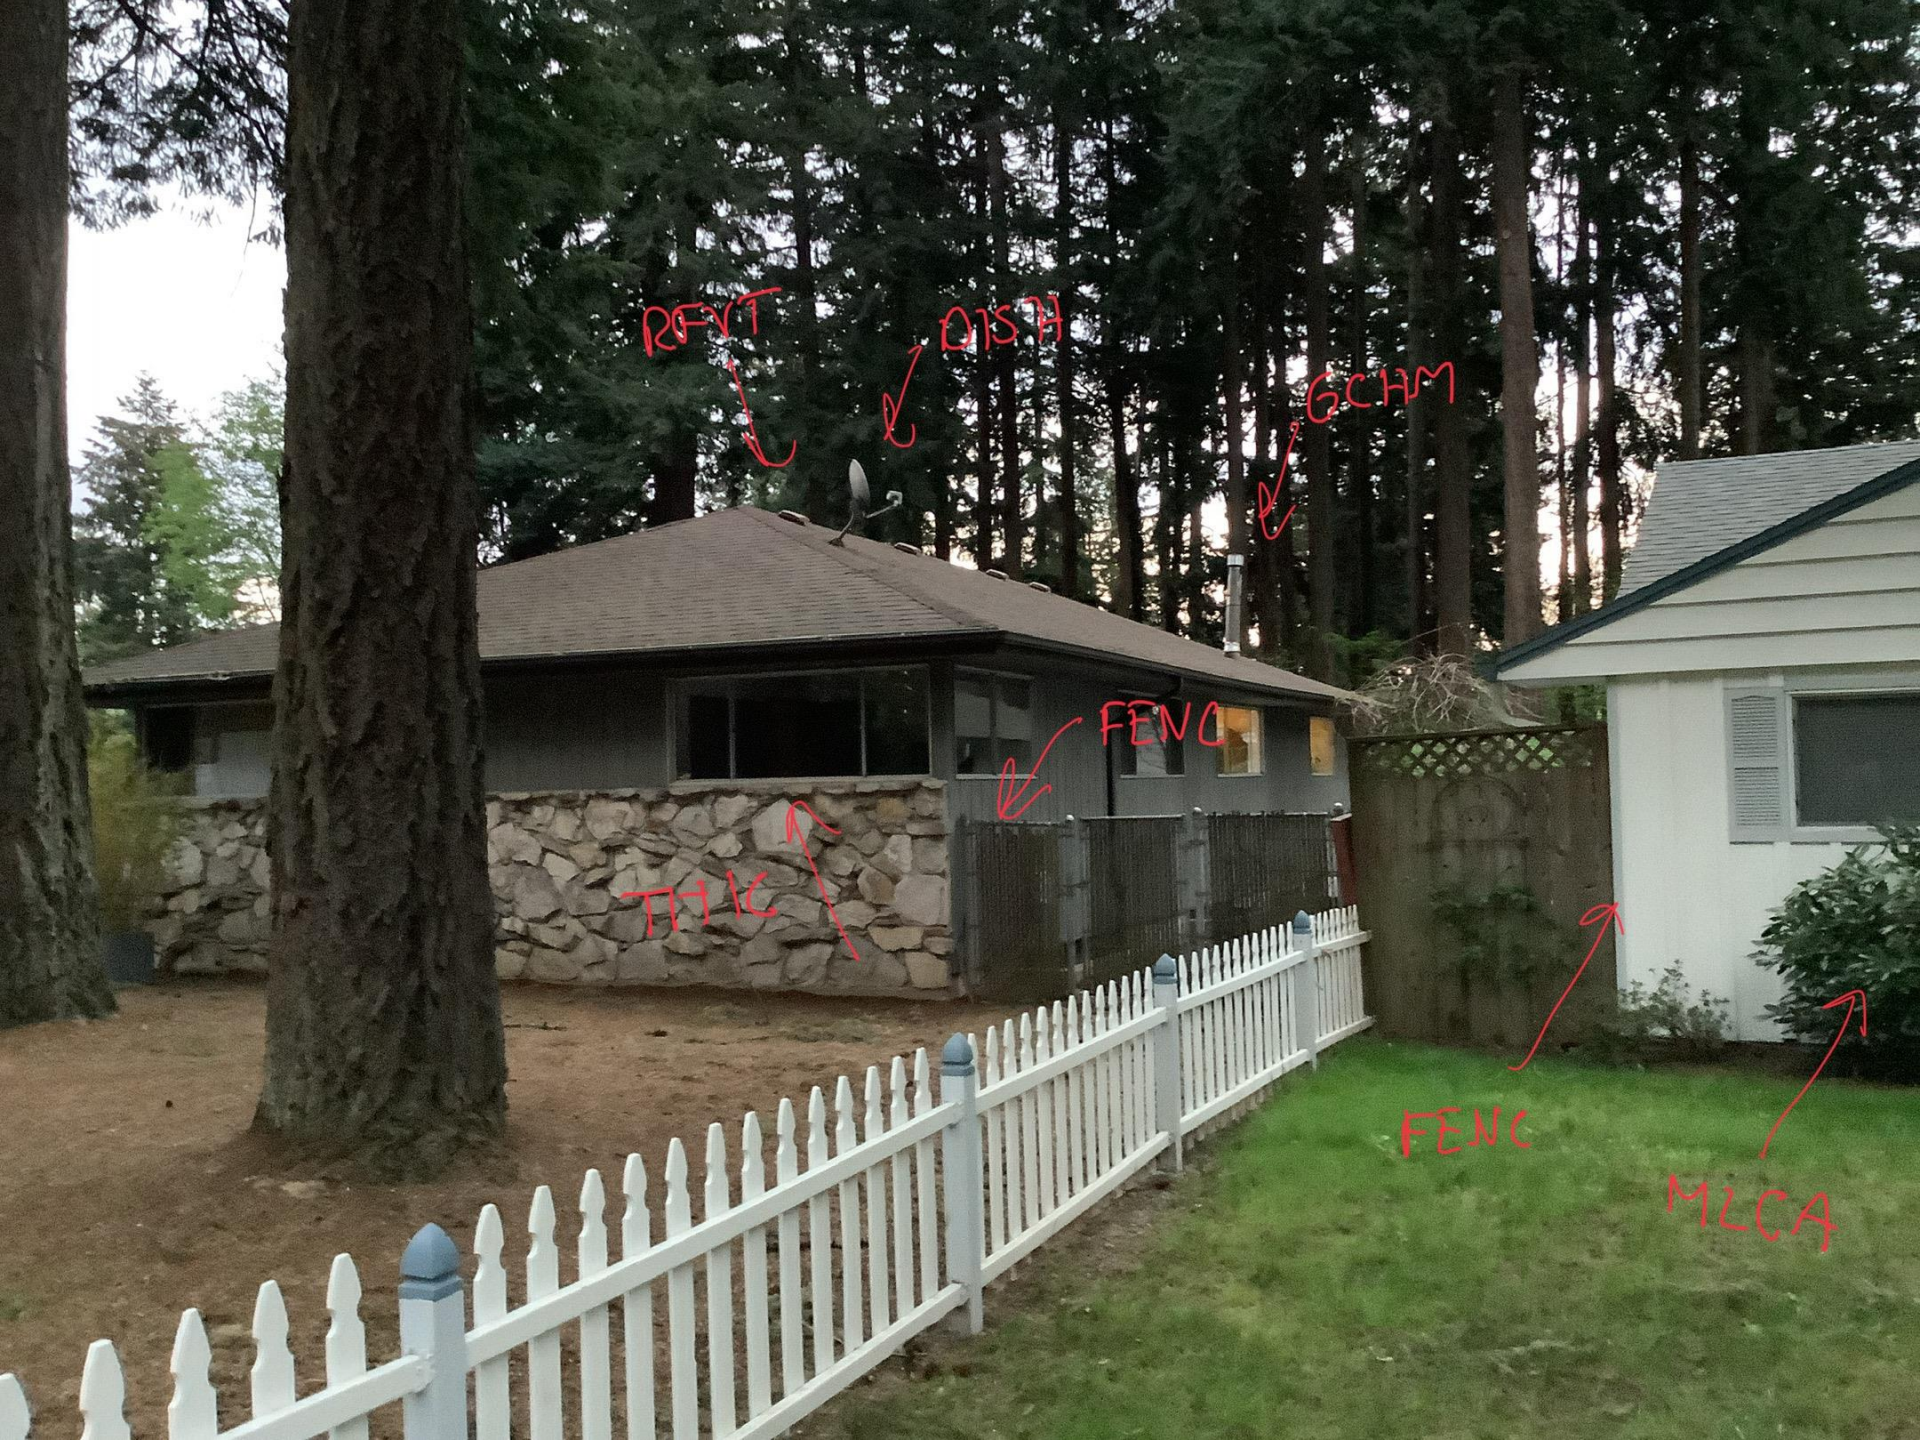
DISH

GCHM

FENC

THIC

MLCA

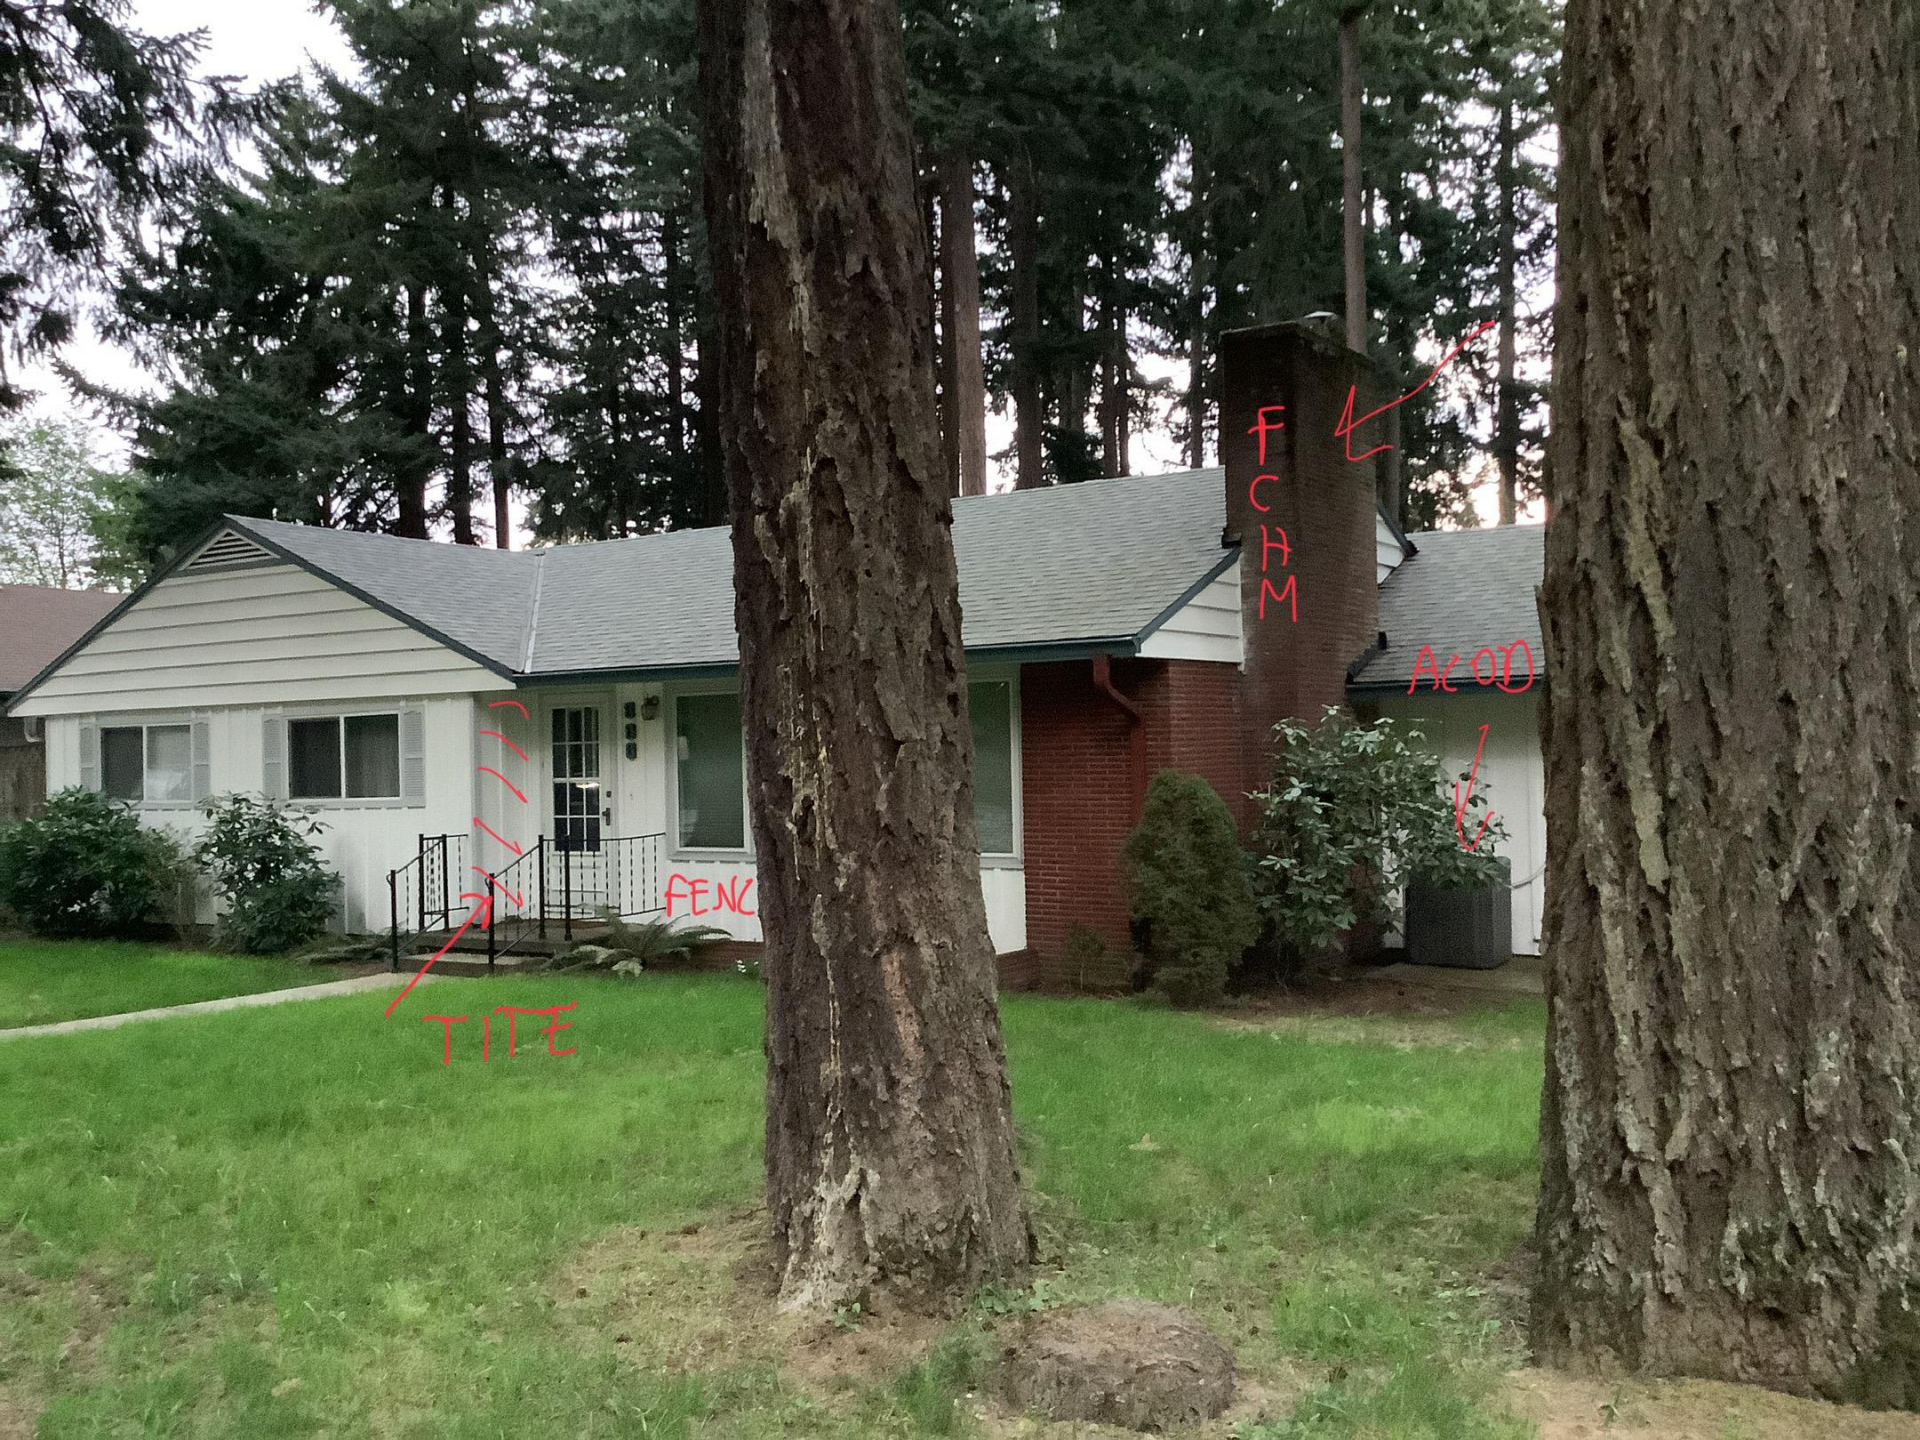
TITE

FENCE

F  
C  
H  
M

ACOD

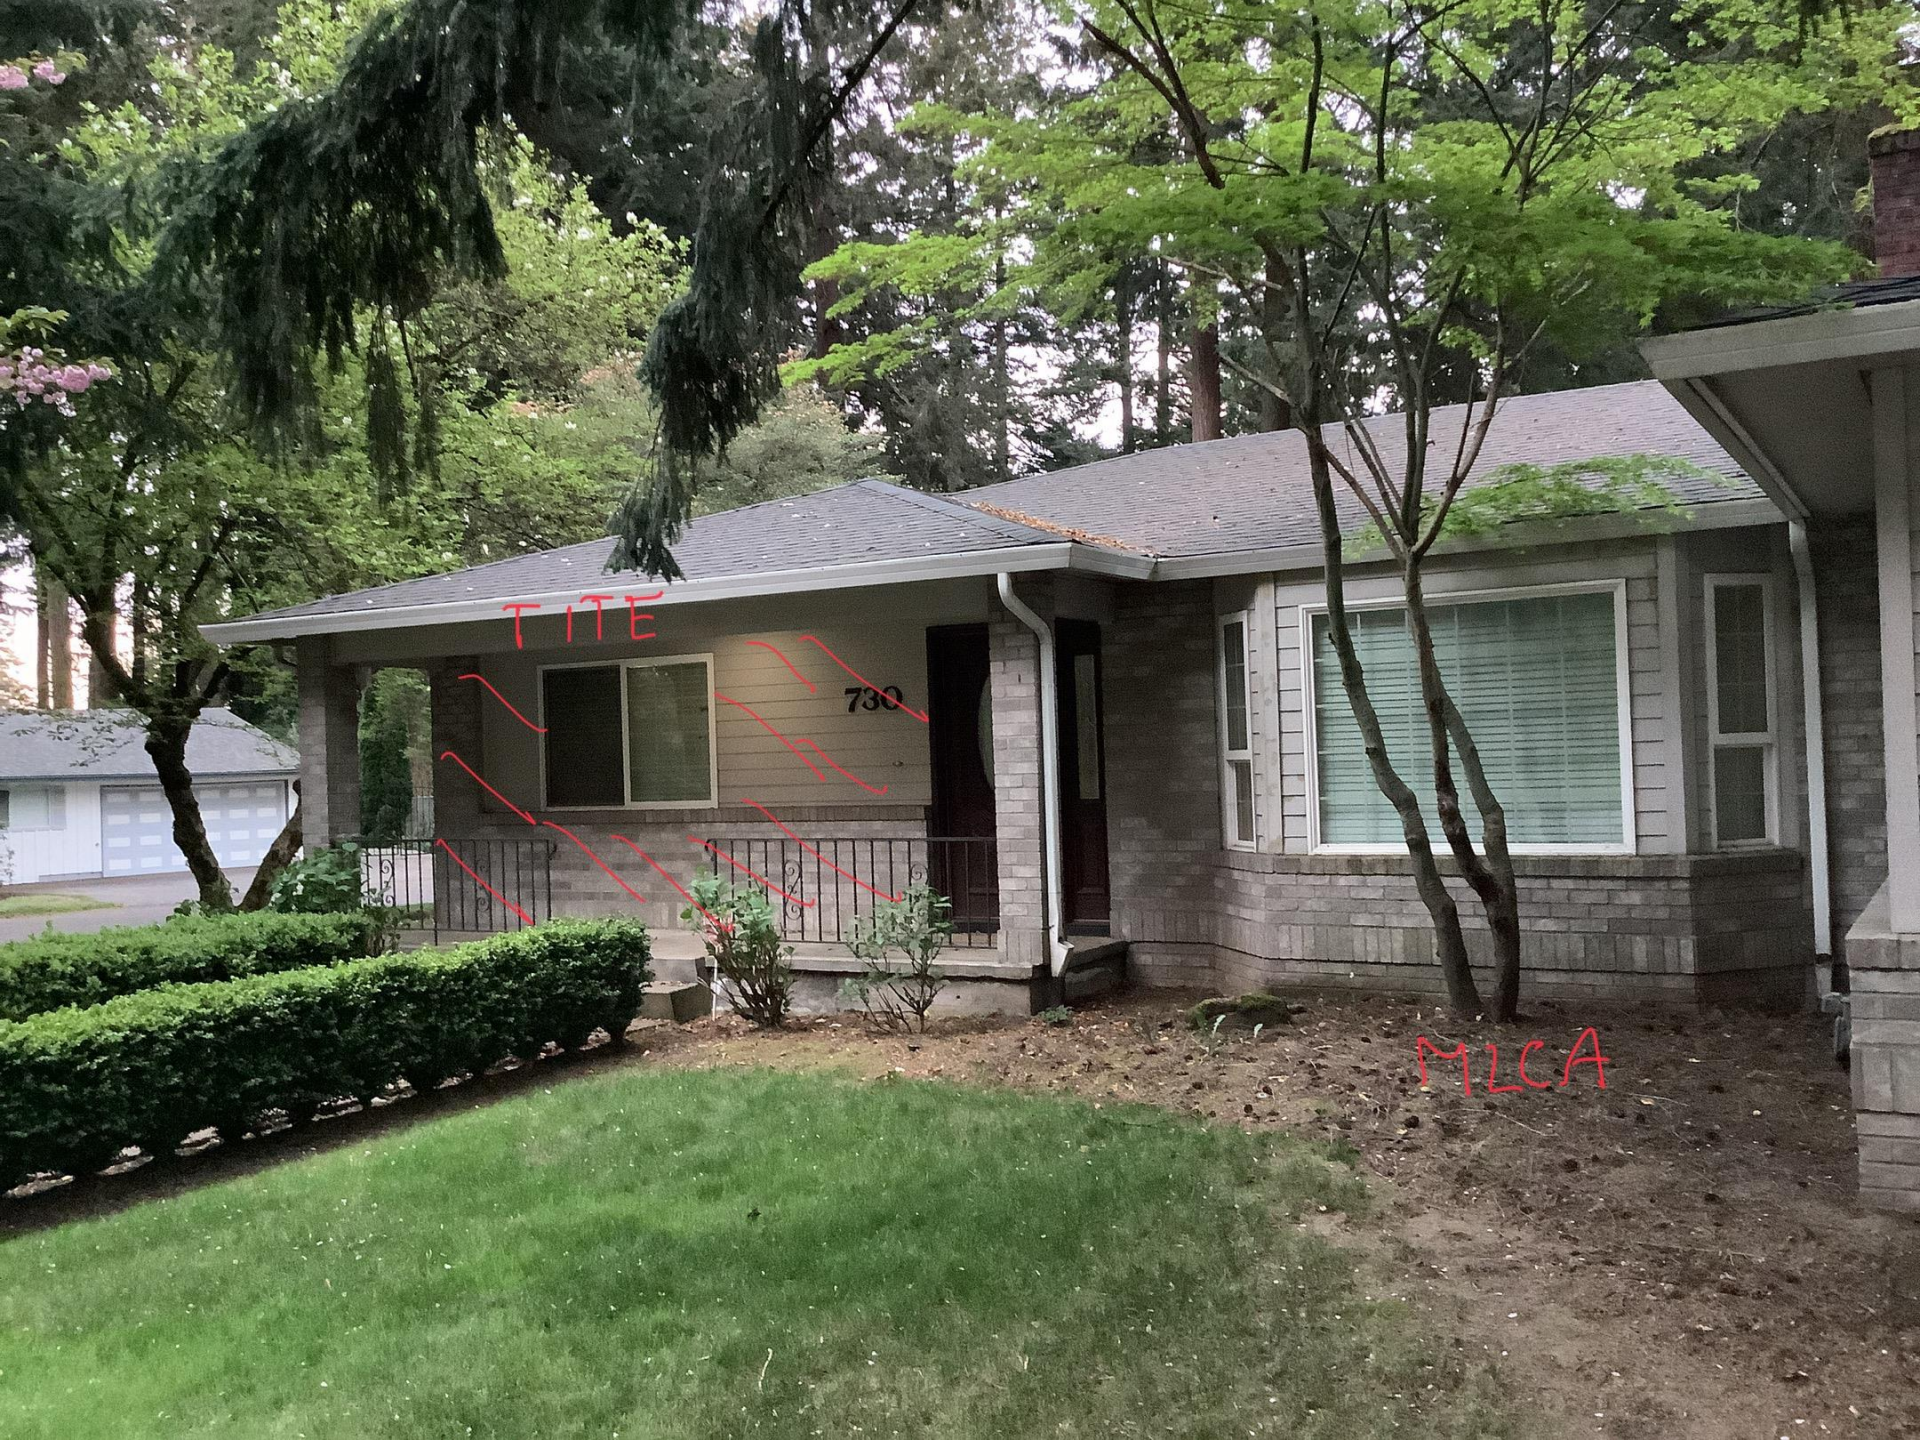
TITE

MLCA

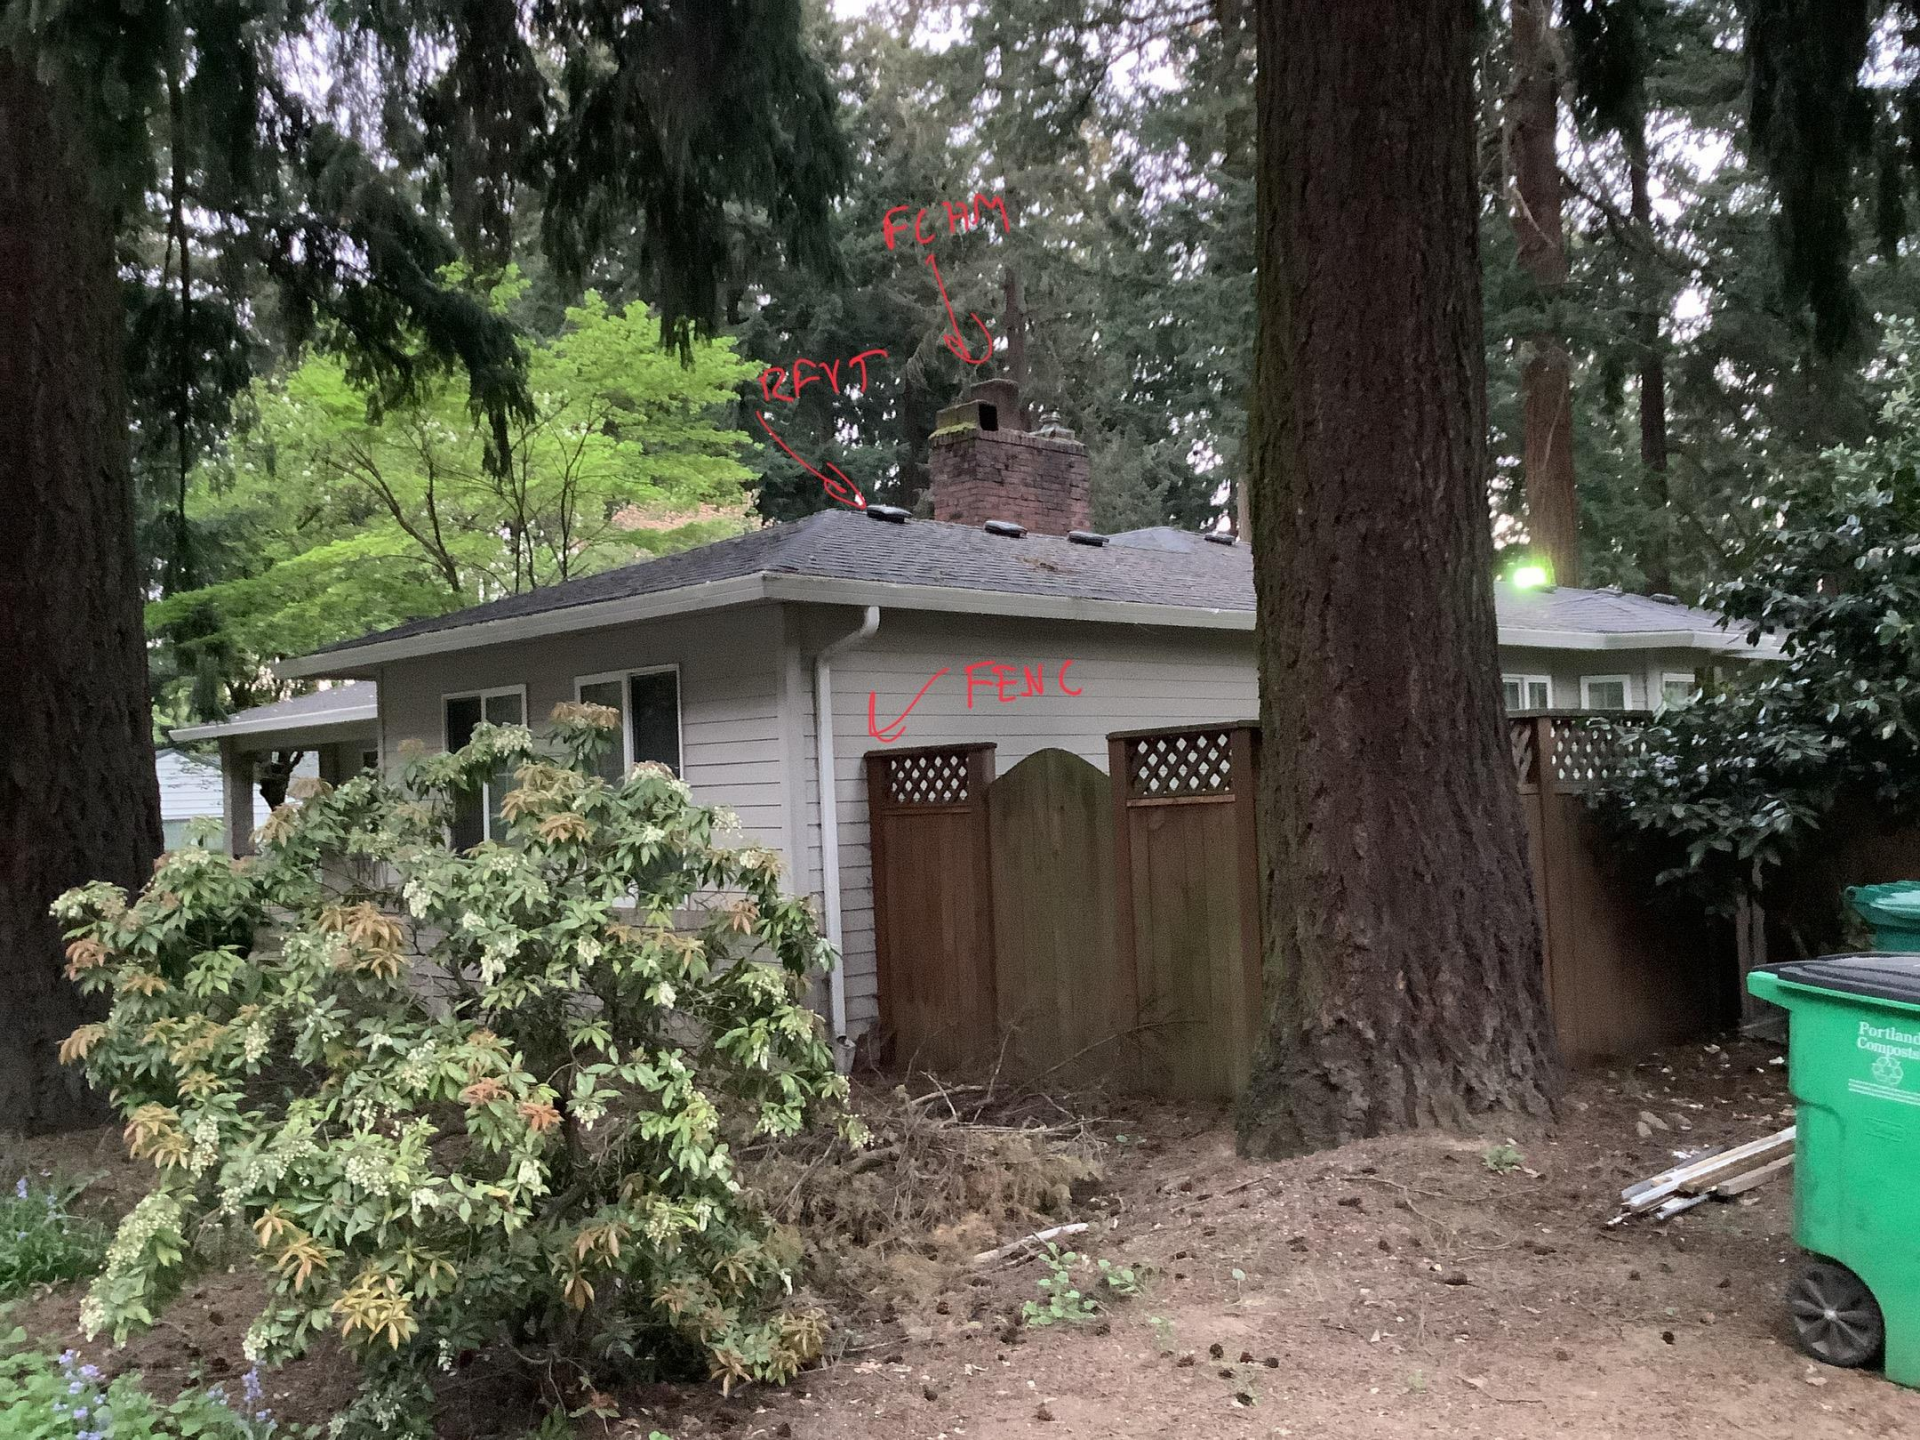
FC RM

RFVT

FENC

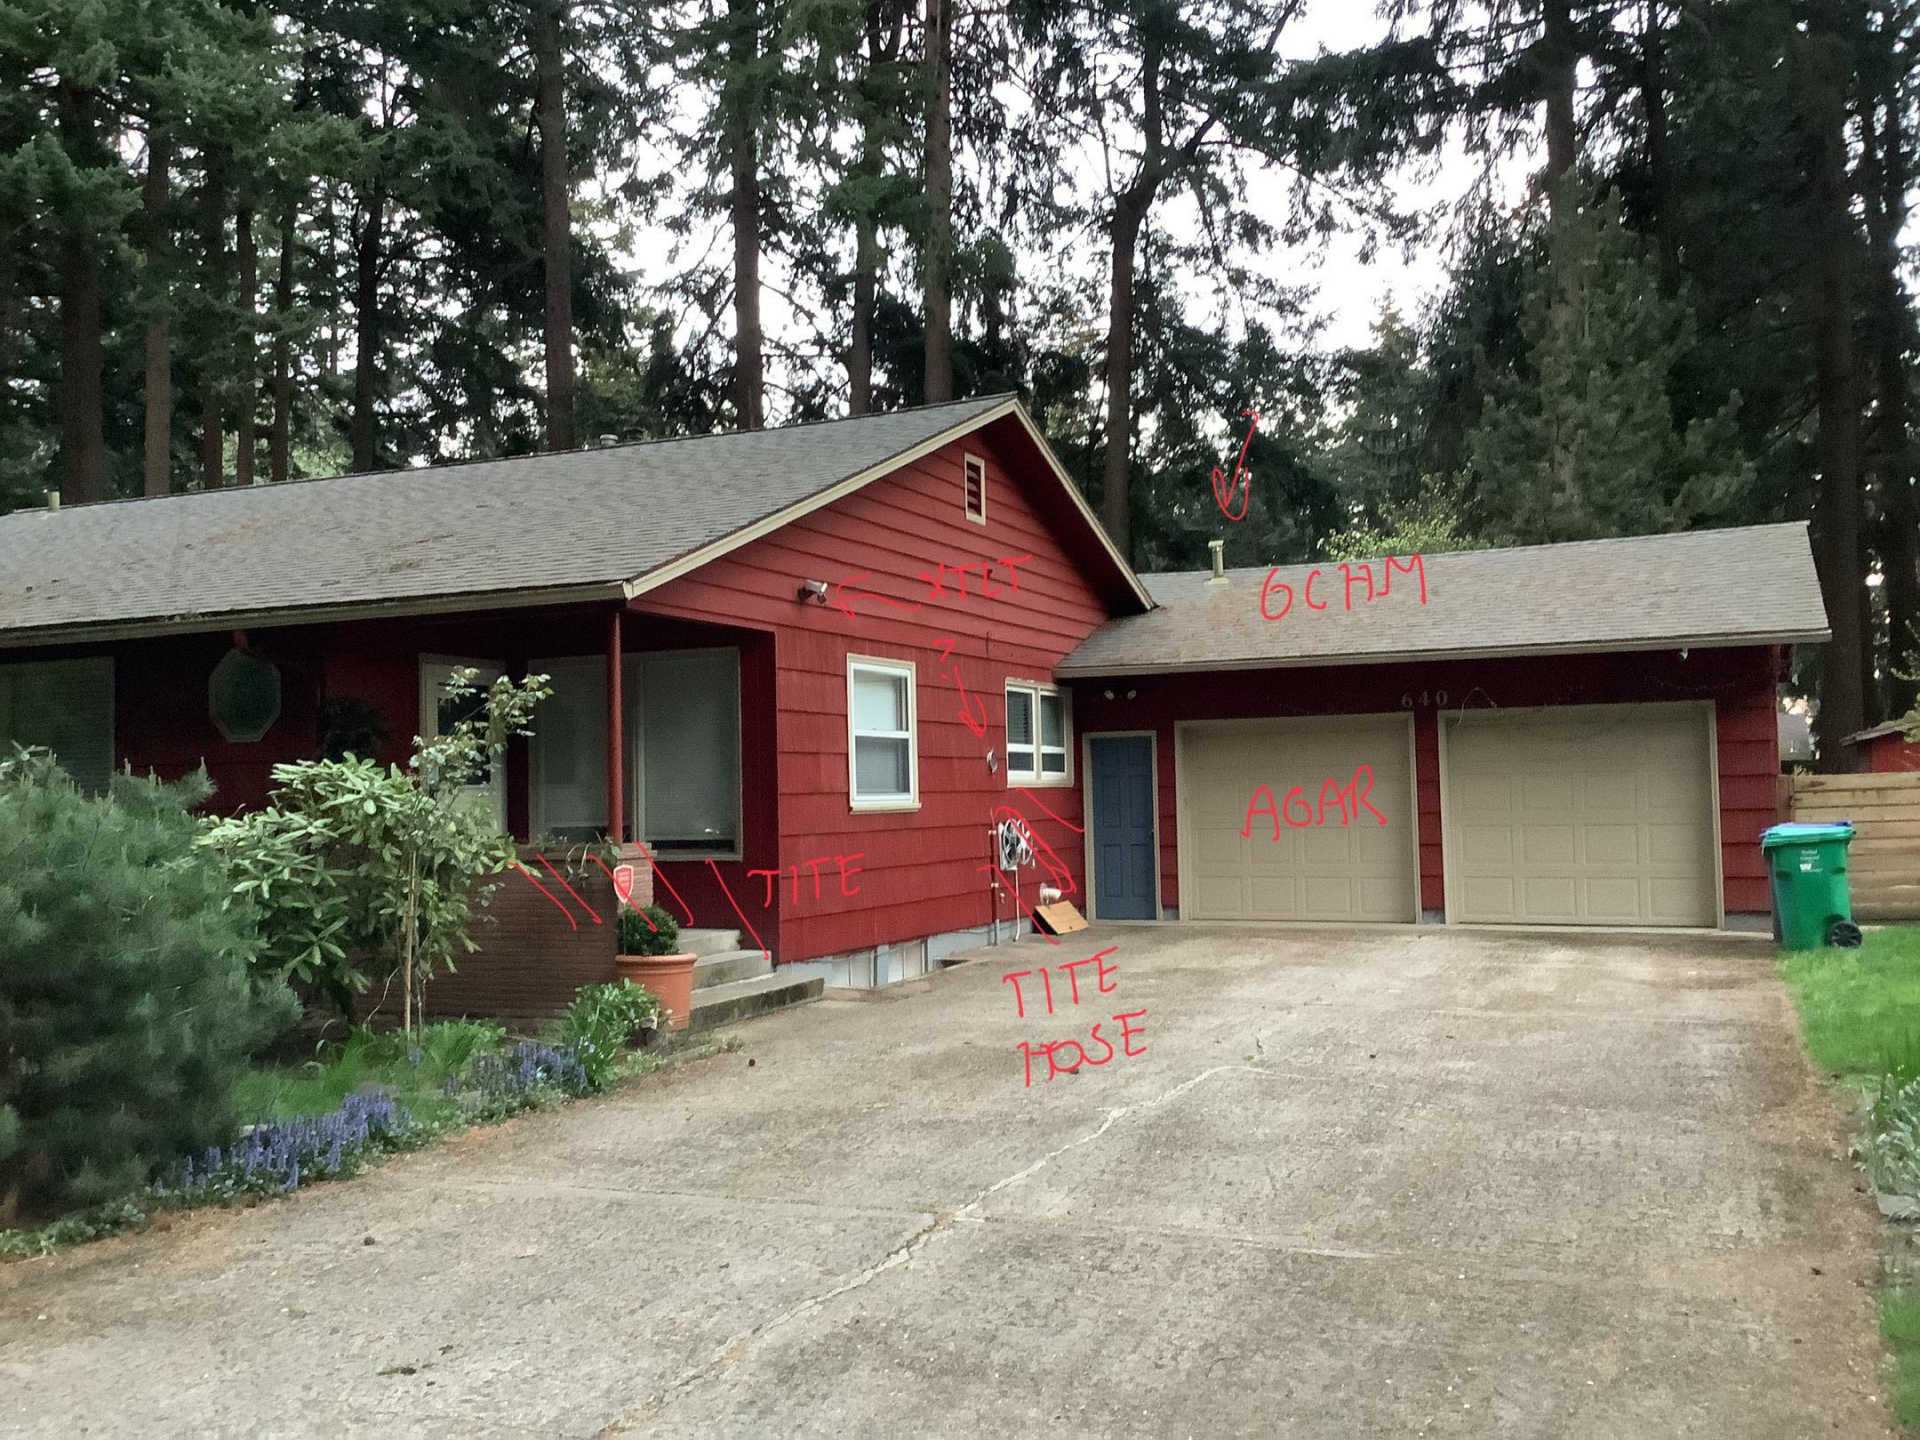
TITE

6CHM

AGAR
