# Retrofit conditions potentially complicating air-sealing and exterior insulation

A brief street-view survey of residential housing in  
Portland, Oregon (Glenfair, Glendoveer, Rockwood nhds)

20 April 2021

Graham S. Wright

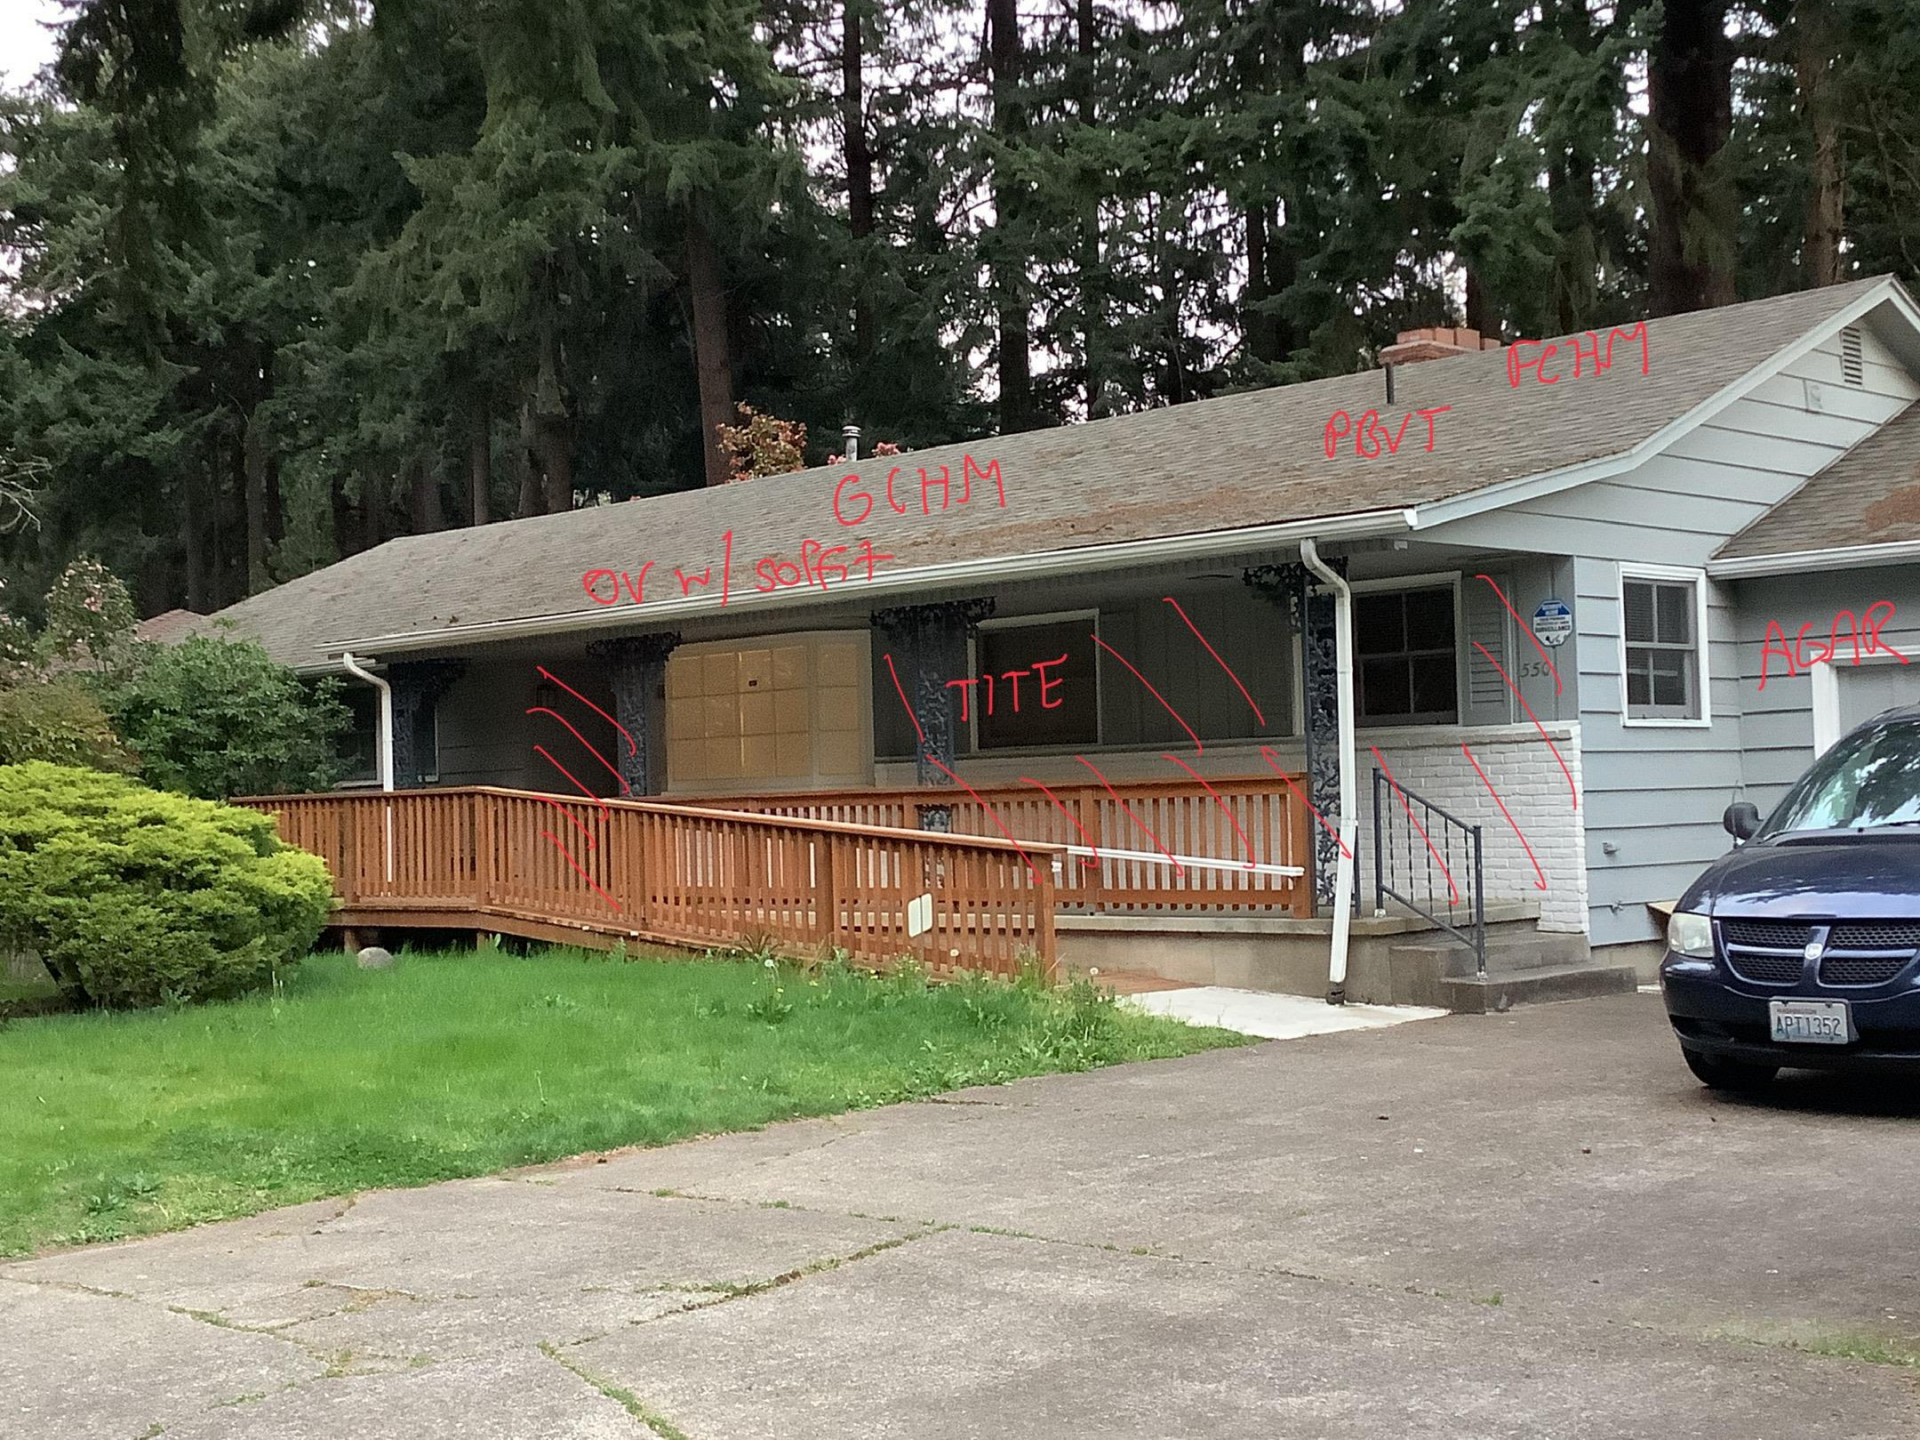
GCHM  
OV w/ soft

PBVT  
FCHM

TITE

AGAR

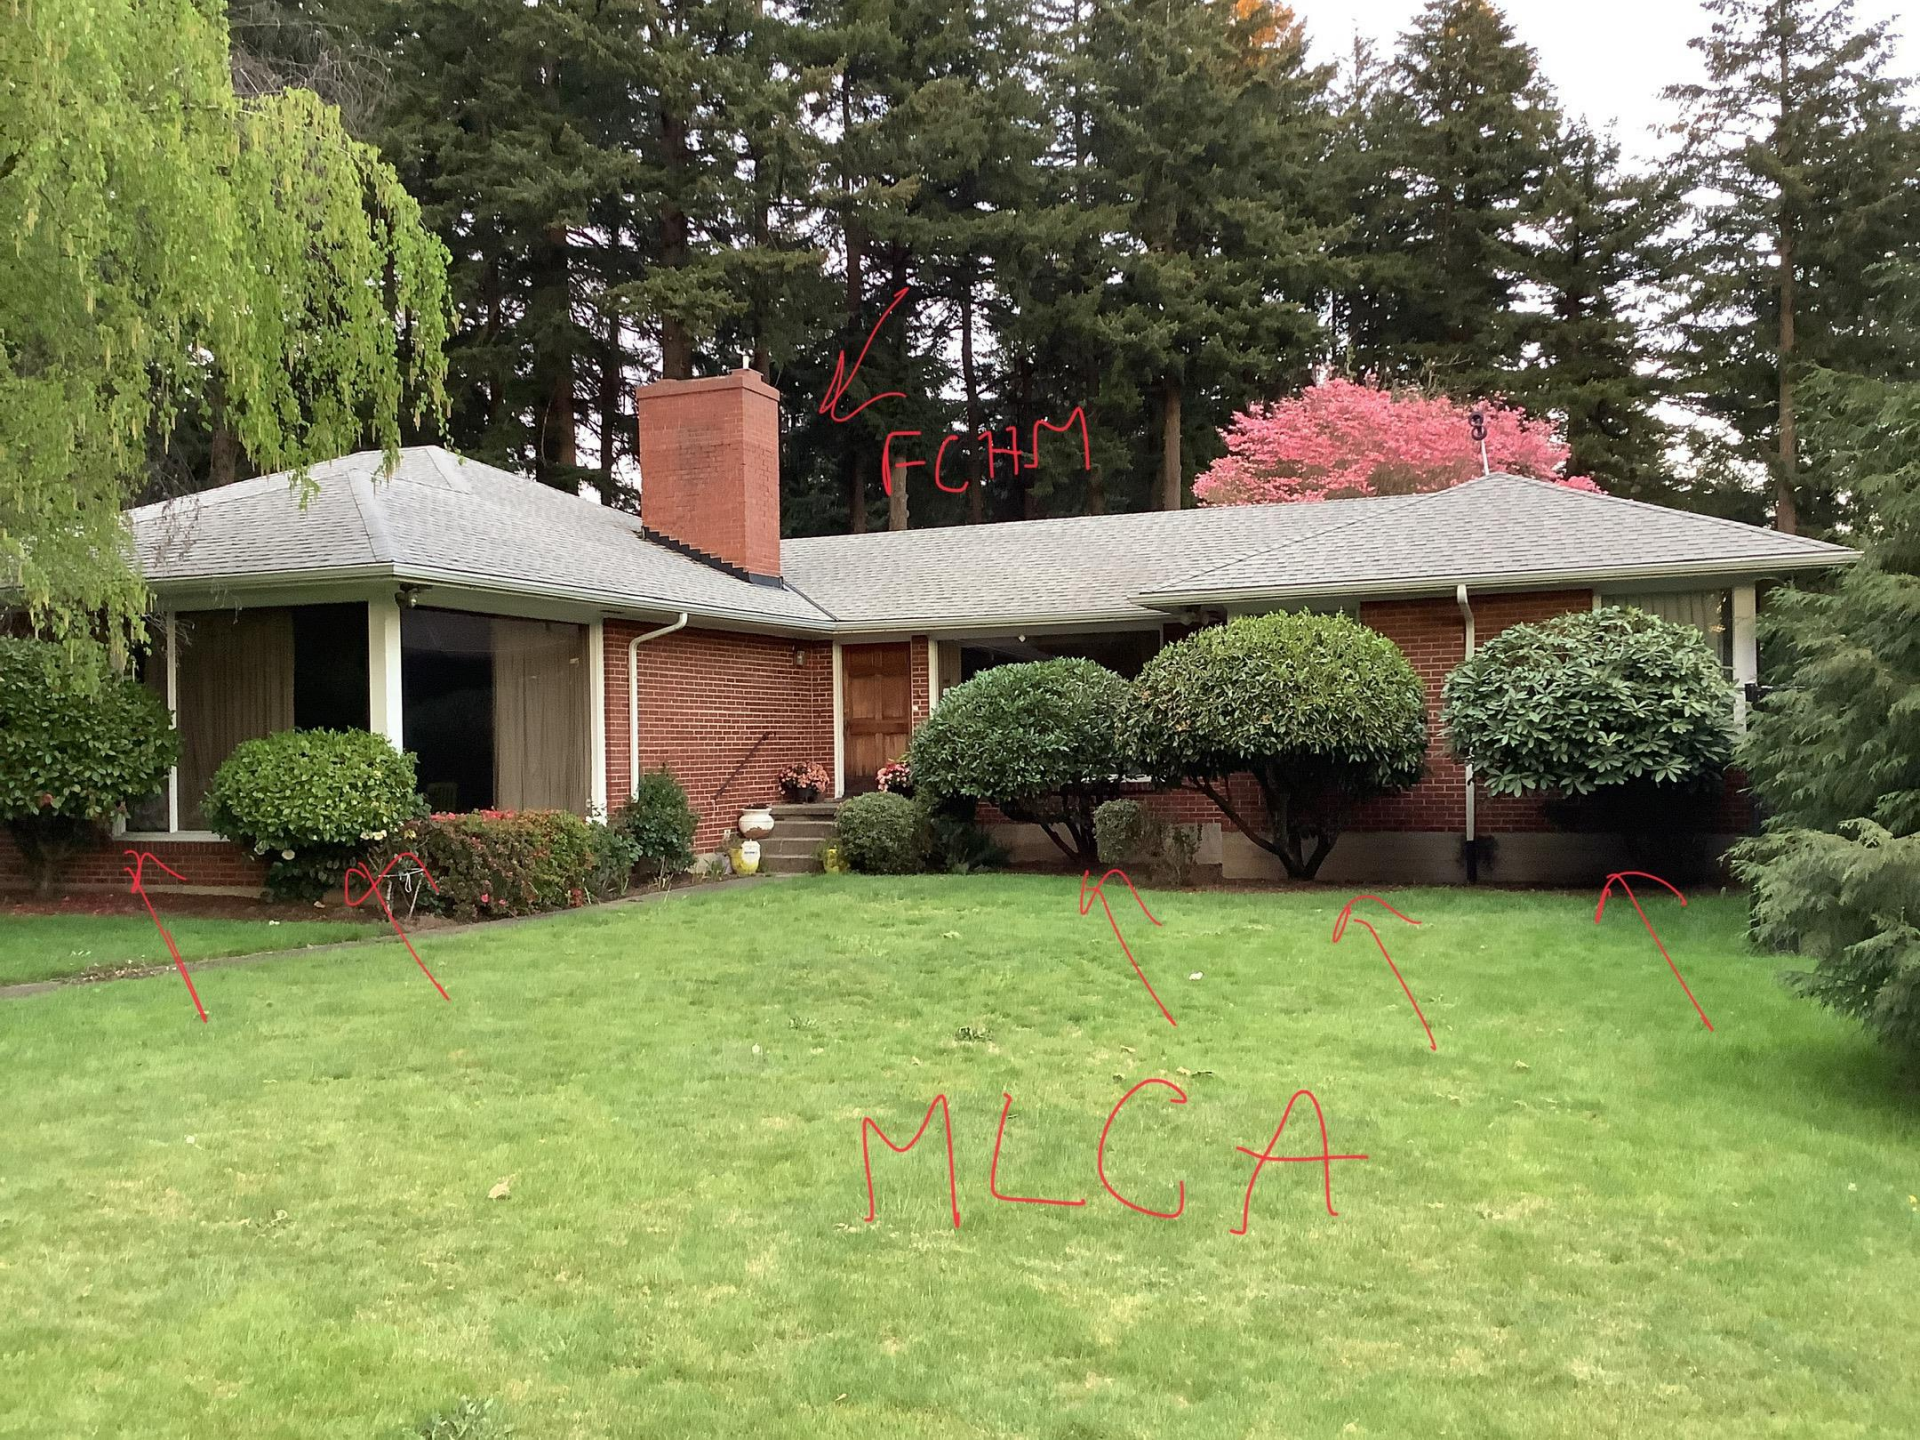
FCHM

MLCA

FLAM →

XTLT ↓

TITE ↓

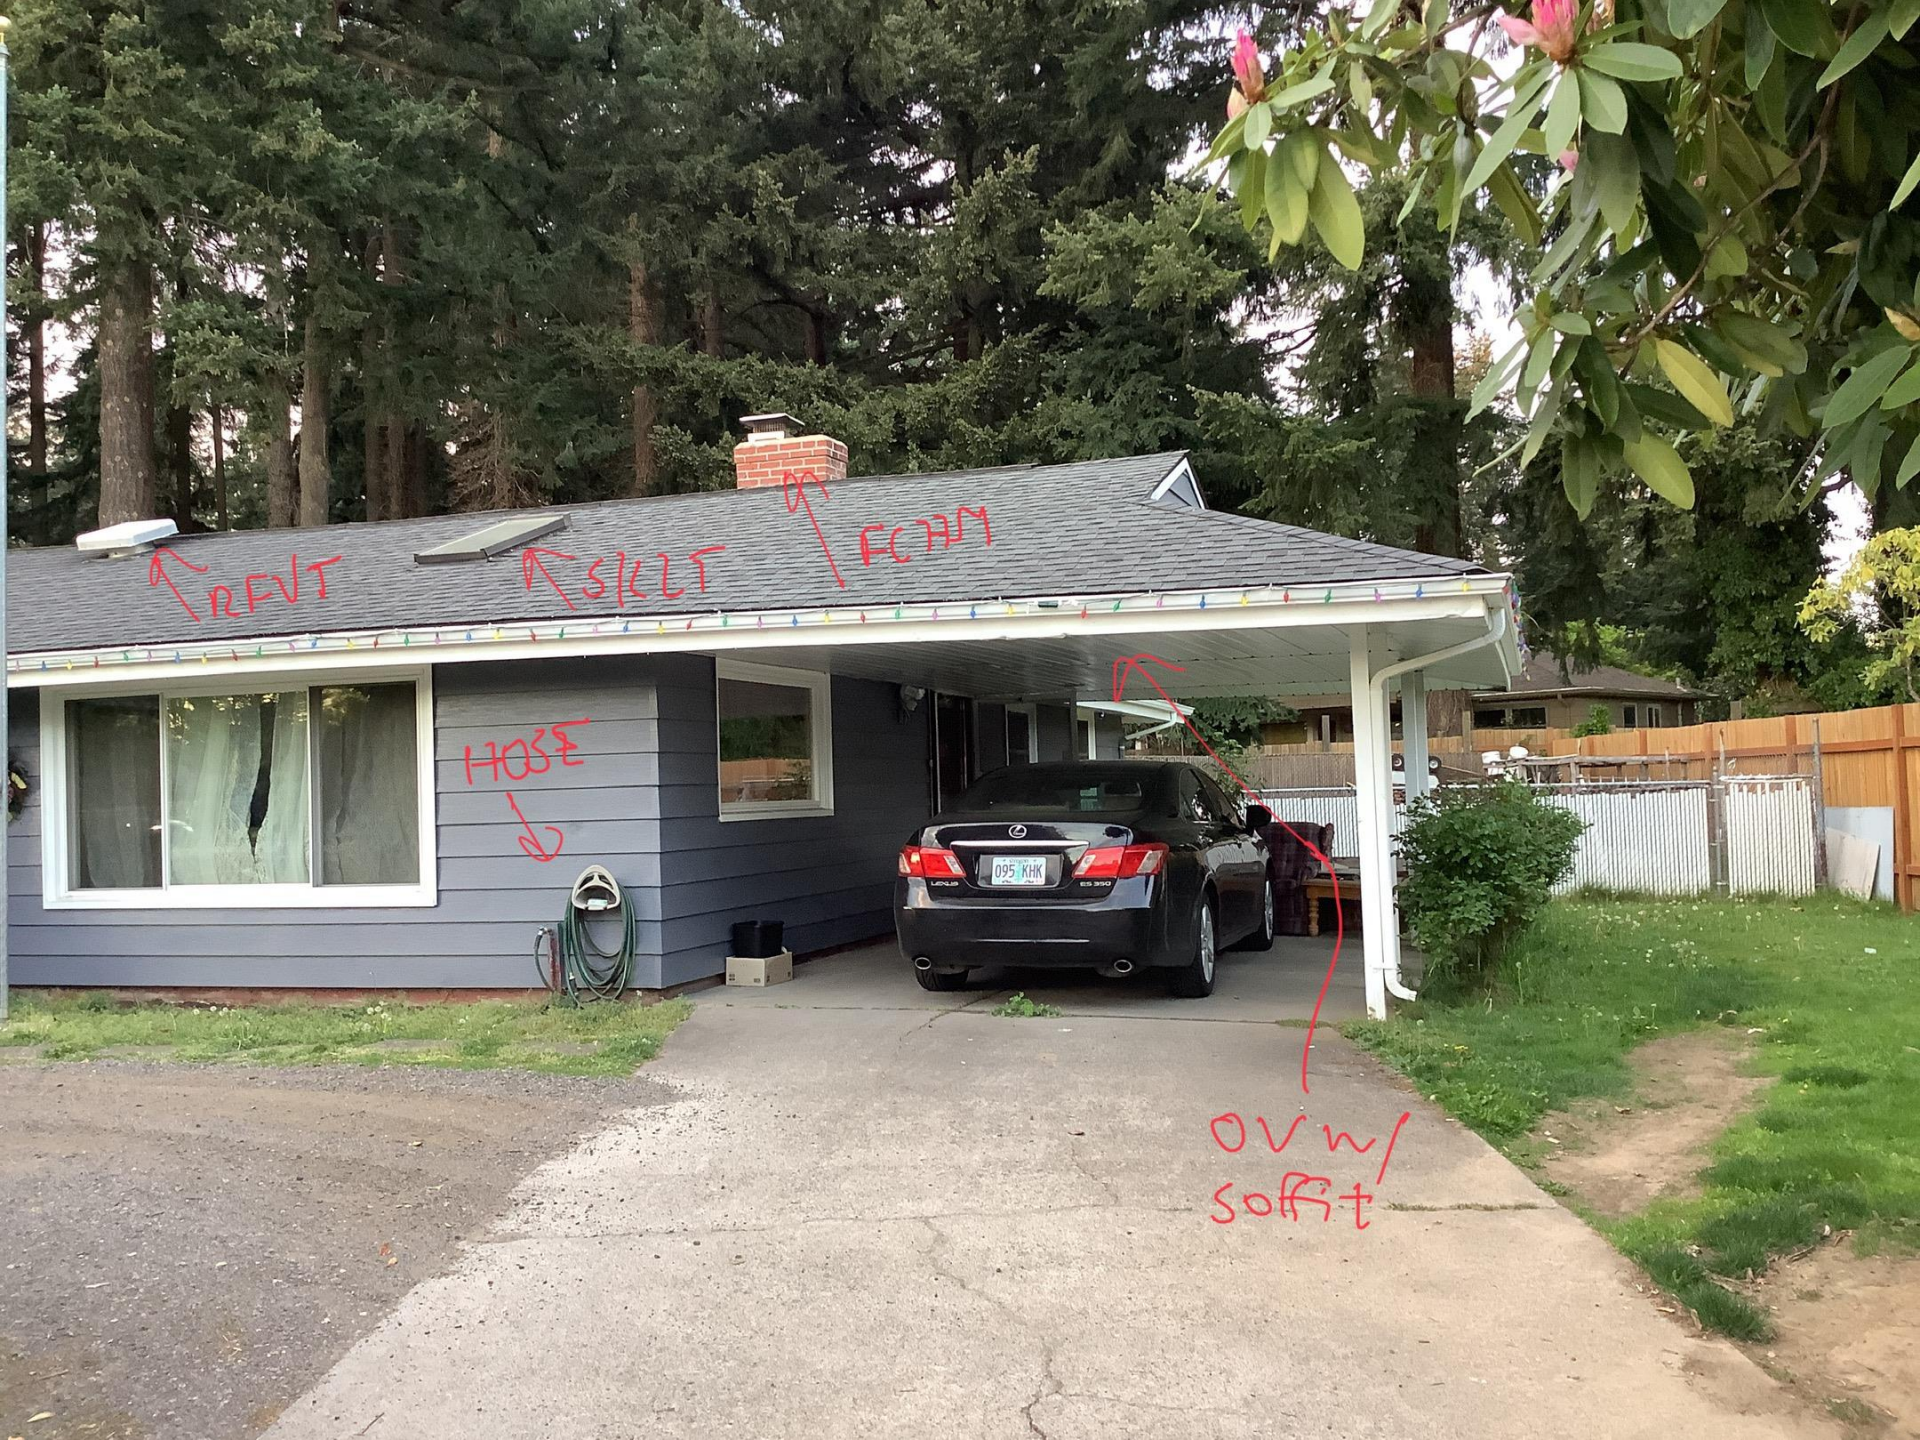
REVT

SILT

HOSE

OV w/  
soffit

STOV

FCAM

SKLT

FENC

AGAN OVER

TITE

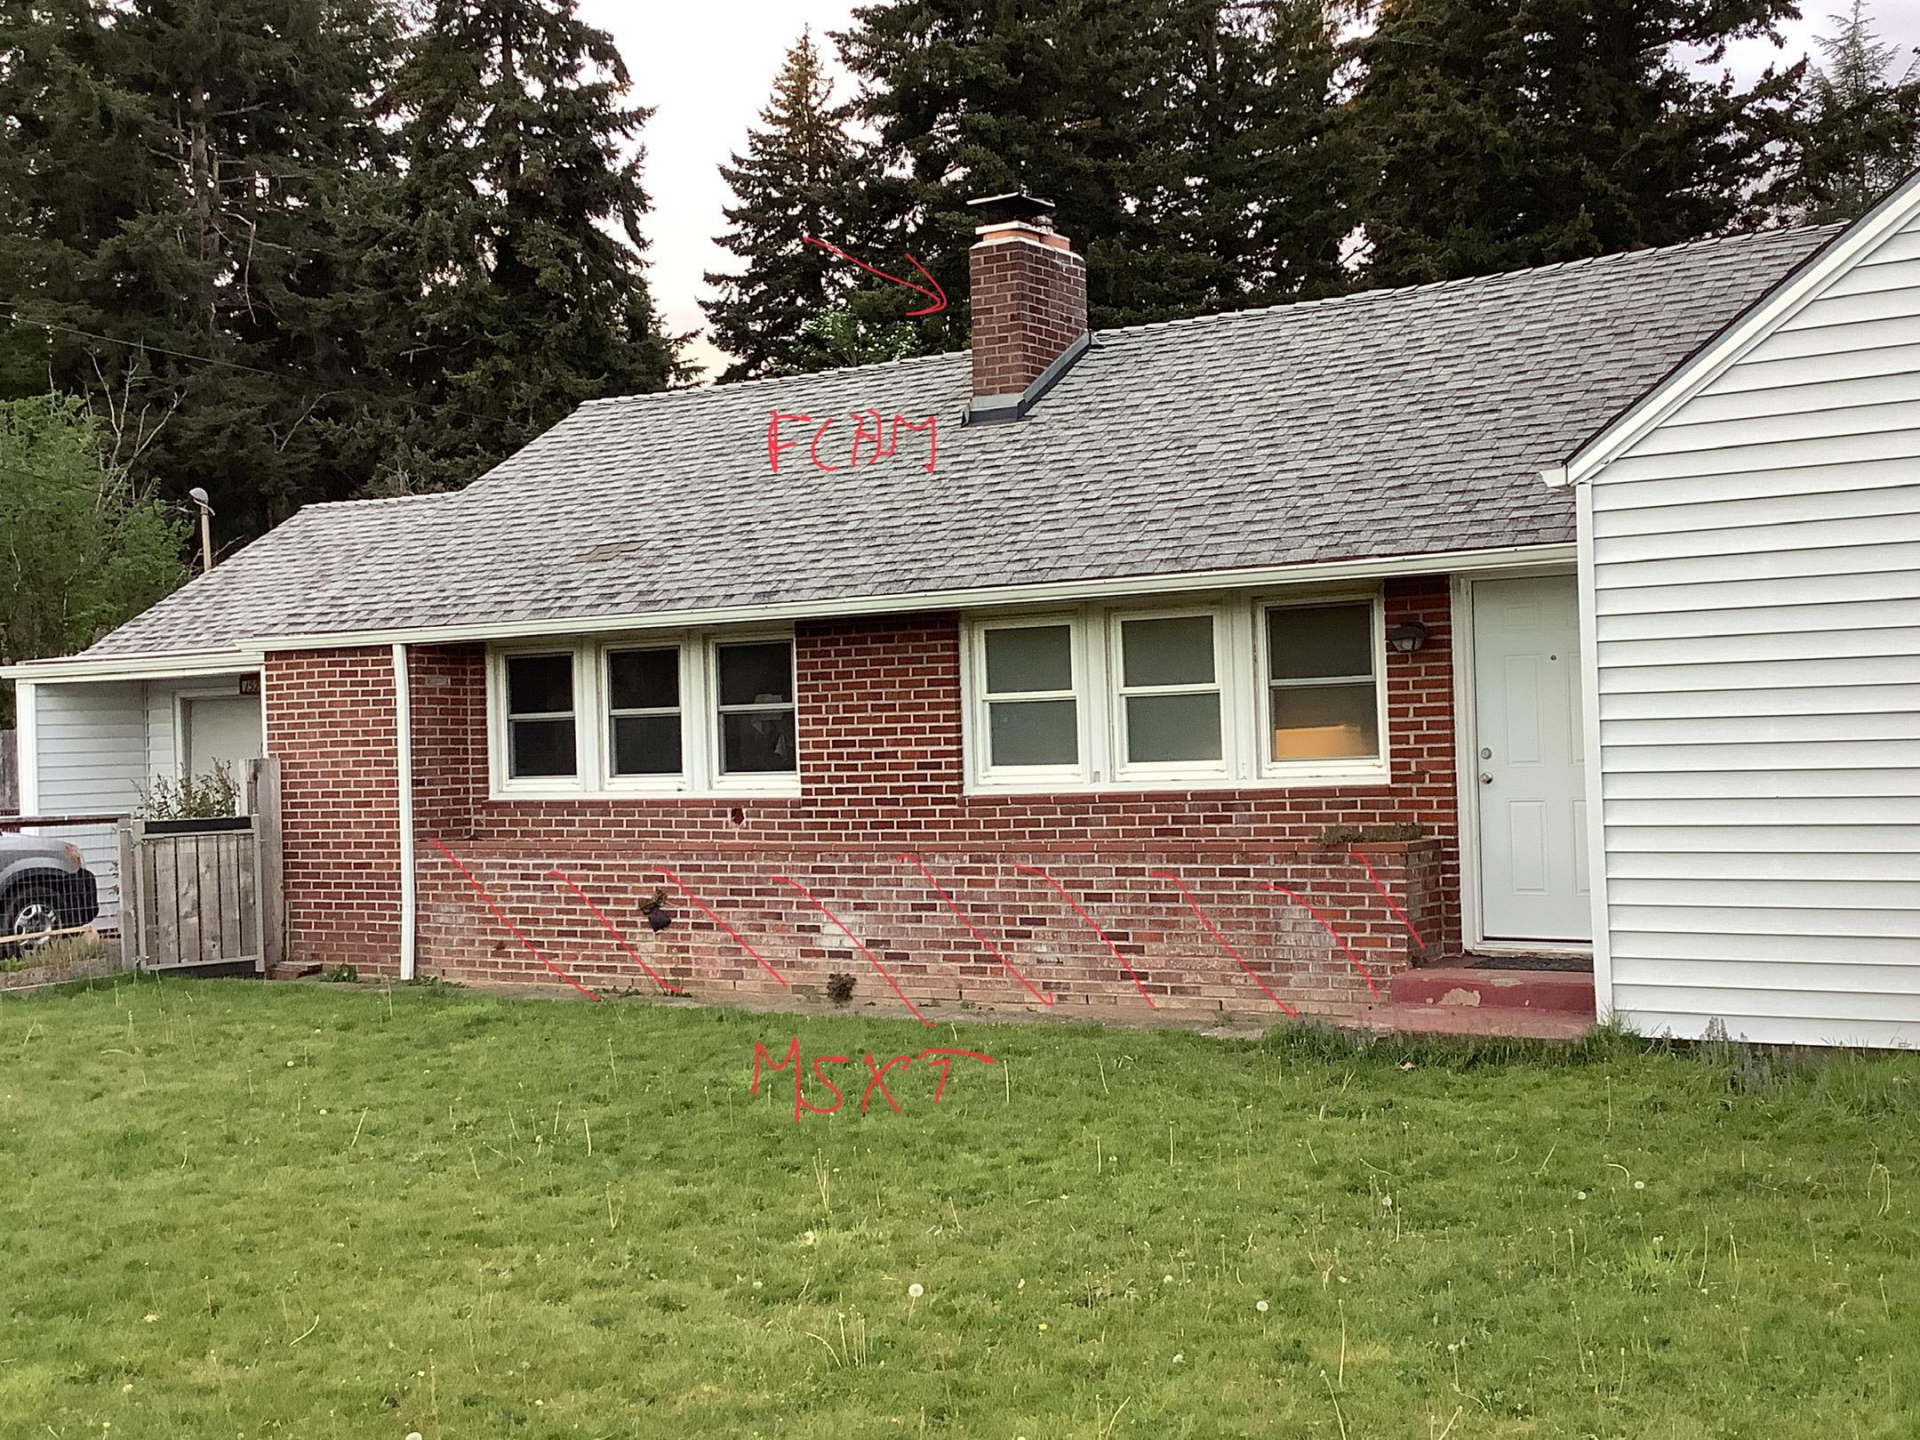
FCAM

MSX7

←  
FCHM

↙ THIC

AGAR

TITE  
ENTR  
GMTR

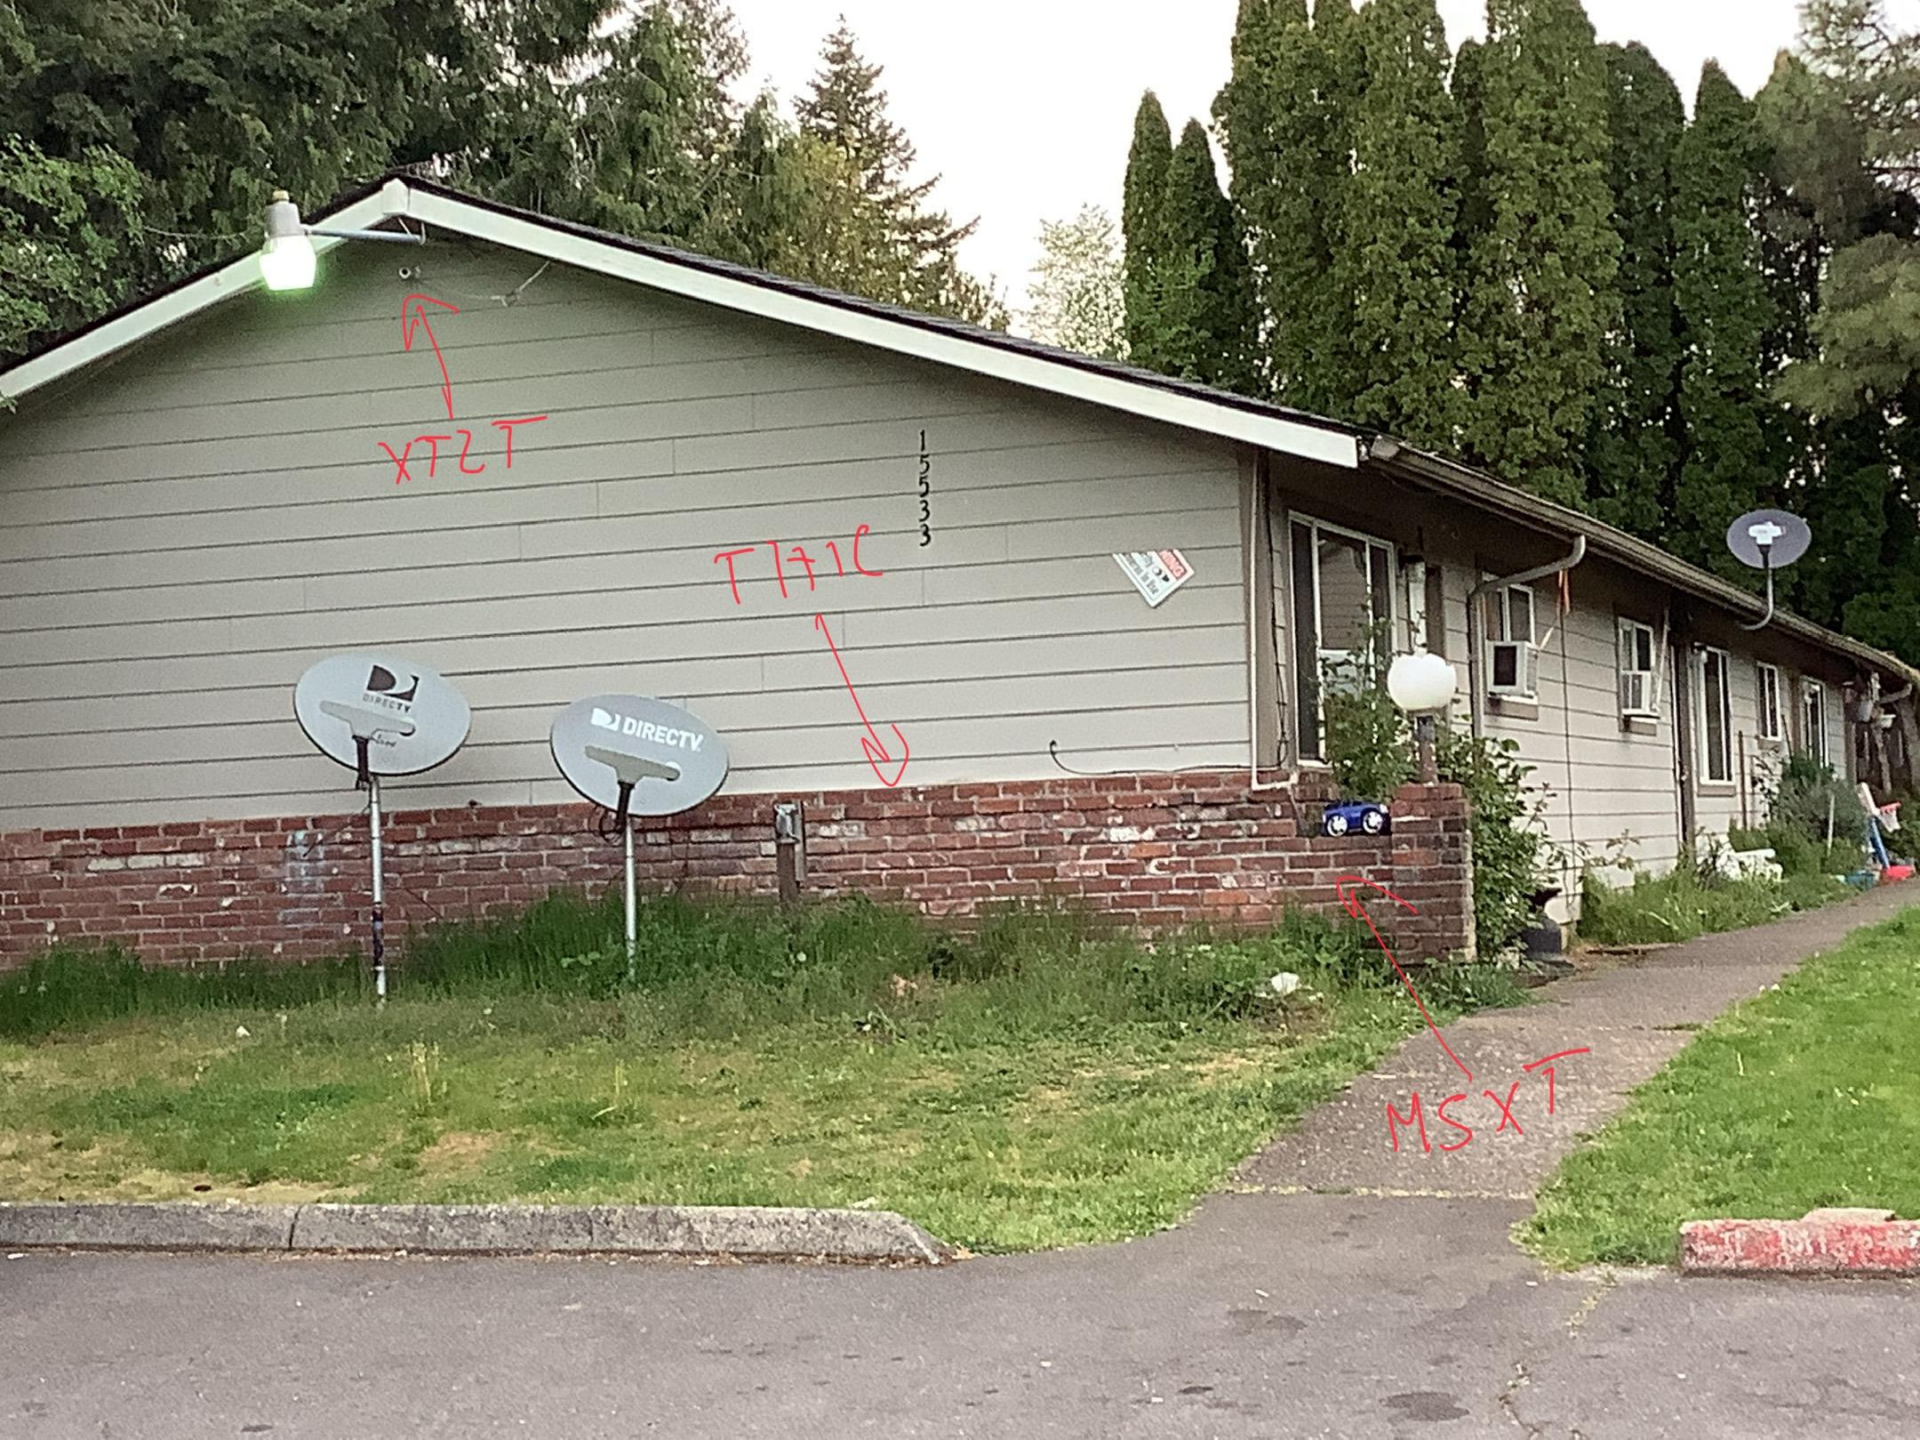
FCAM

MZCA

TITE

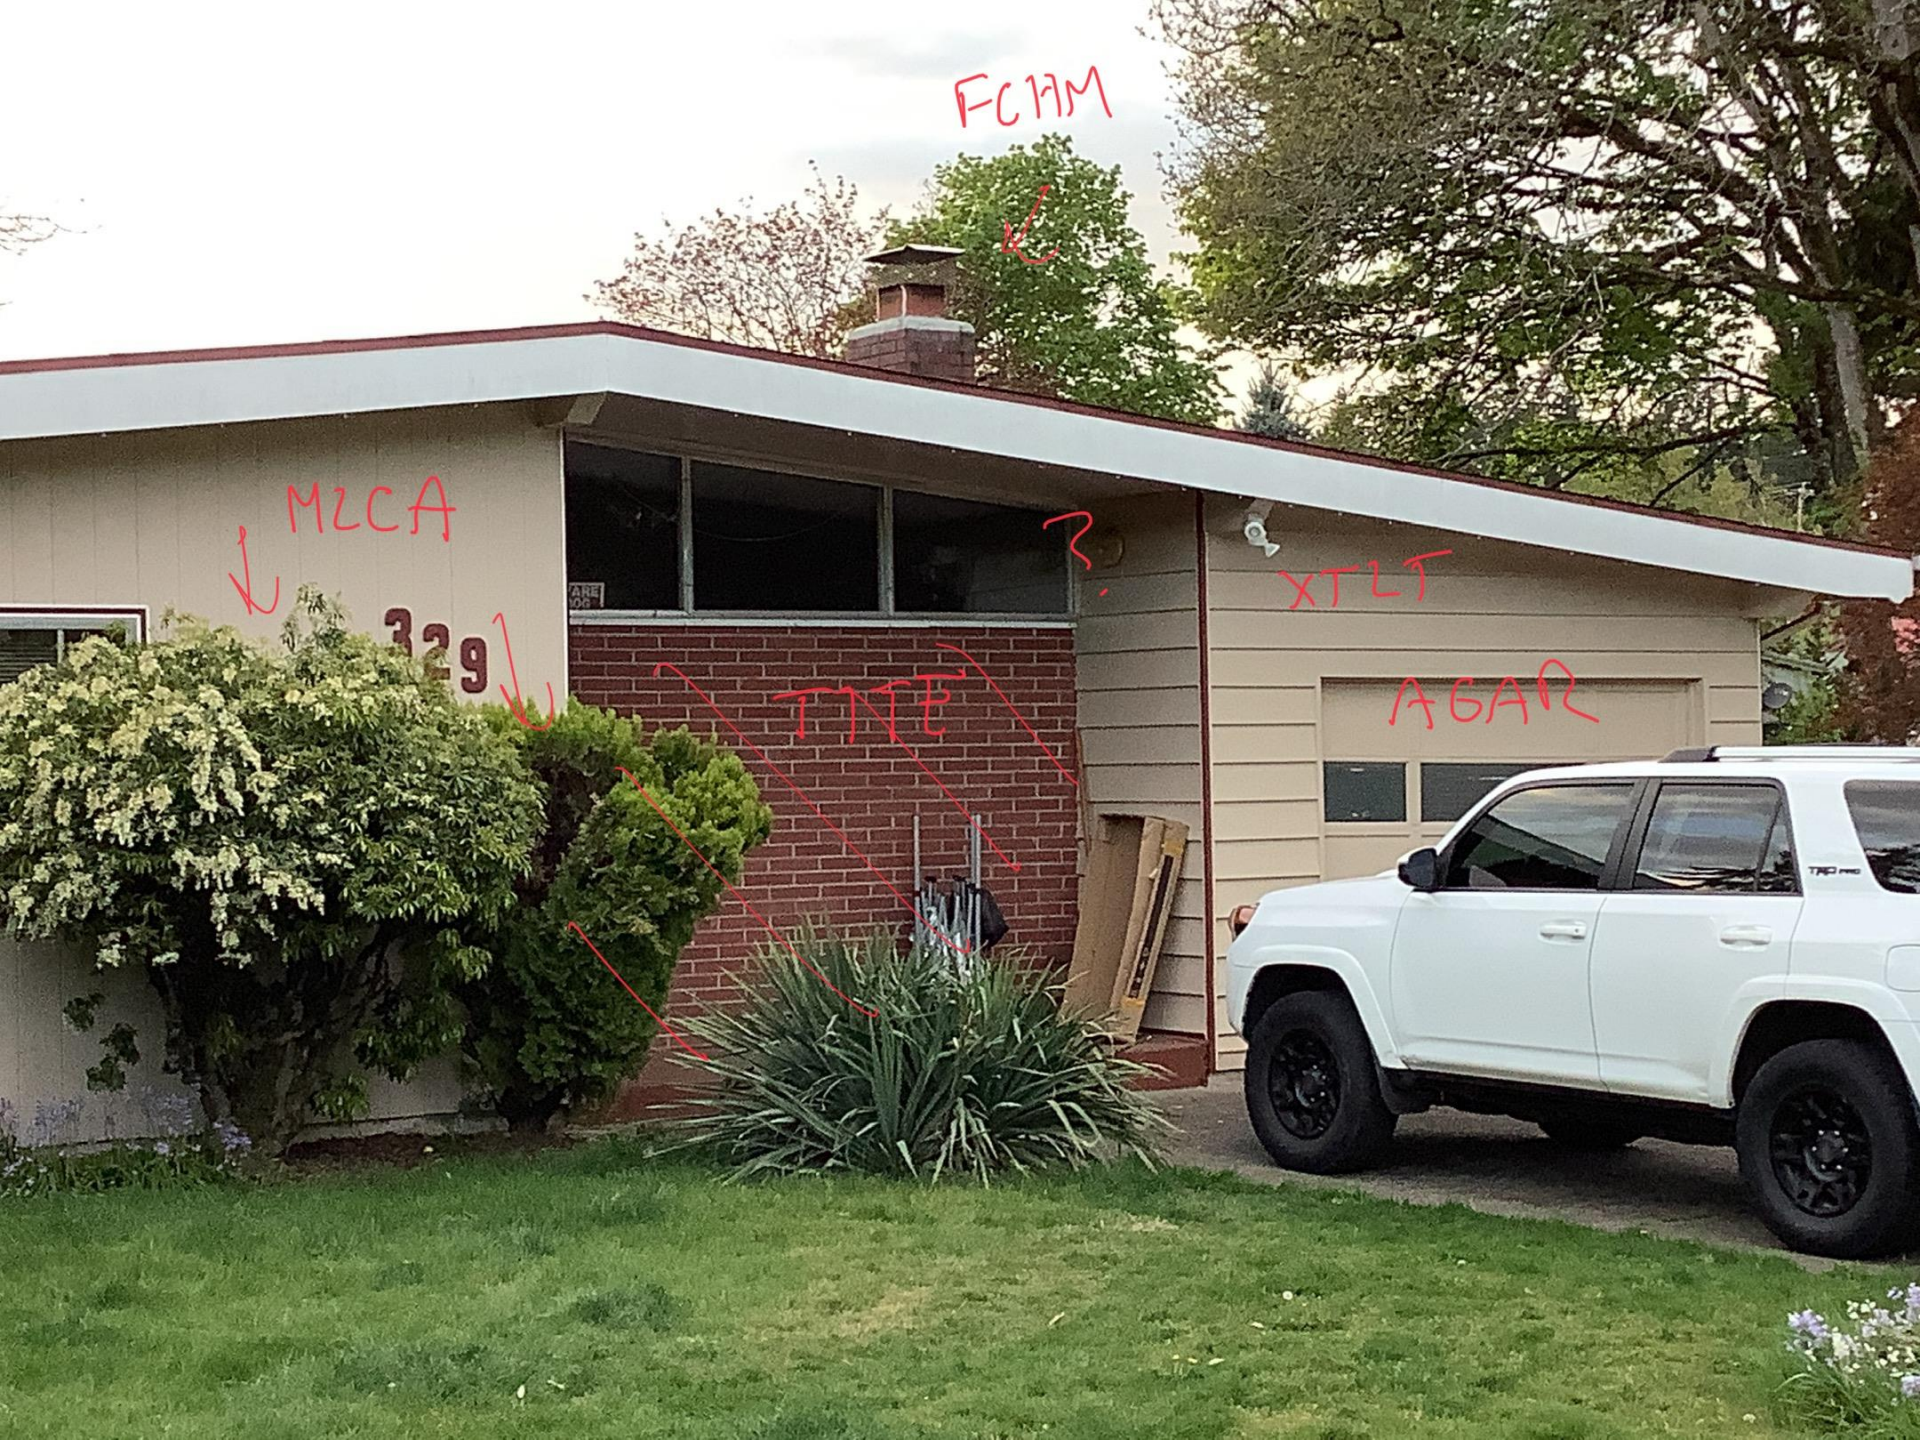
E@RF

↓ OVER

XTLT →

FENC

← XTLT

TITE

EOUT →

HOSE? ↓

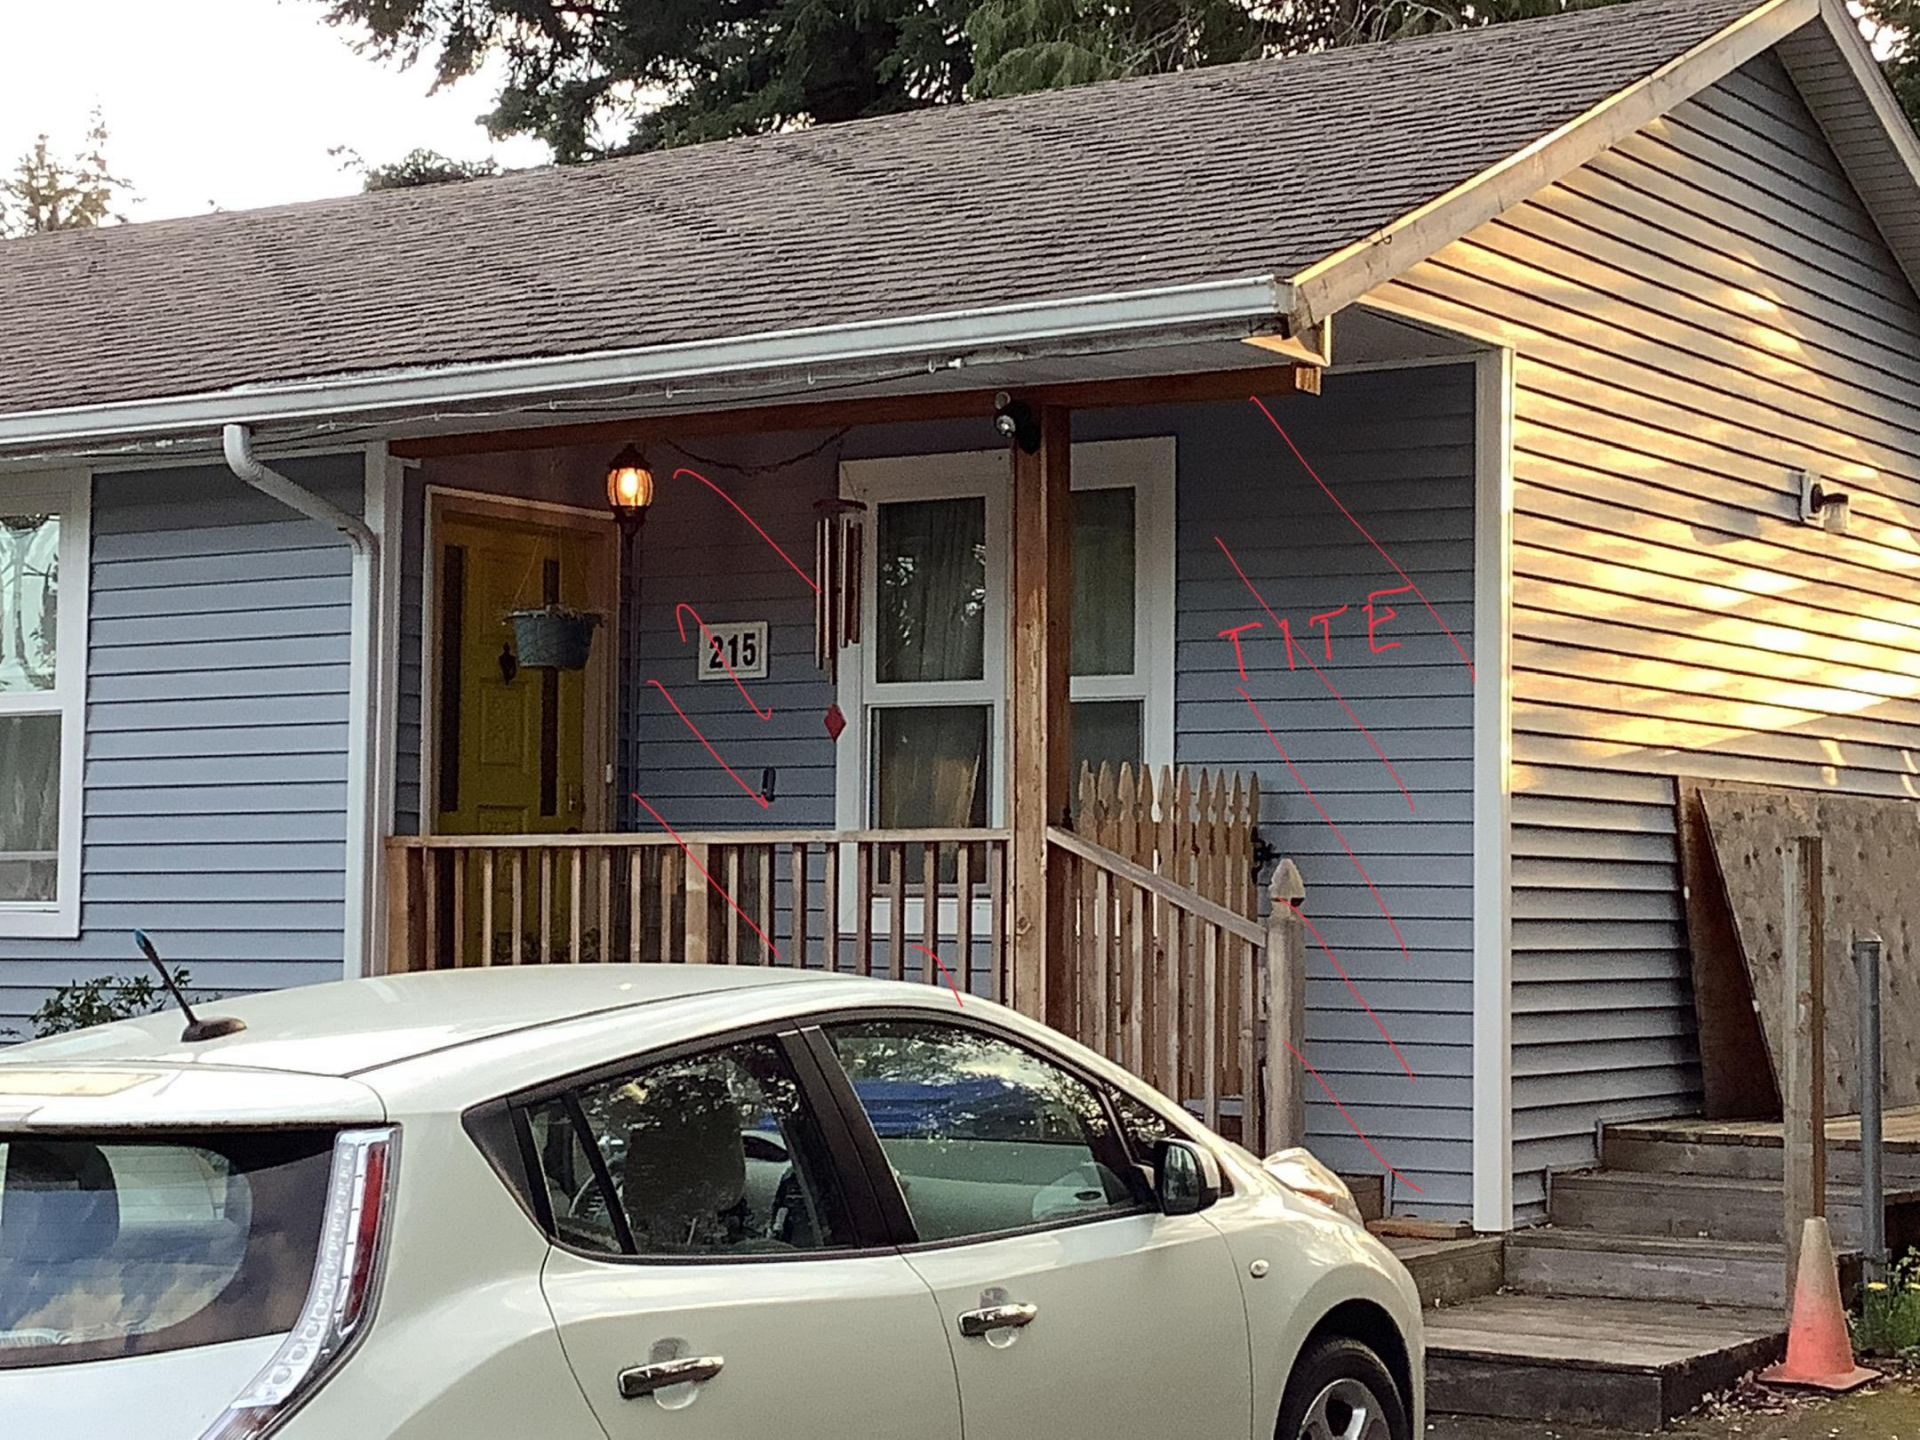
TITE

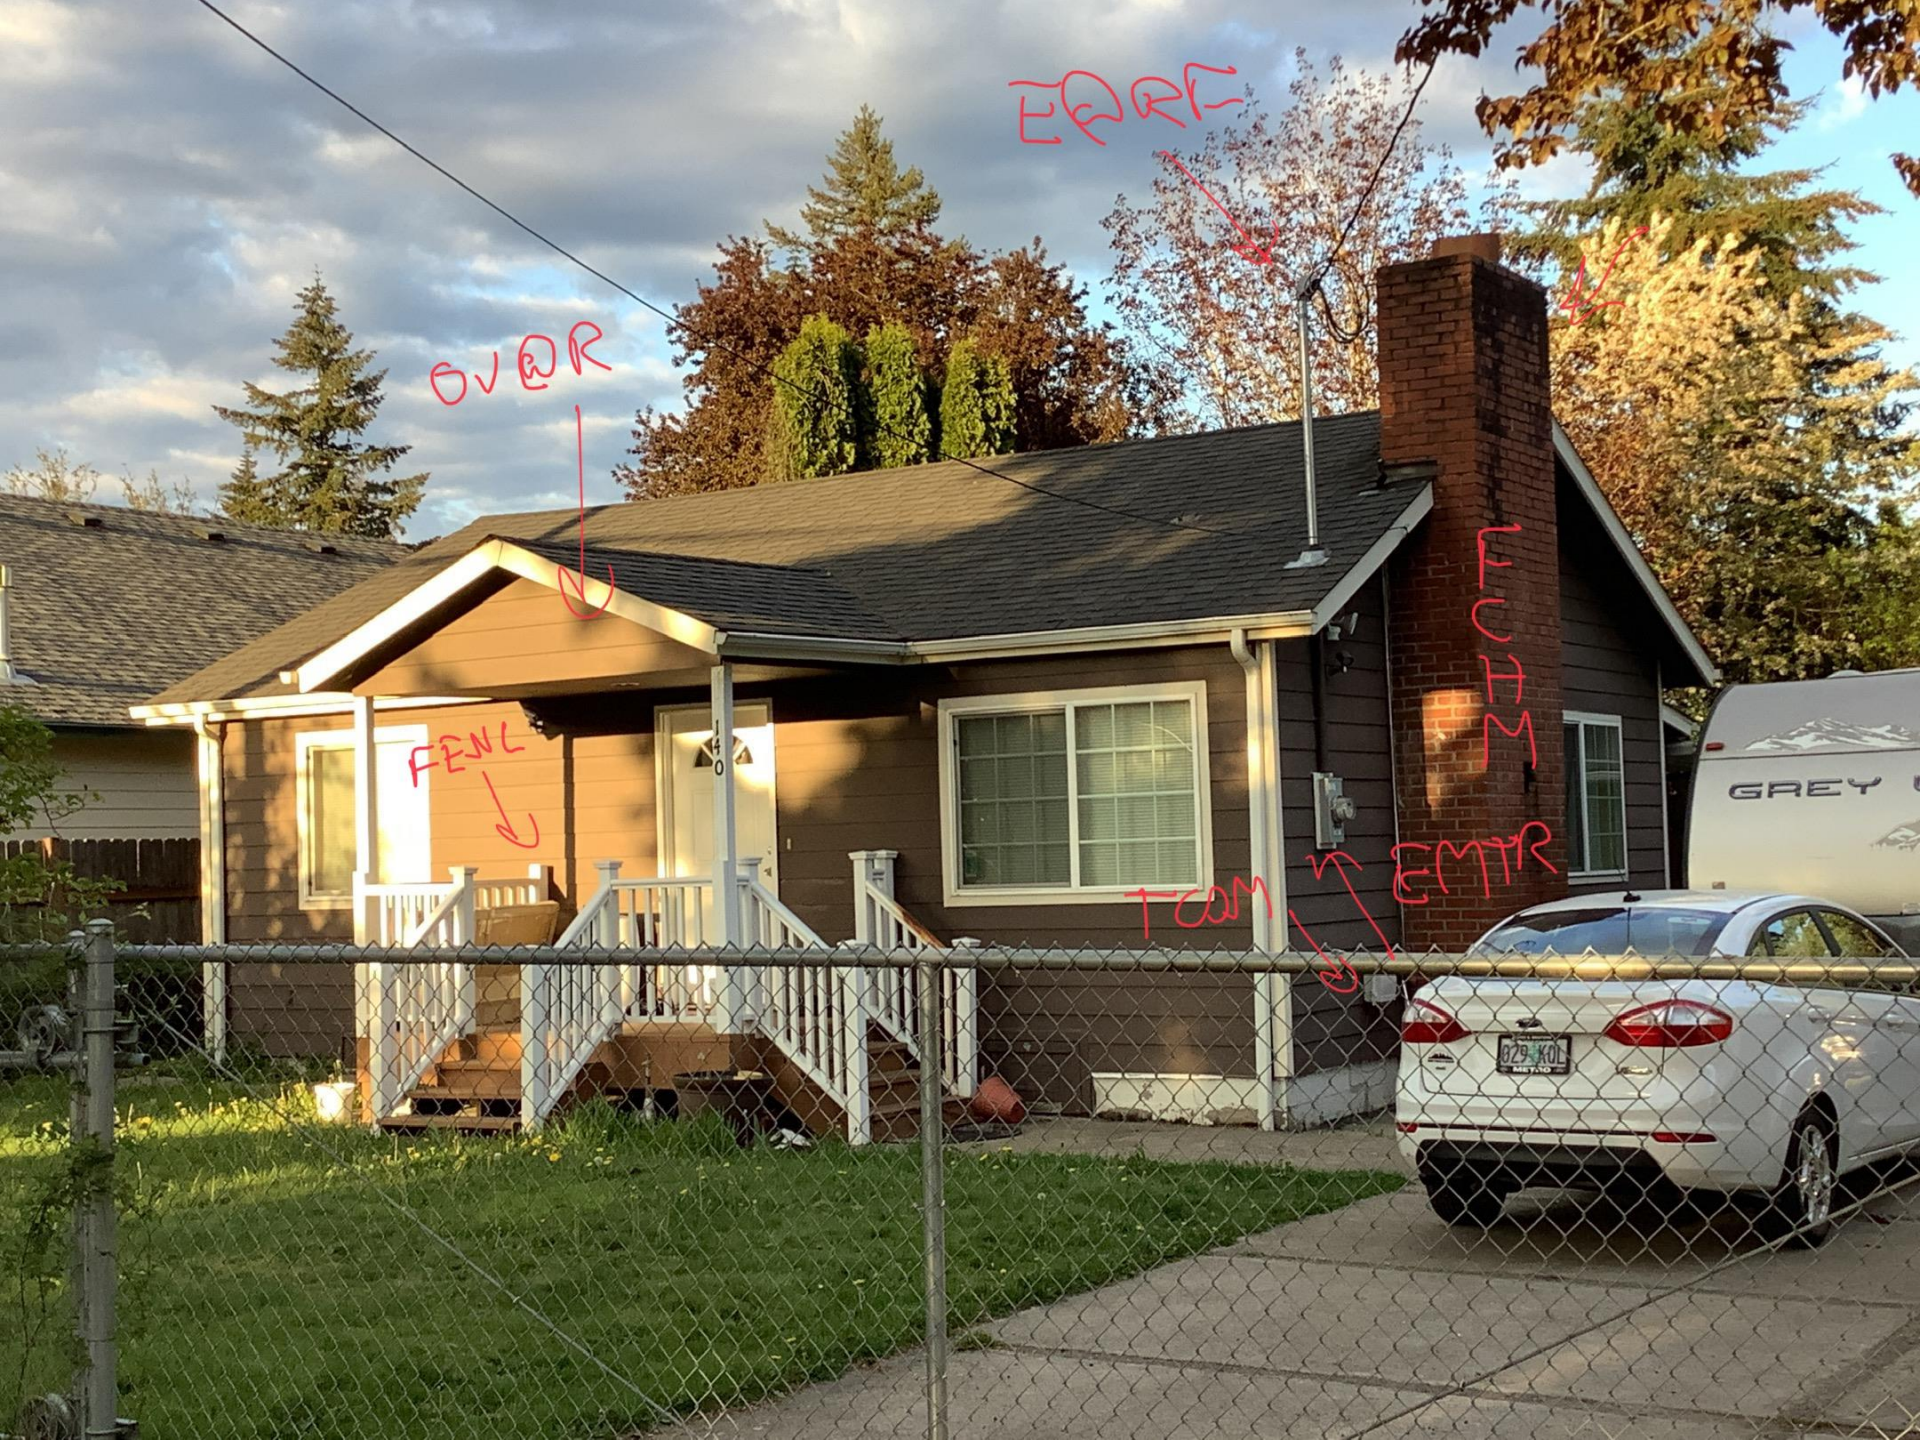
EQRF

OVQR

FENC

EMTR
