# Retrofit conditions potentially complicating air-sealing and exterior insulation

A brief street-view survey of residential housing in  
Portland, Oregon (Glenfair, Glendoveer, Rockwood nhds)

20 April 2021

Graham S. Wright

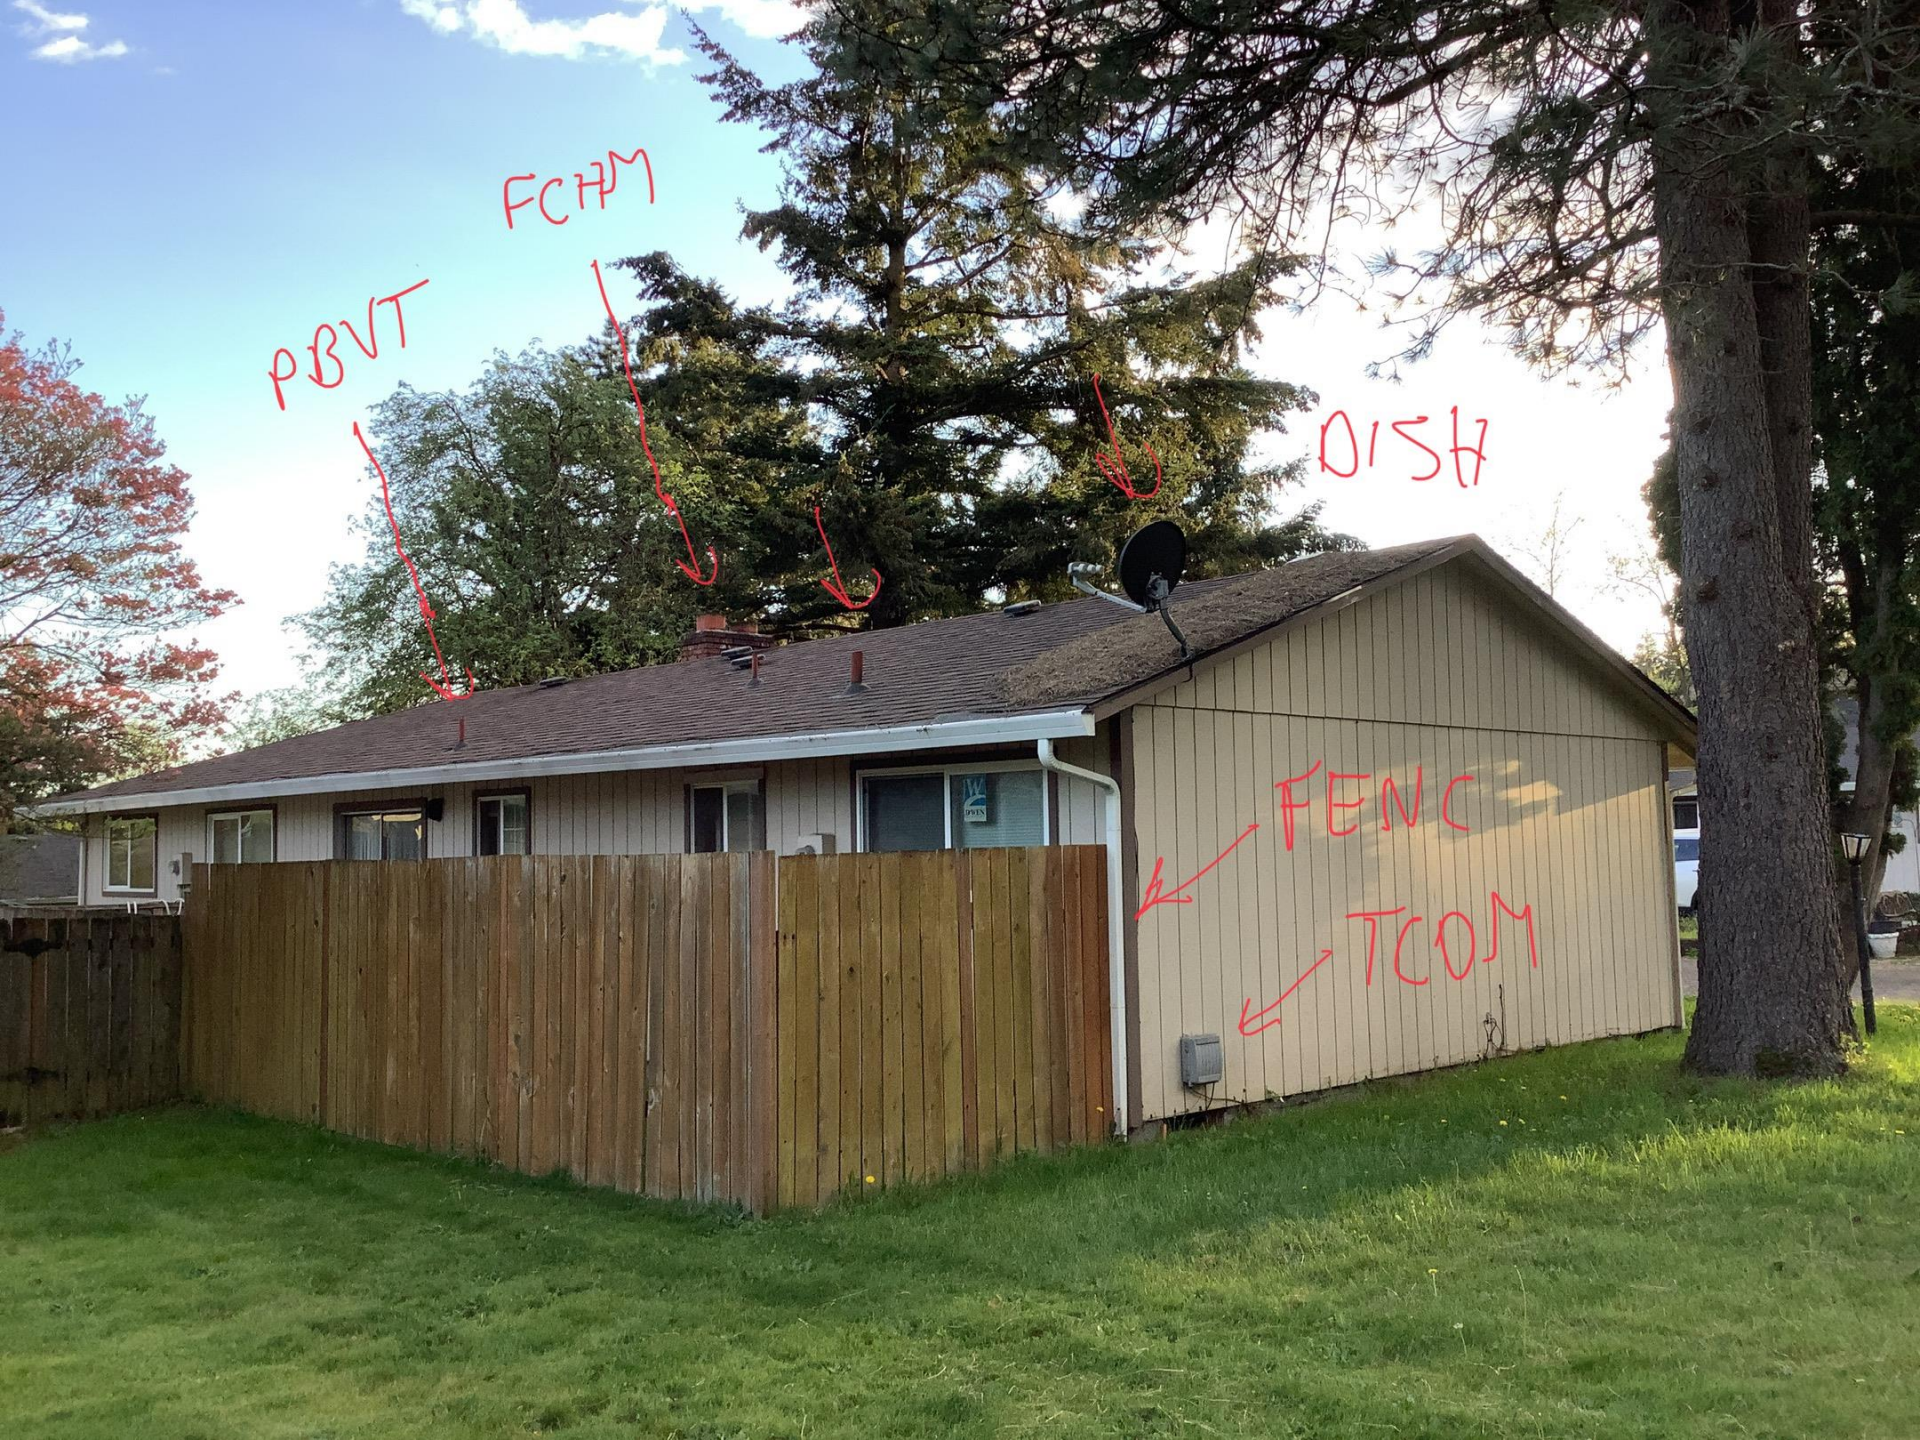
PBVT

FCHM

DISH

FENC

TCOM

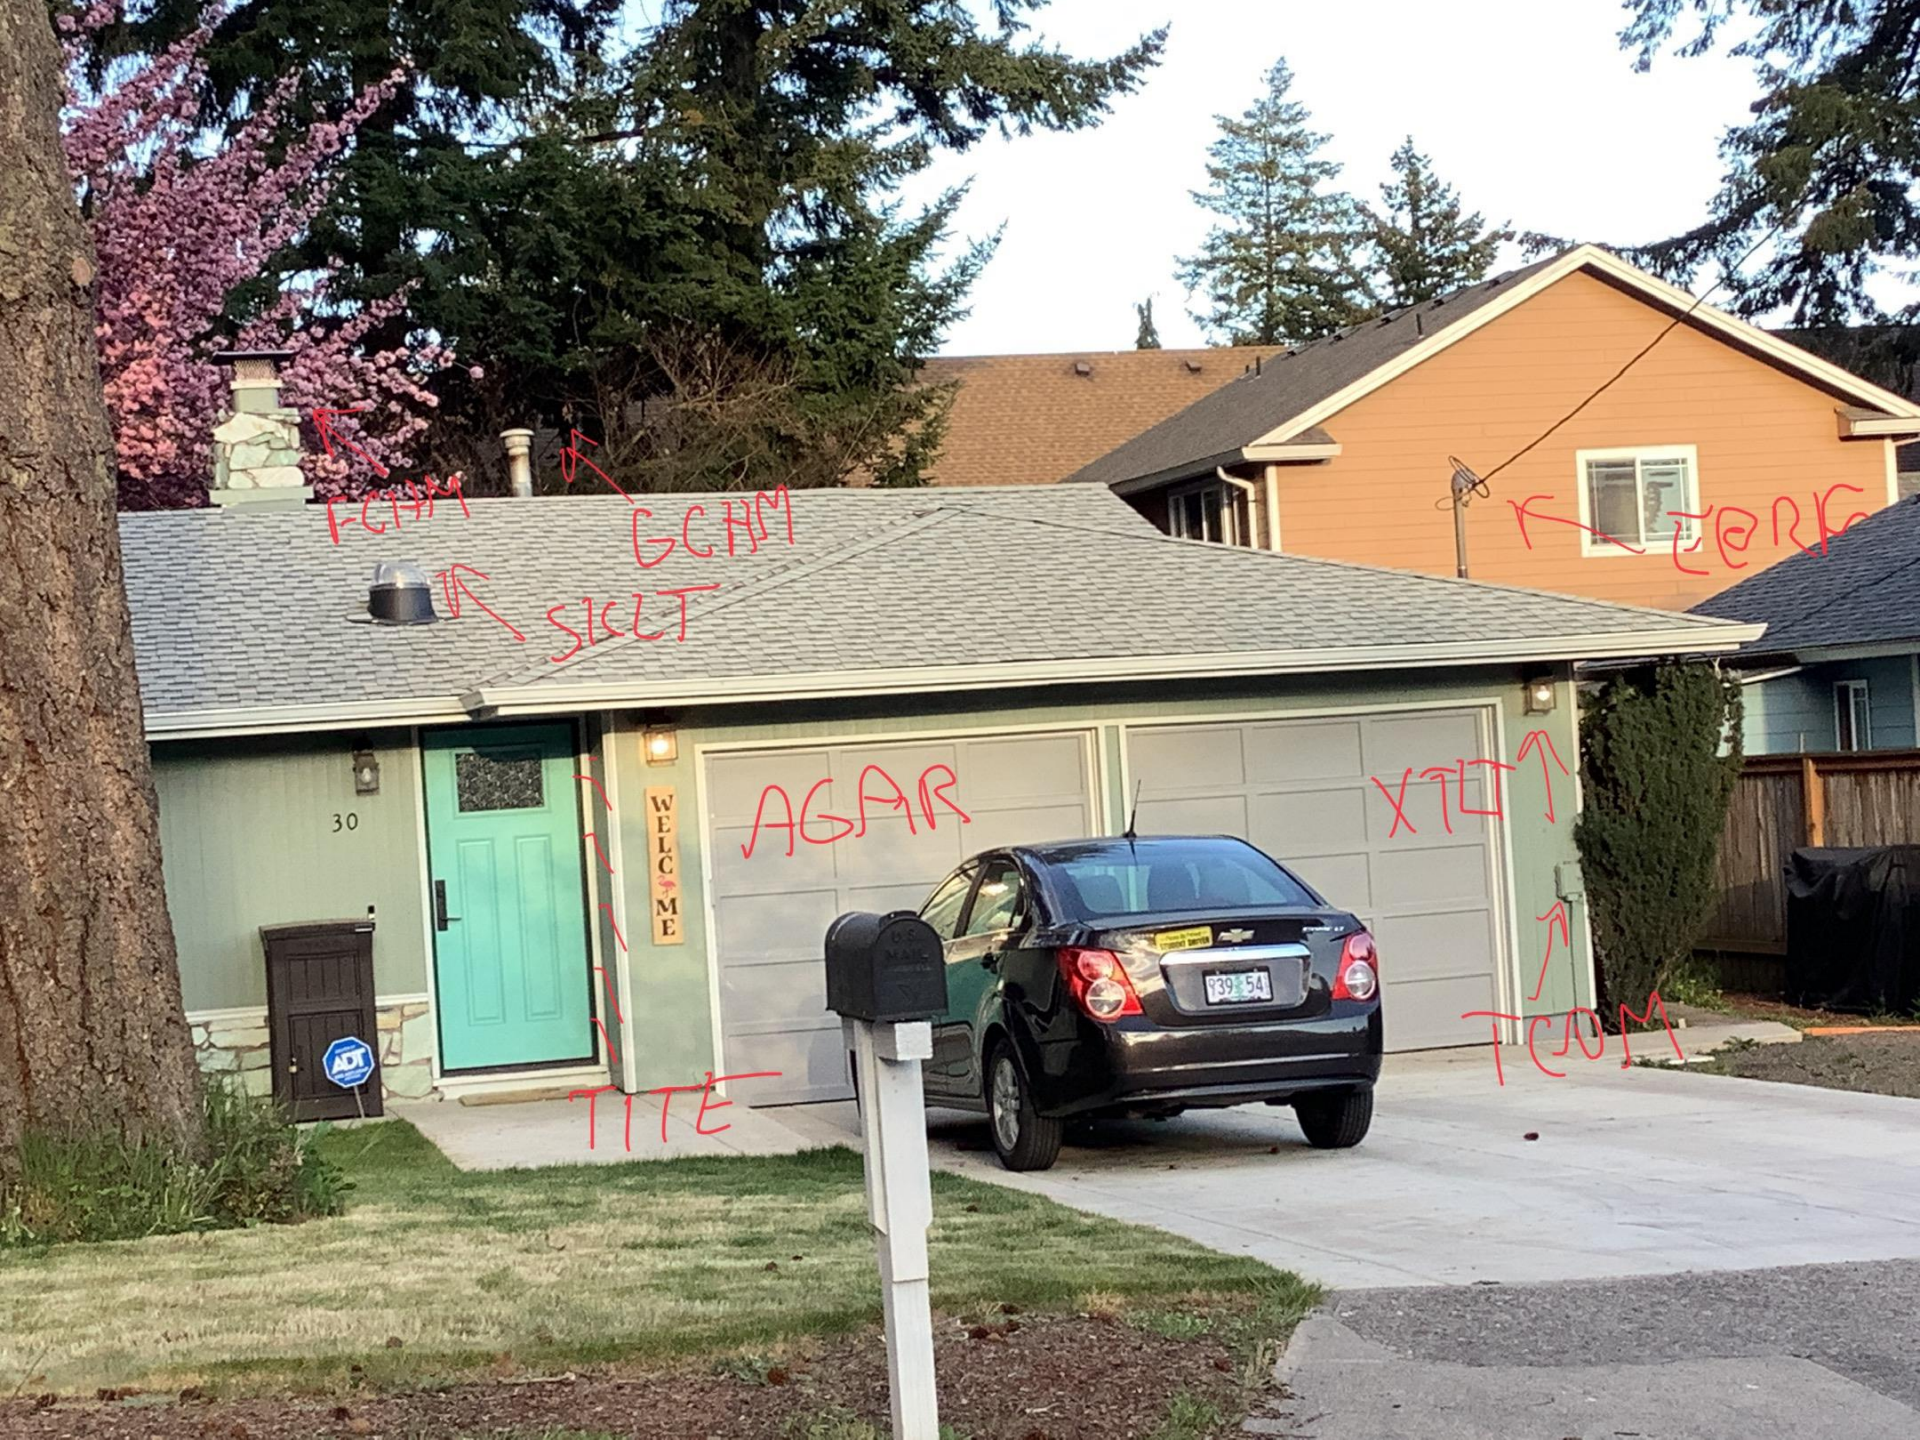
FCIM

GCHM

AGAR

XTL

TITE

TCOM

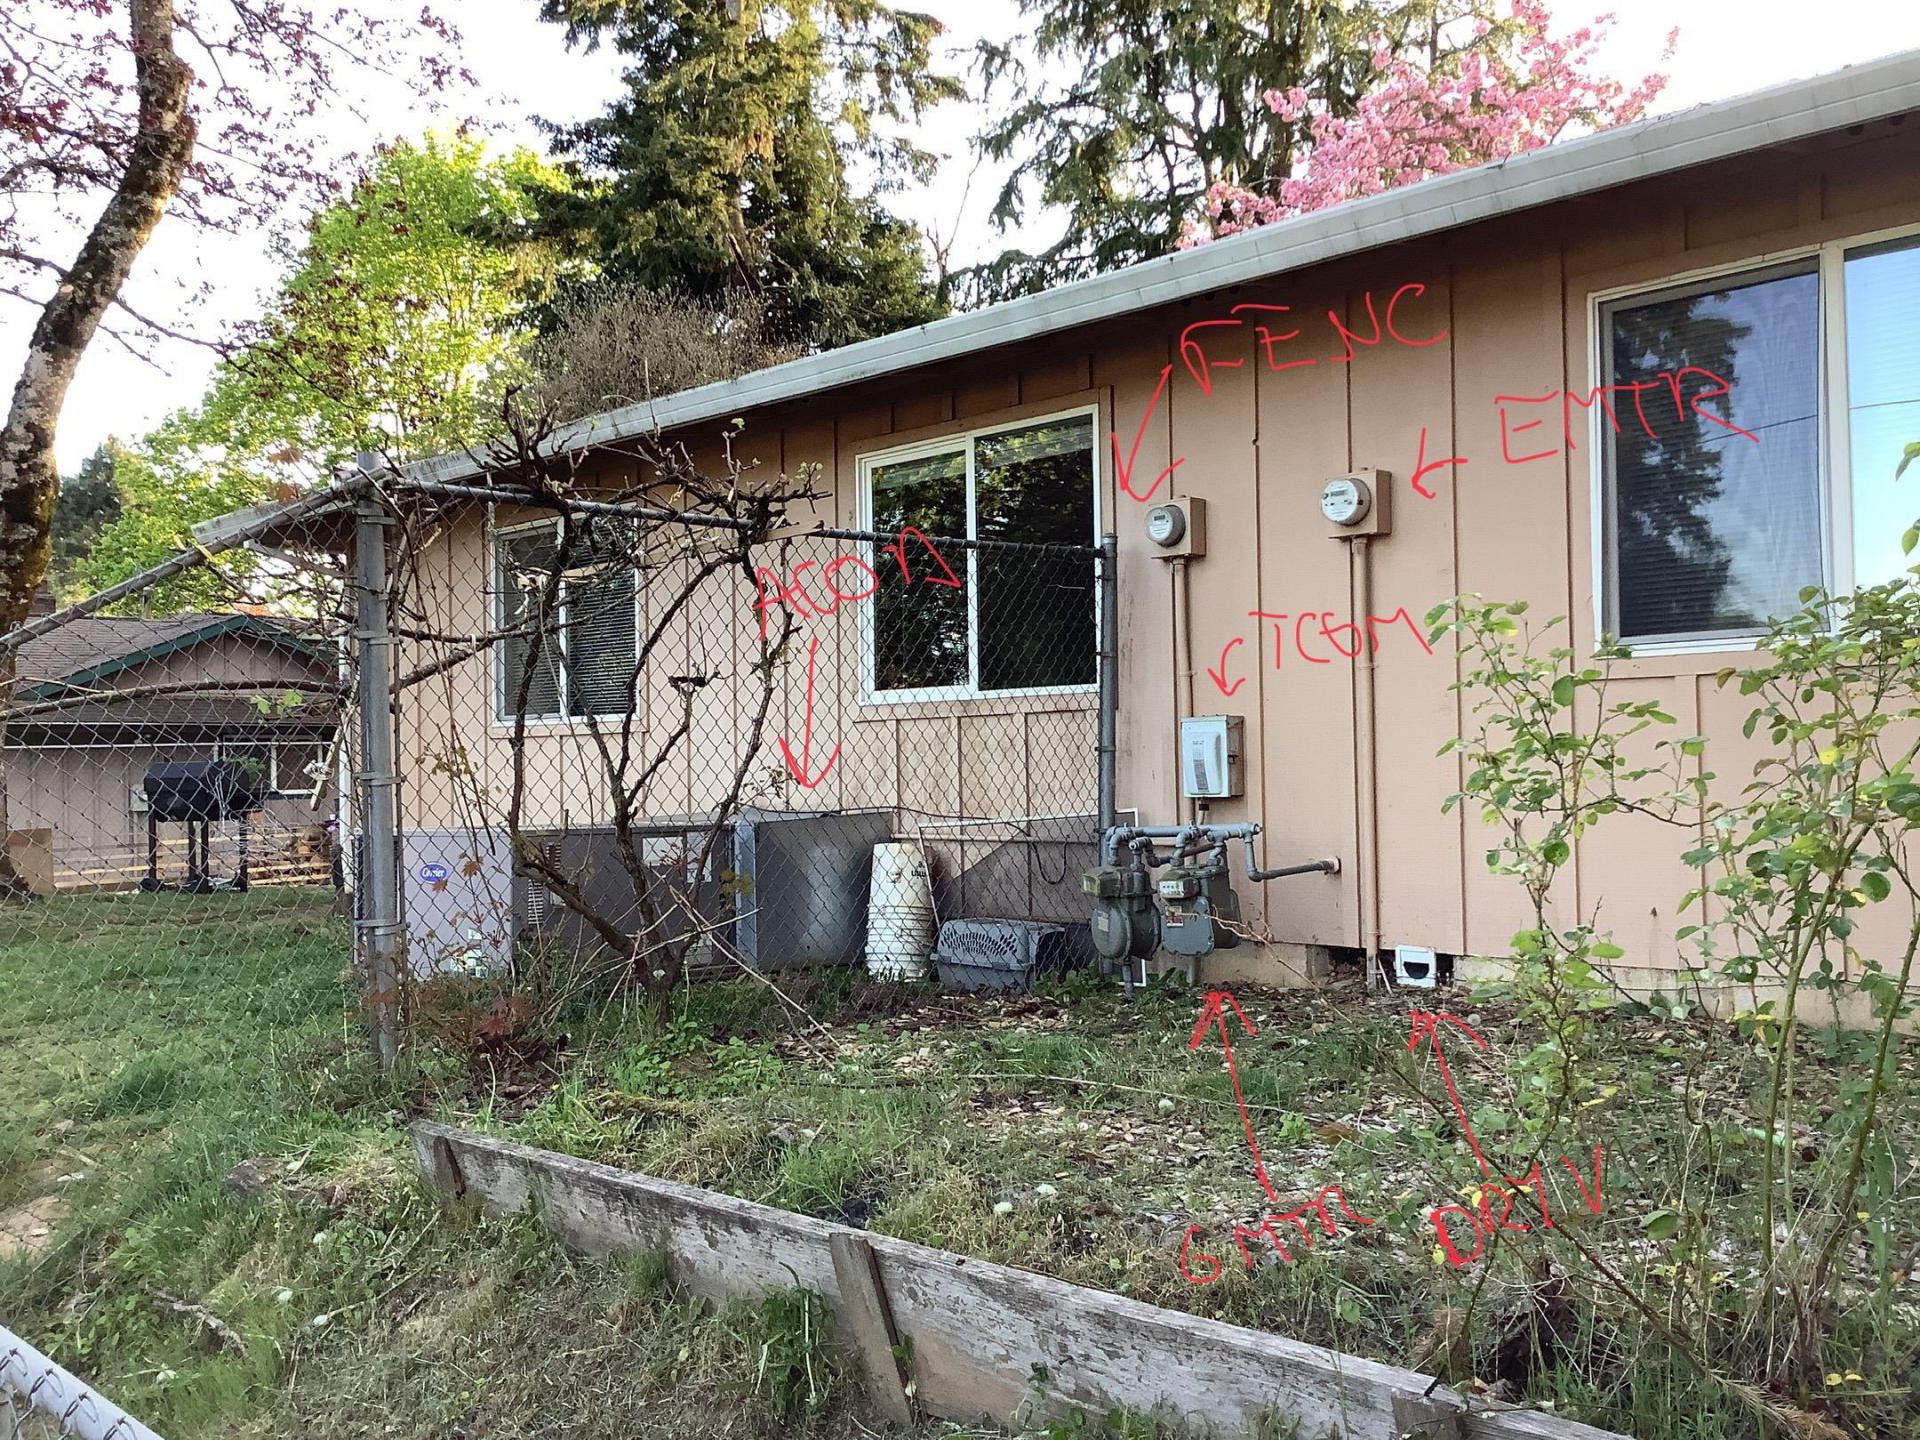
FENCE

ENTR

TCOM

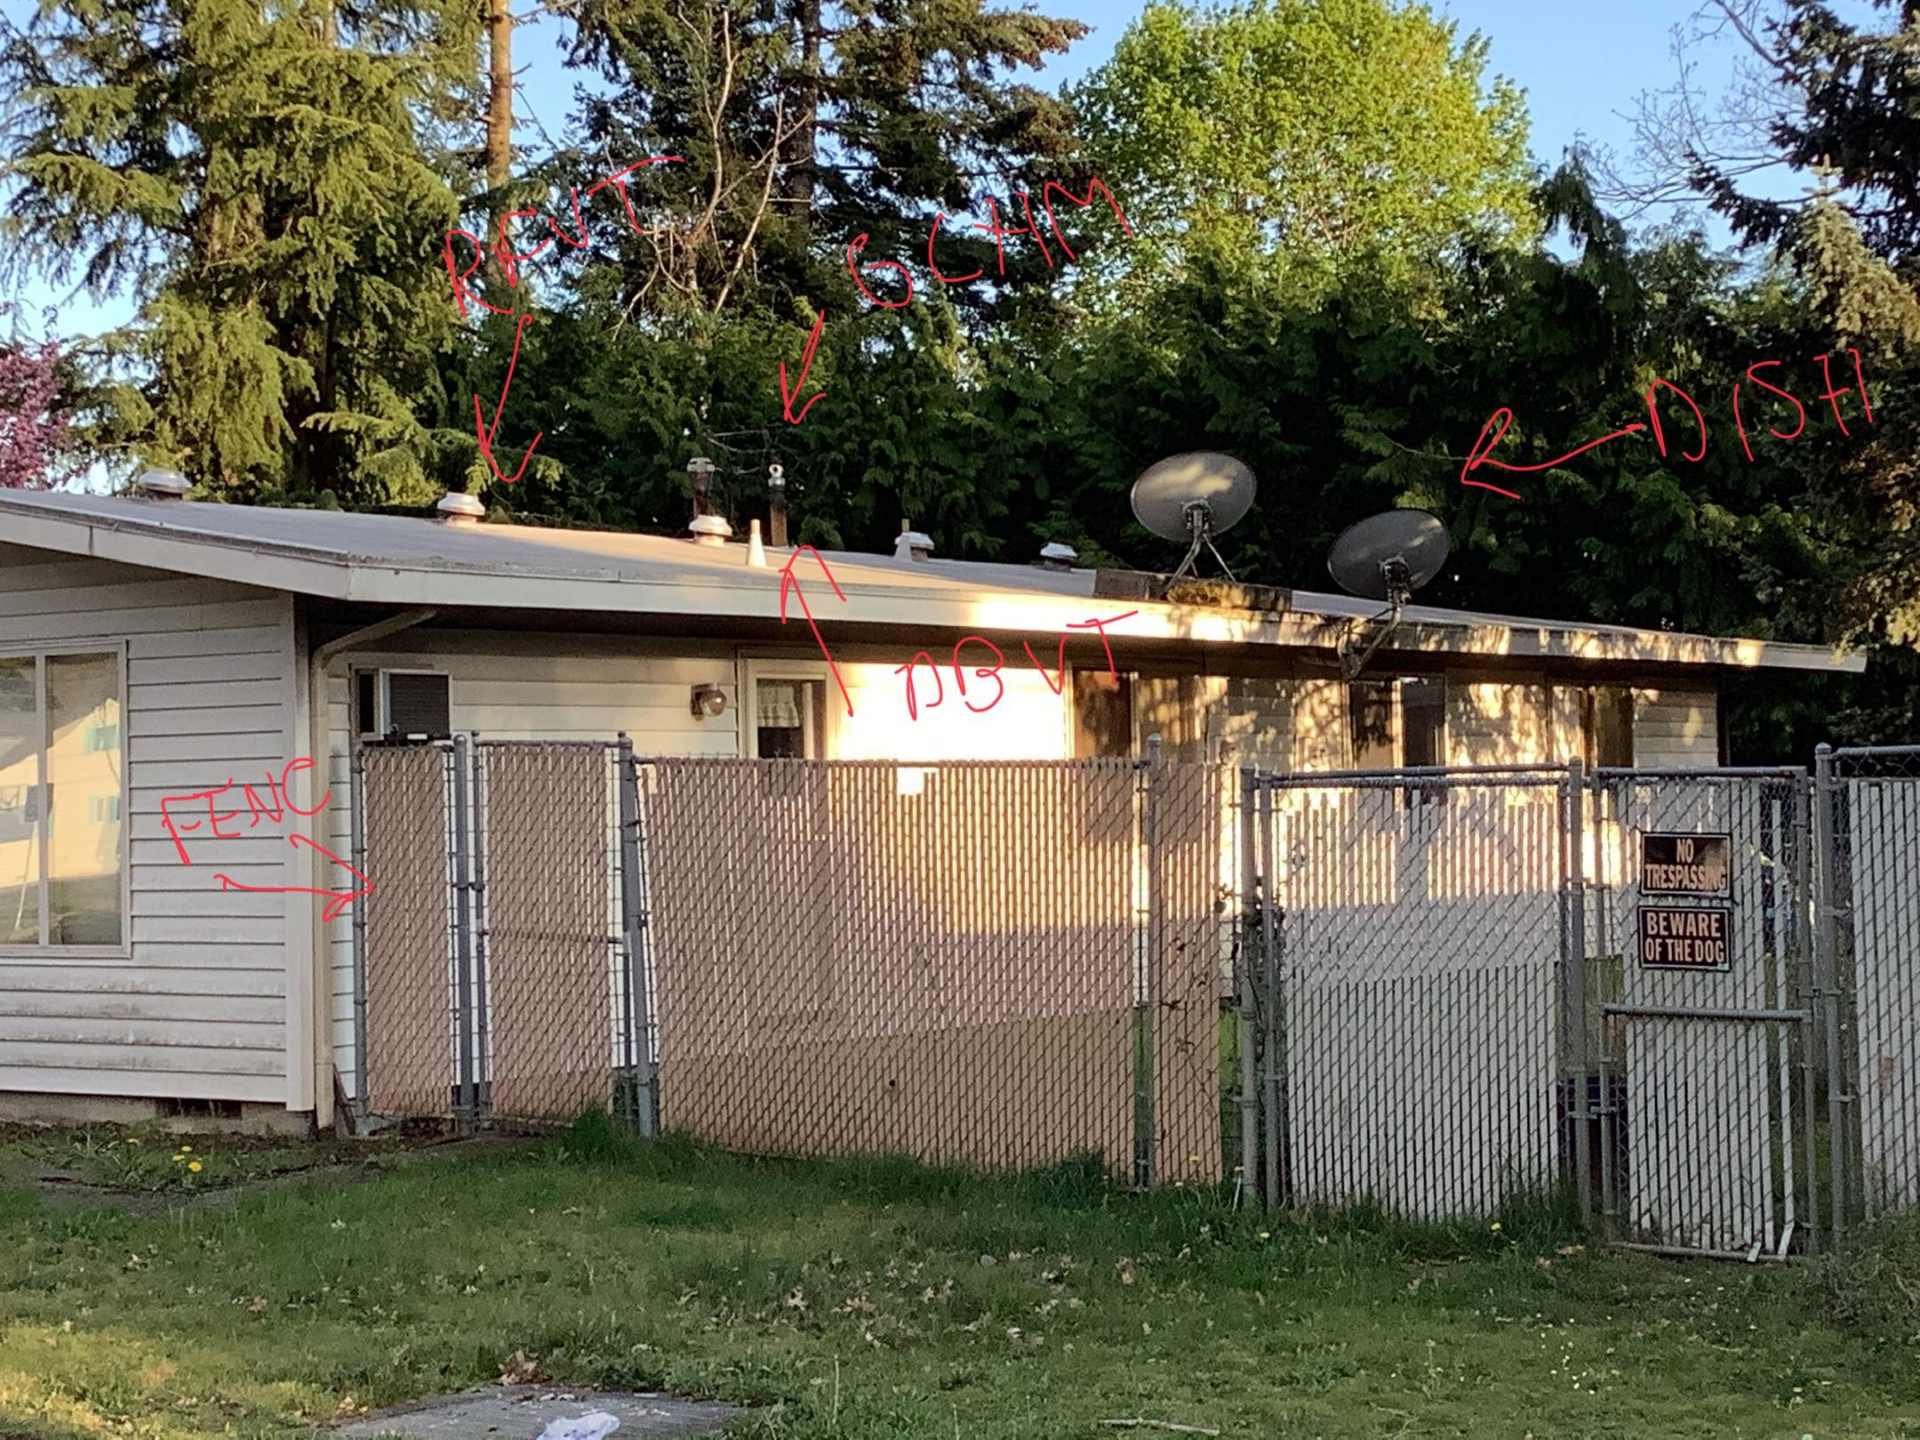
DISH

DBVT

FENC
