PH Verification for Large Buildings: What We've Learned So Far

Lois B. Arena, PE

- Focus: Verification of Insulation and Air Barrier Continuity
- Issues that dictate QA/QC program
- Case Studies
 - Cornell
 - Beach Green North
 - 3365 Third Ave

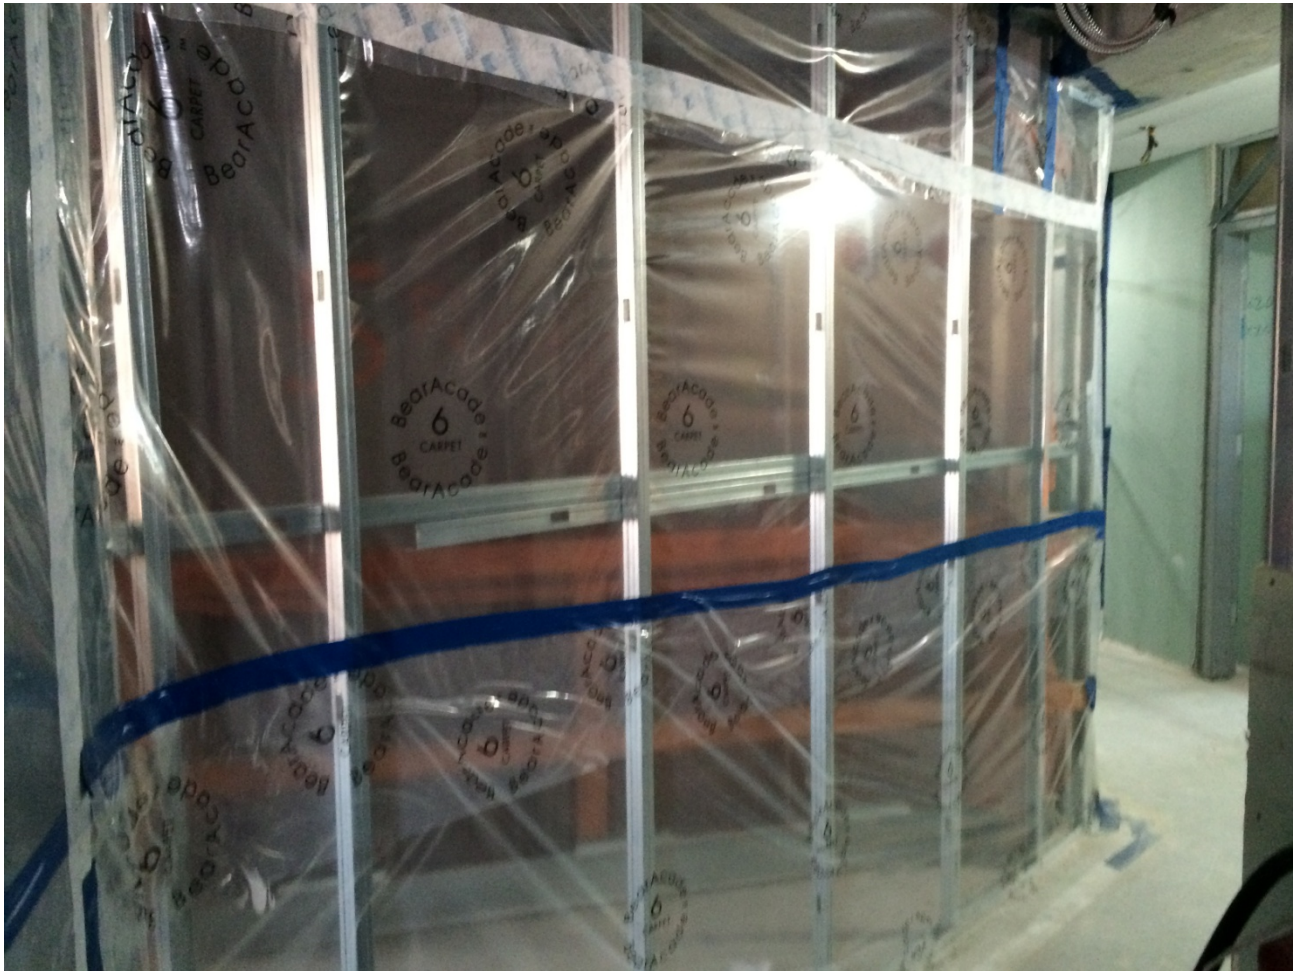
Temporary Air Barrier

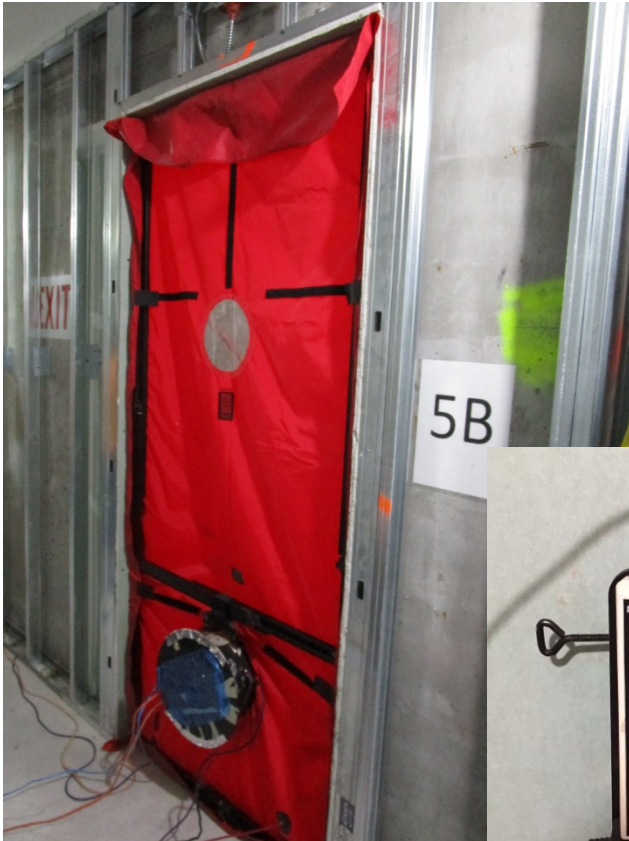
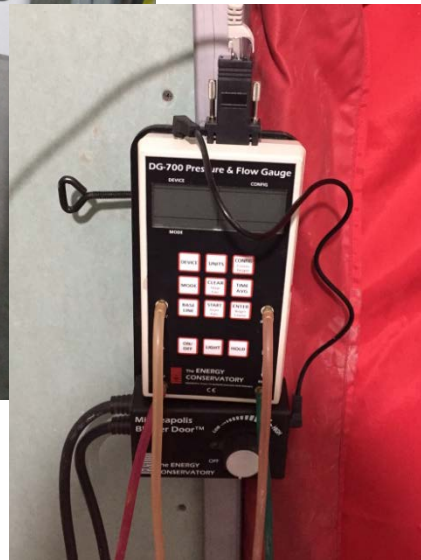
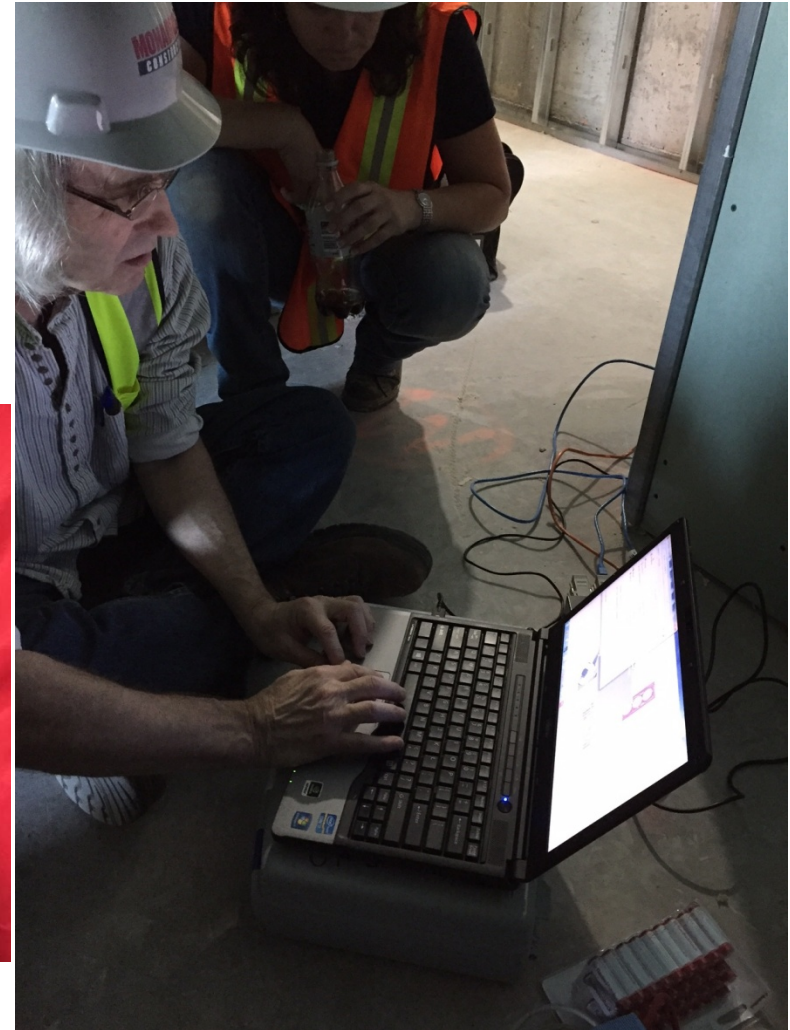
Blower Doors on 3 Floors

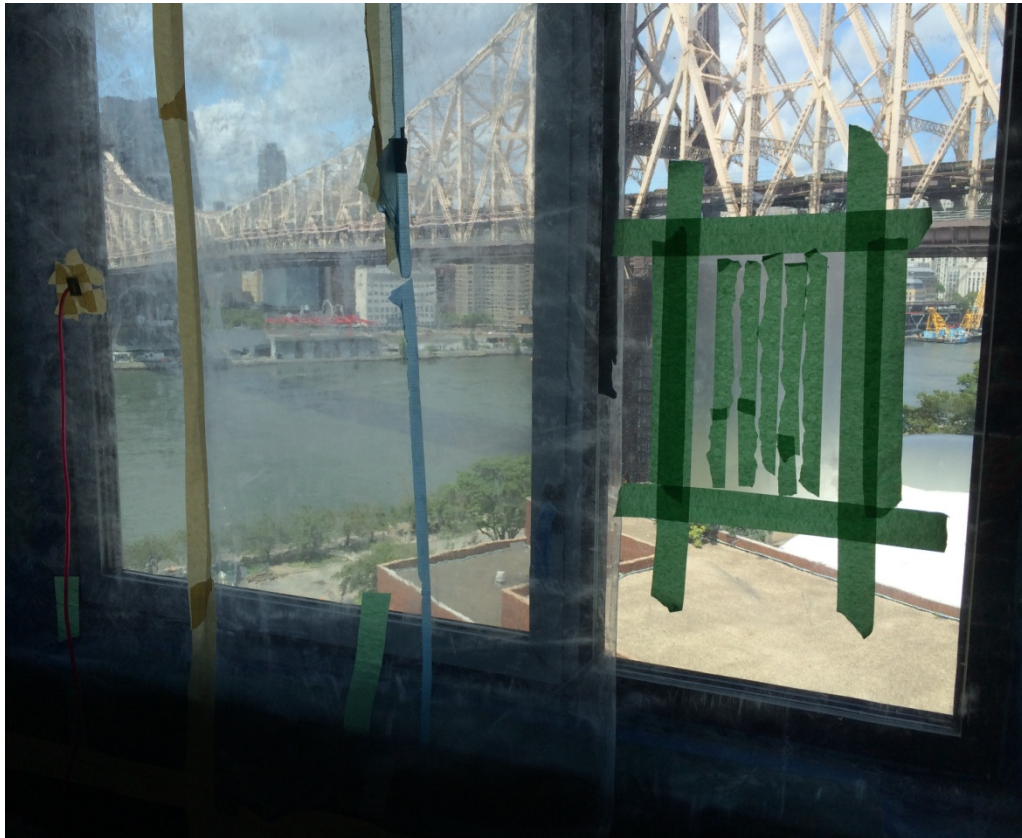
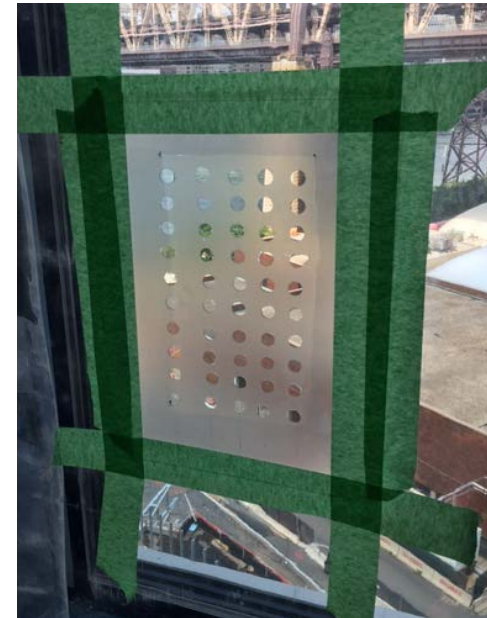
Façade Leakage Measurements: Quantitative

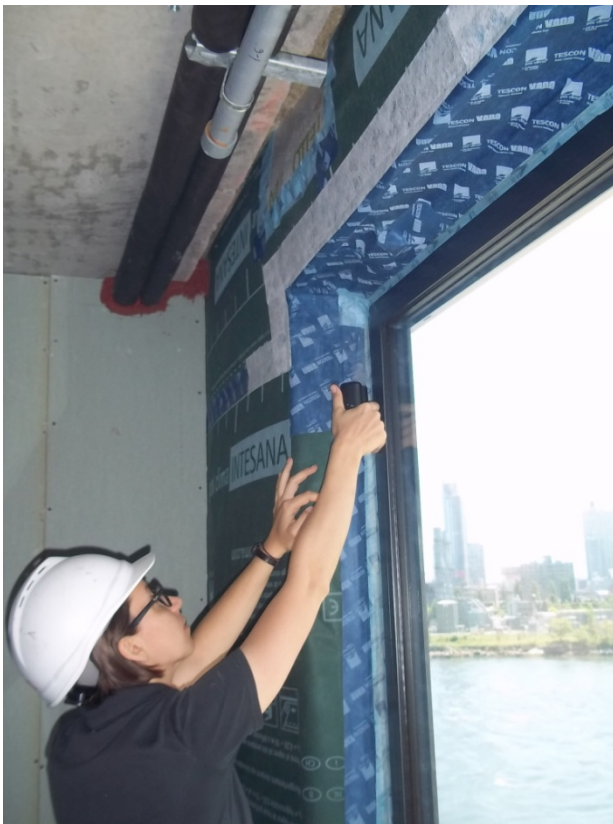
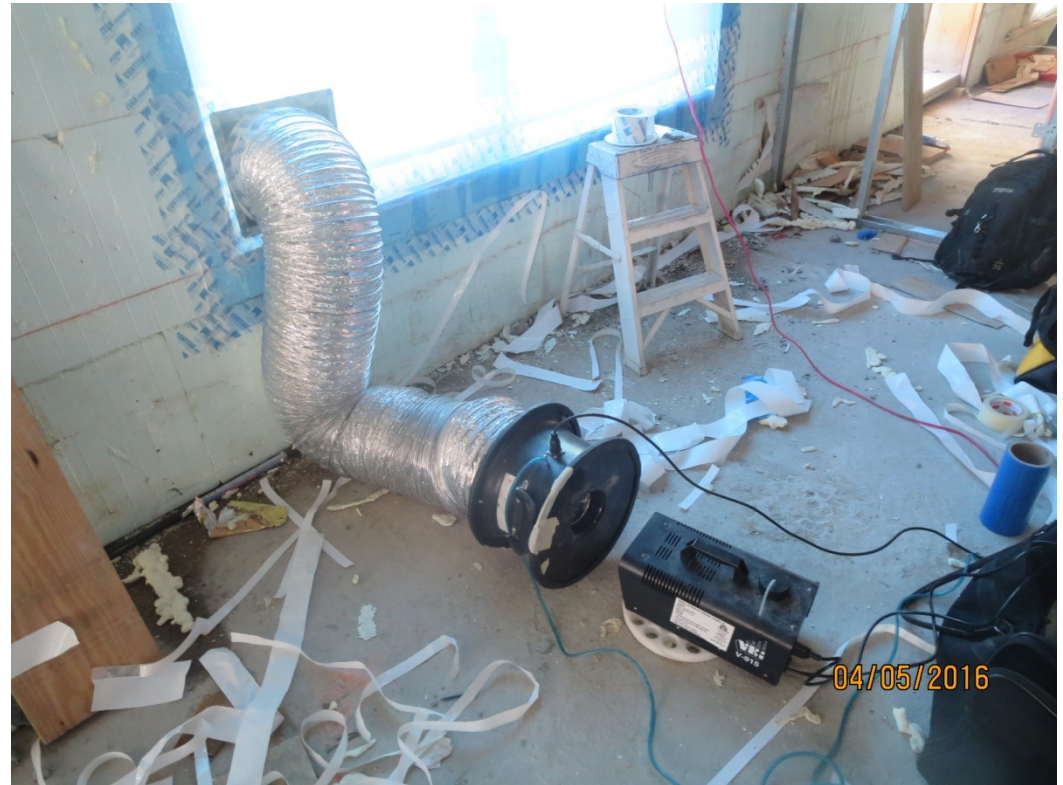
Façade Leakage Measurements: Qualitative

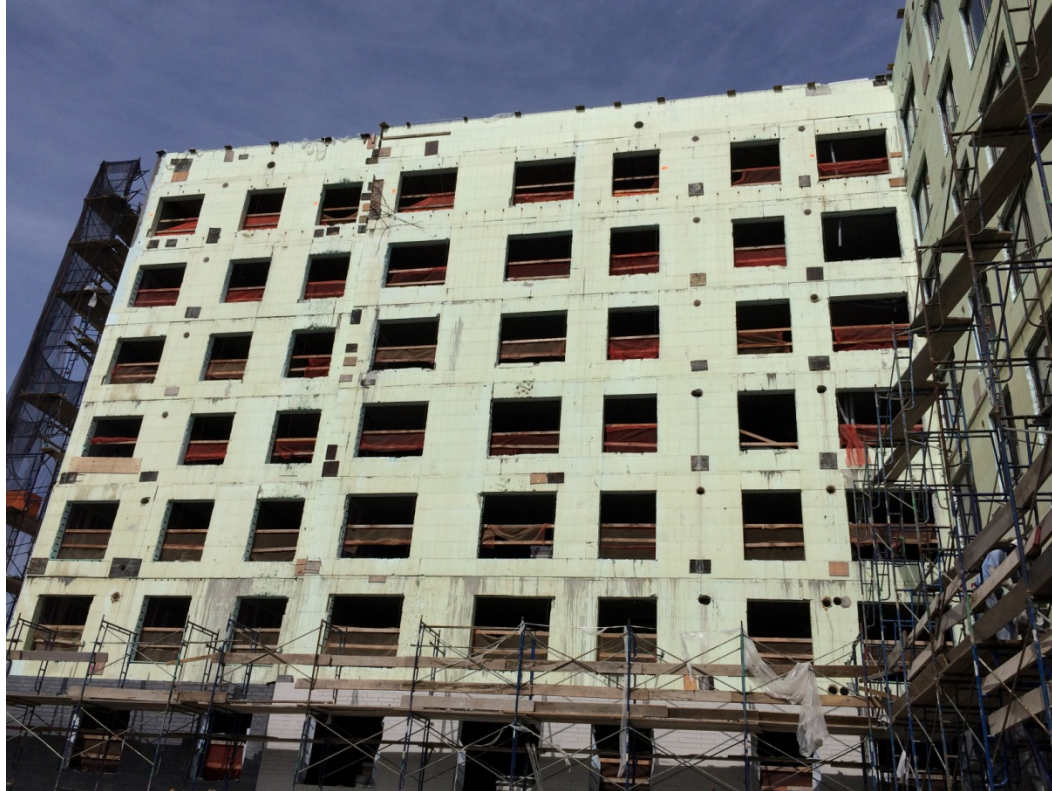
Wall Insulation Inspections

- ICF doesn't require as many inspections for insulation

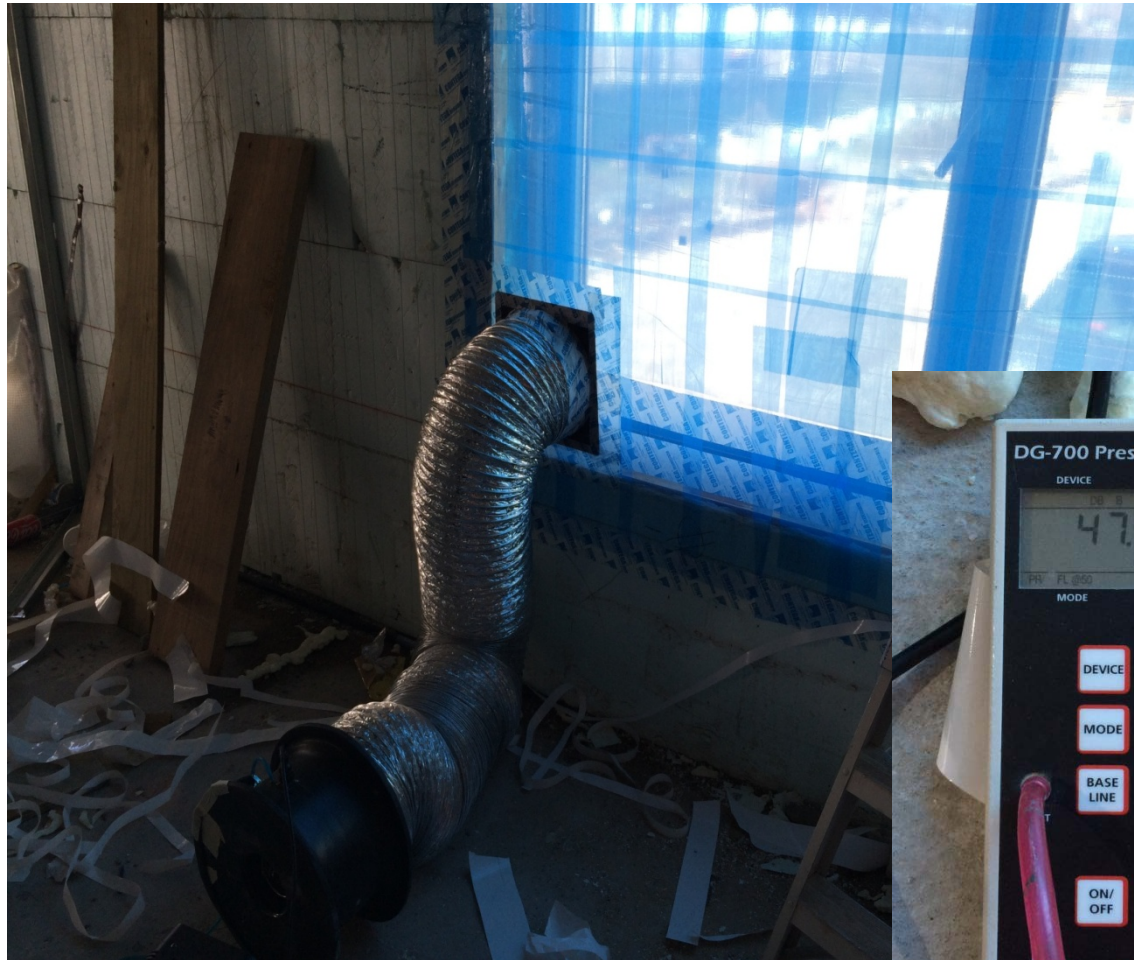
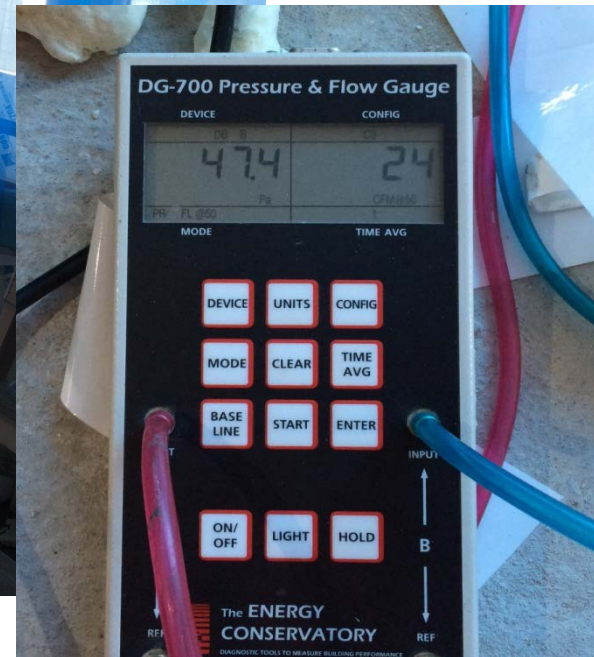
1st Window Mockup

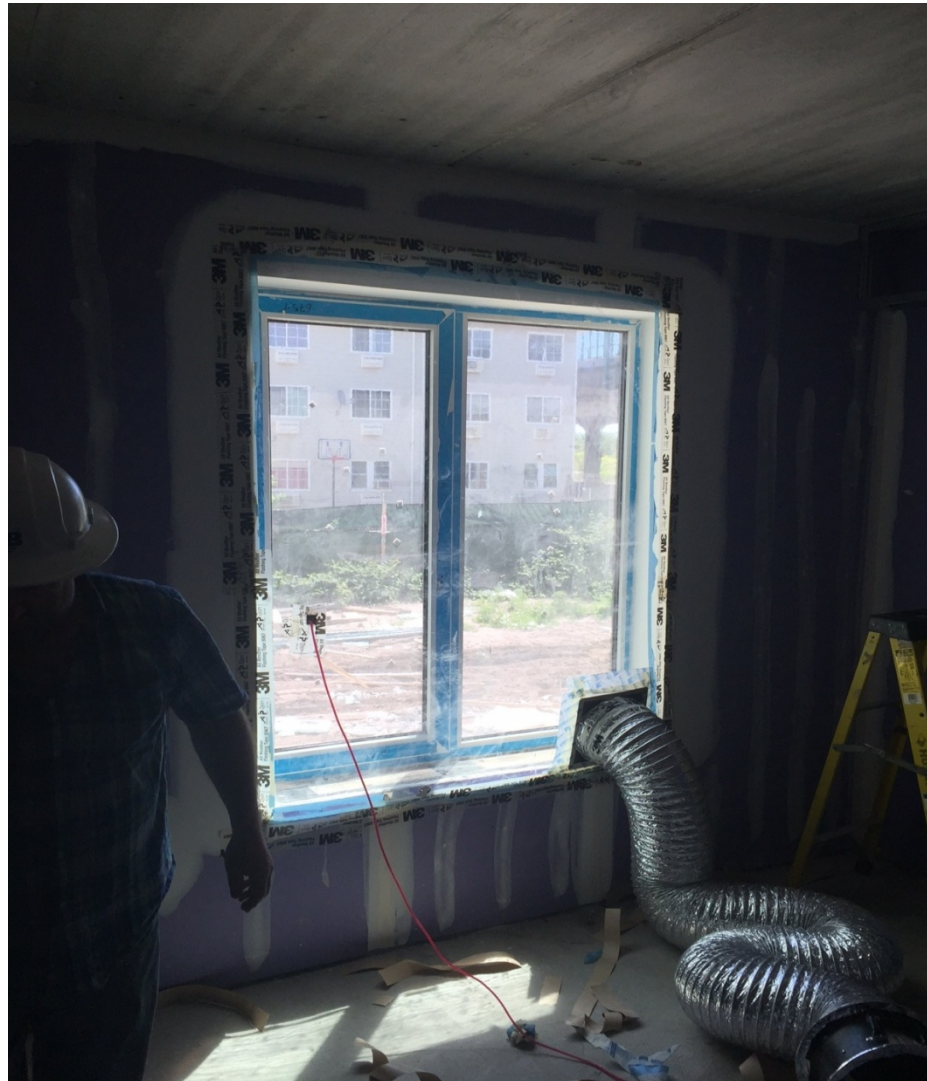
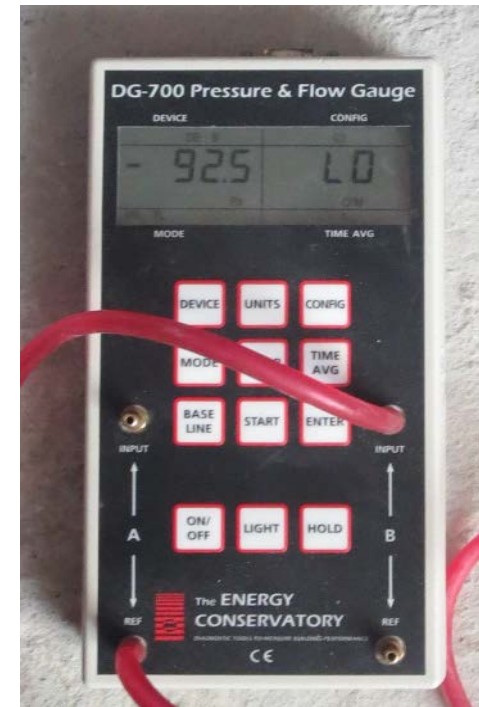
2nd Window Mockup

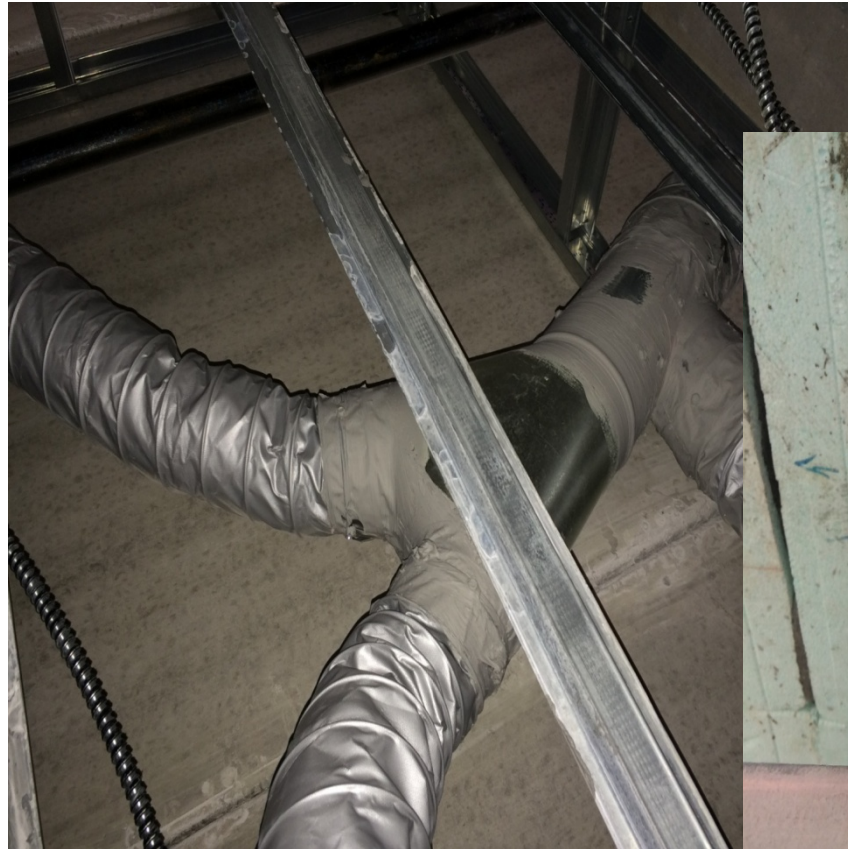
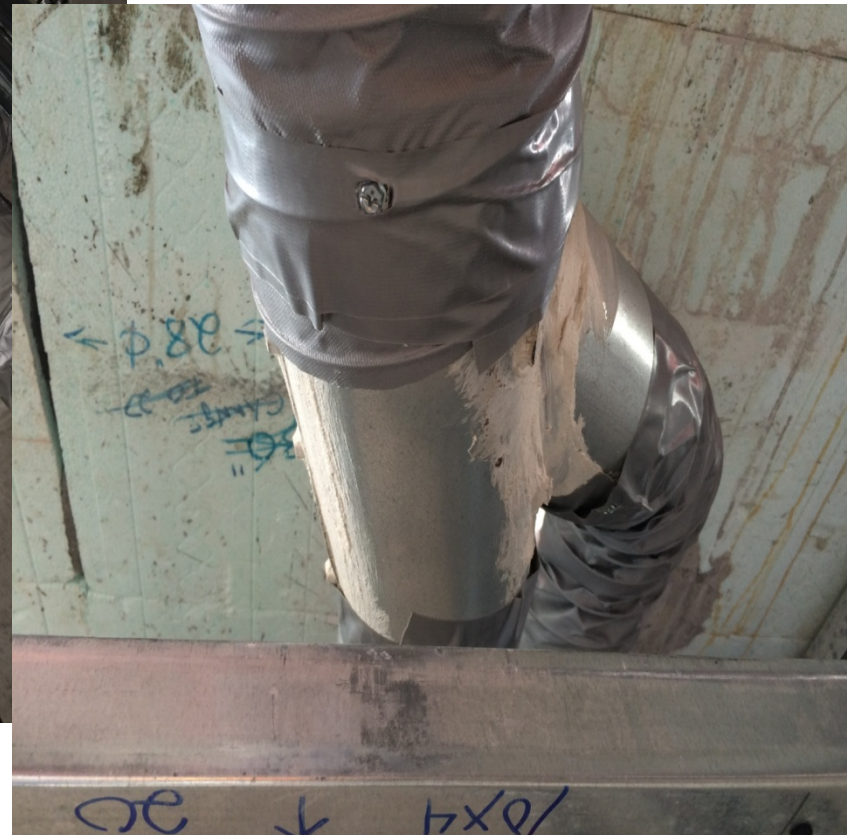
Duct Sealing on ERVs

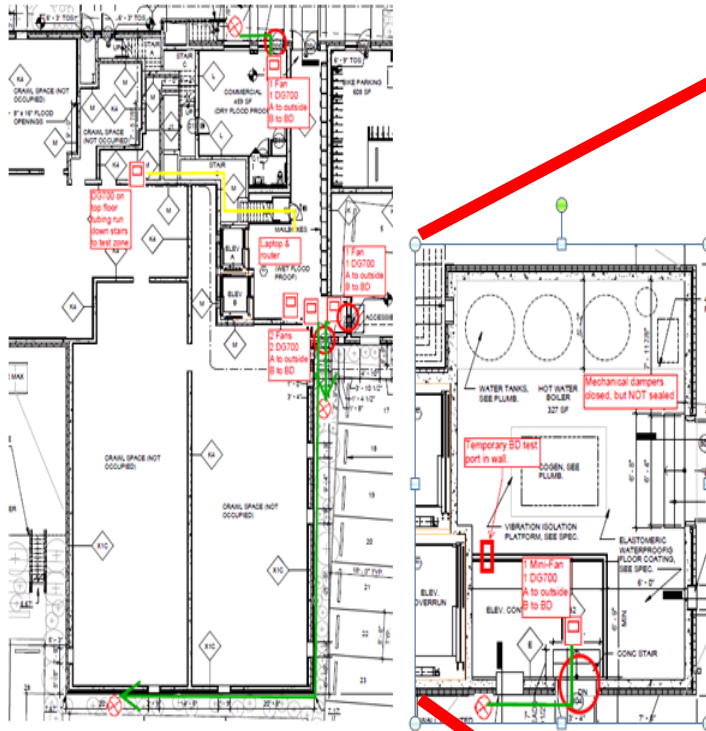
Figure 1 – location of test fans, indoor and outdoor pressure taps

Intentional Opening	Test Setting	Notes
Windows, doors, skylights and hatches in the building enclosure	Closed and latched	
Dryer doors	Closed and latched	
Doors, hatches and operable windows inside the <u>test enclosure</u>	Open	Use stairways A & B to connect all zones of the building
All motorized dampers	Fan off, damper closed but NOT sealed	Penthouse boiler room. Elevator hoistway
Fire dampers	Remain as found	
ERV's	Fan off, dampers closed. Ducts to outside sealed inside ERV cabinet.	Ventilation is continuous, so dampers closed and sealed
Heat / Cool system	Thermostat to 'off', supply and return ducts open & uncovered	
Combustion appliance flue gas vents	Appliance set to pilot or off Flue left in their as-found position	Penthouse boiler room
Plumbing traps	Sealed or filled with water

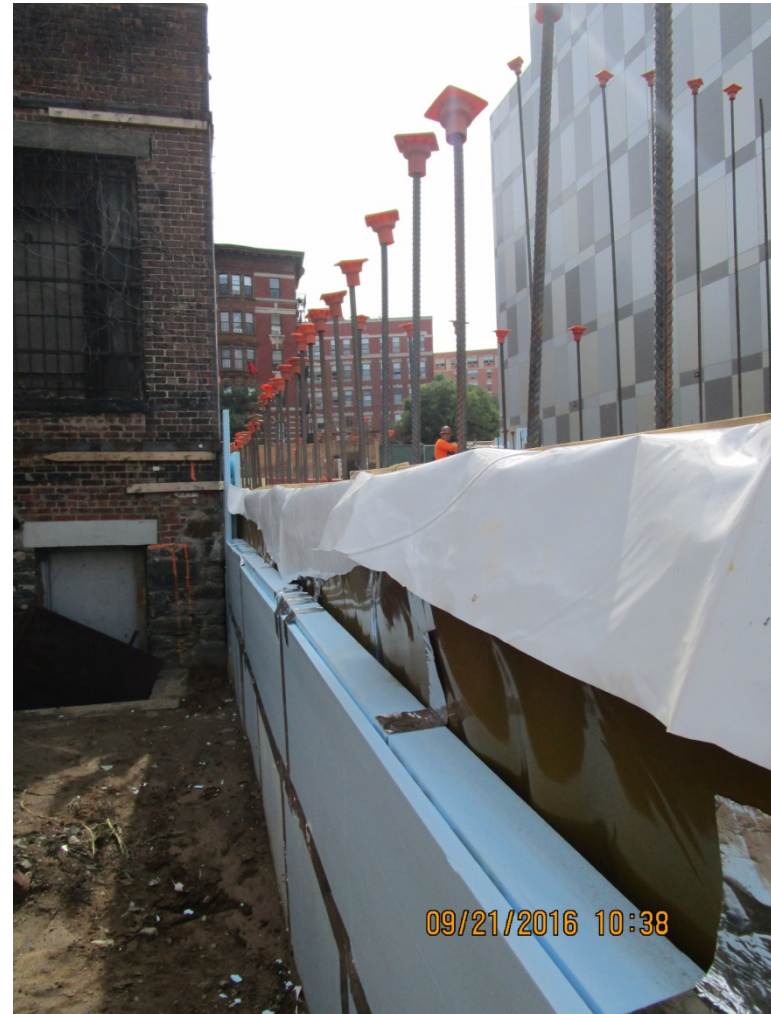
Complicated Foundations

- Infill site
- Walls near neighbors being poured in stages
- Several foundation inspections needed
