Ritchie Deep Energy Retrofit

Connors Hill Deep Energy Retrofit

Sundance Project Plan

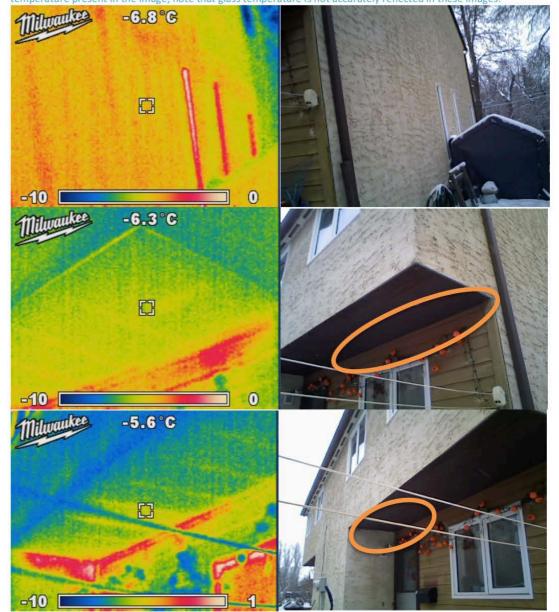
Figure 9: Infrared Thermal Images of Sundance Unit #15, taken just after sunrise on November 15, 2017. IR images shown on the left, with corresponding regular image shown to the right. The color legend represents the range in temperature present in the image; note that glass temperature is not accurately reflected in these images.

Similar to Unit #15, Unit #22 has a history of occupant complaints due to cold rooms and wall surfaces. We undertook a similar thermal imaging review of this unit, with findings summarized in Figure 8 and 9. Similarly, we found minor areas with raised surface temperature, mostly around the front patio wall to ceiling connection. This area could certainly lead to a localized cold spot on the interior of the unit, however, we'd suggest that a proper volume of heating air supply should maintain internal comfort. The main wall areas show a relatively uniform surface temperature, which suggests current insulation levels are quite consistent. We'd suggest that if thermal comfort continues to be an issue in this unit, then a service contractor could be brought into assess the airflow balance of the furnace.

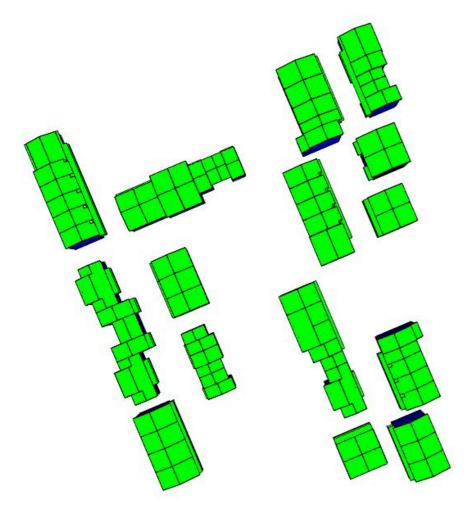
Figure 4: Screen capture of IES<VE> energy model representing the Sundance Housing Cooperative, plan view.

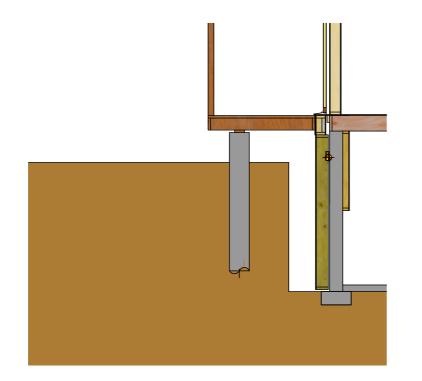
Full Height 2x8 PFW Exterior Wall

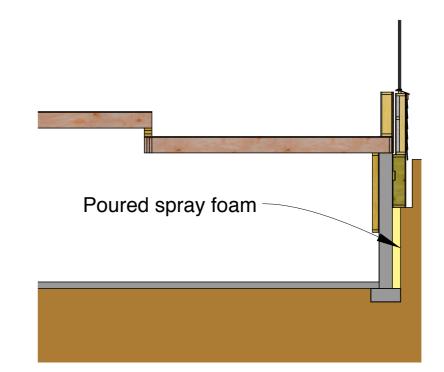
Partial 2x8 PFW Exterior Wall w/ Poured Spray foam Below

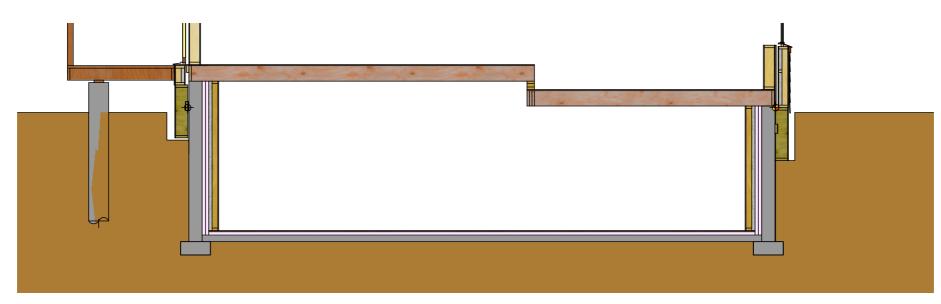
Inside R 35 Frostwall with R 10 Basement Floor Insulation

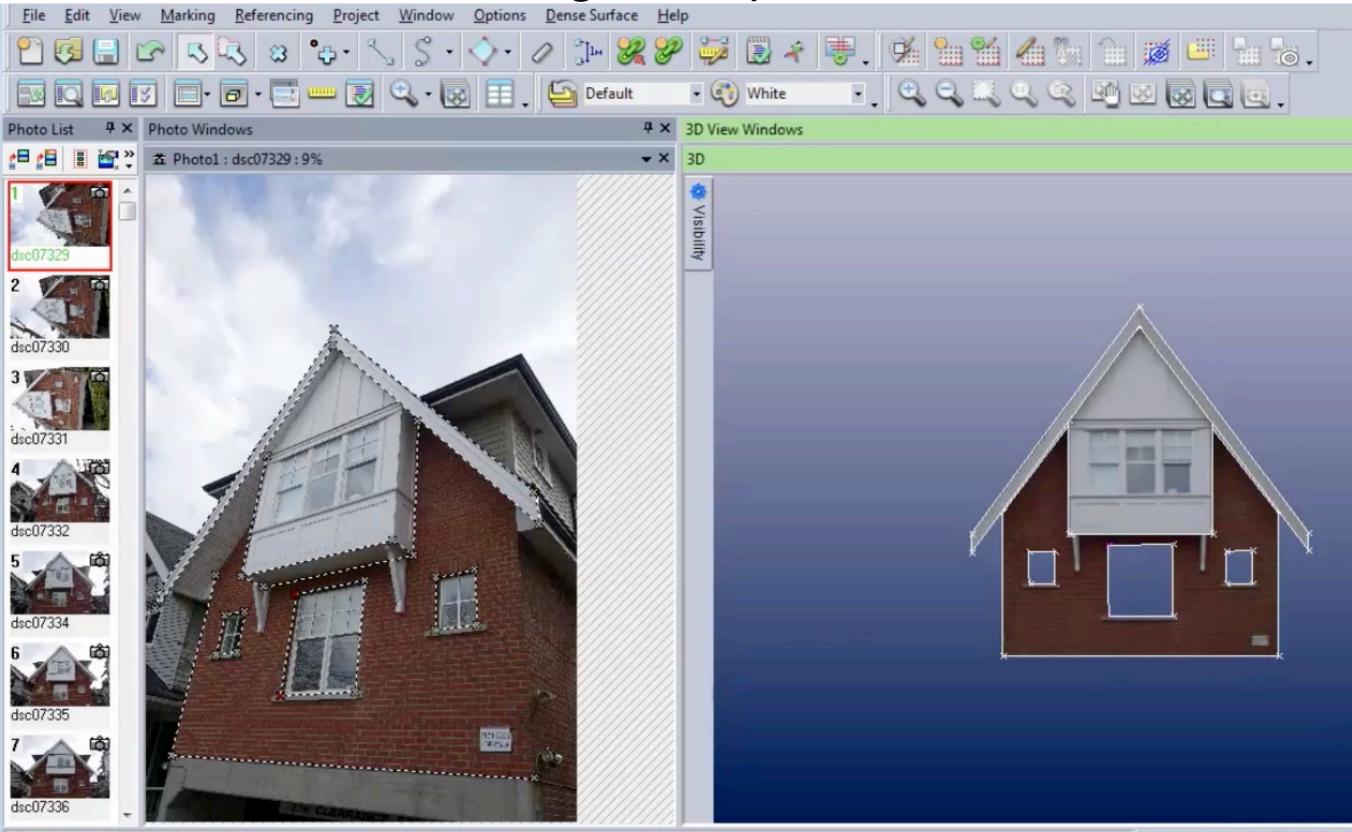
Digital Capture

Image from PhotoModeler Video

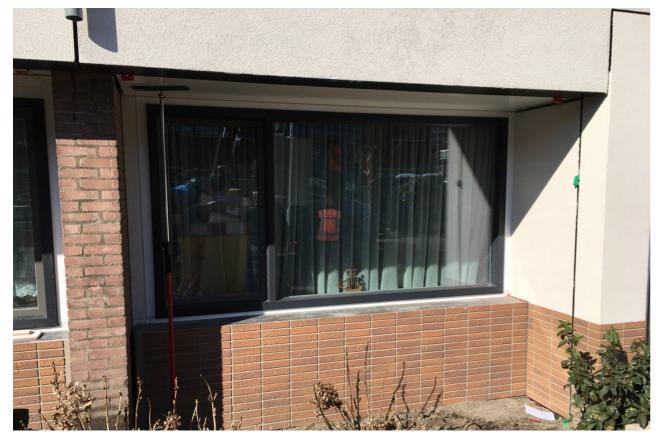
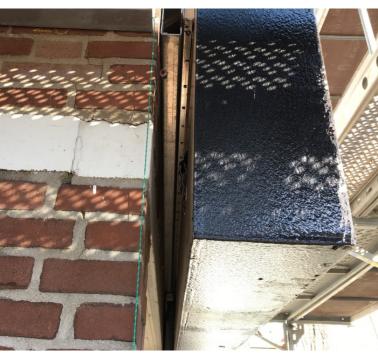
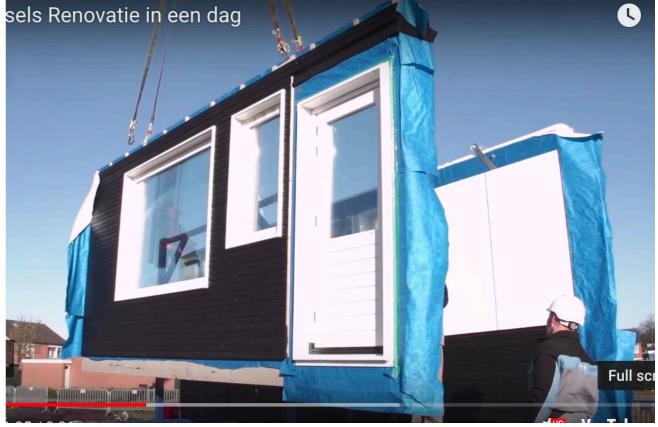
Air and Water Sealing Caulking vs Sealed Flaps
