Multifamily Construction Verification – Planning for Success

2018 PHIUS North American Passive House Conference

BEACH GREEN NORTH Affordable Housing – 101 units

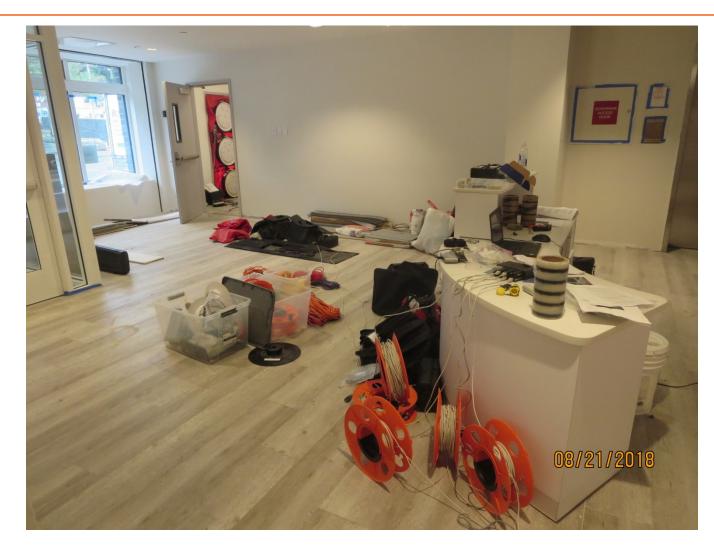
Blower Door Testing – Whole Building

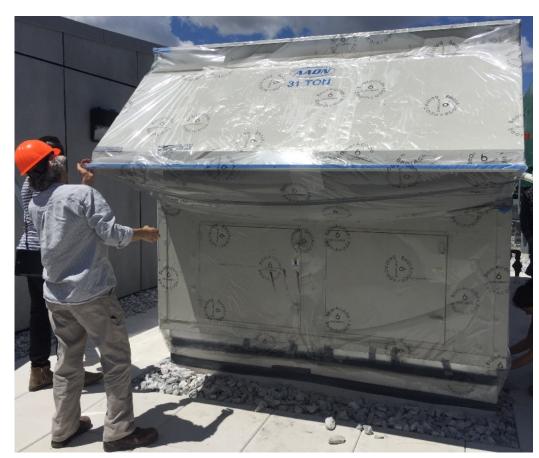
Central ERVs & Blower Door

- Need to seal off ERVs for the final test
- Wrap rooftop ERVs or seal exterior intake and exhaust louver ports

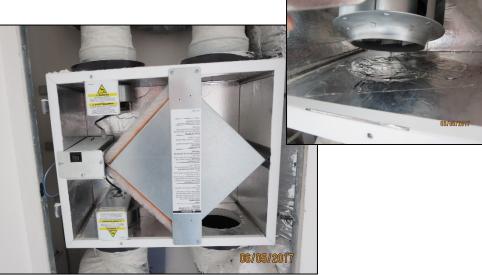
Individual ERVs & Blower Door

• Typically can't reach all vents to seal from outside

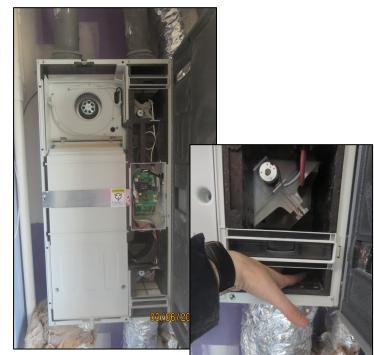
Tape off both outdoor connection ports inside every ERV
