Kohta Ueno and Joseph Lstiburek

# Unvented Roof Without Spray Foam:

## The Latest Building America Research

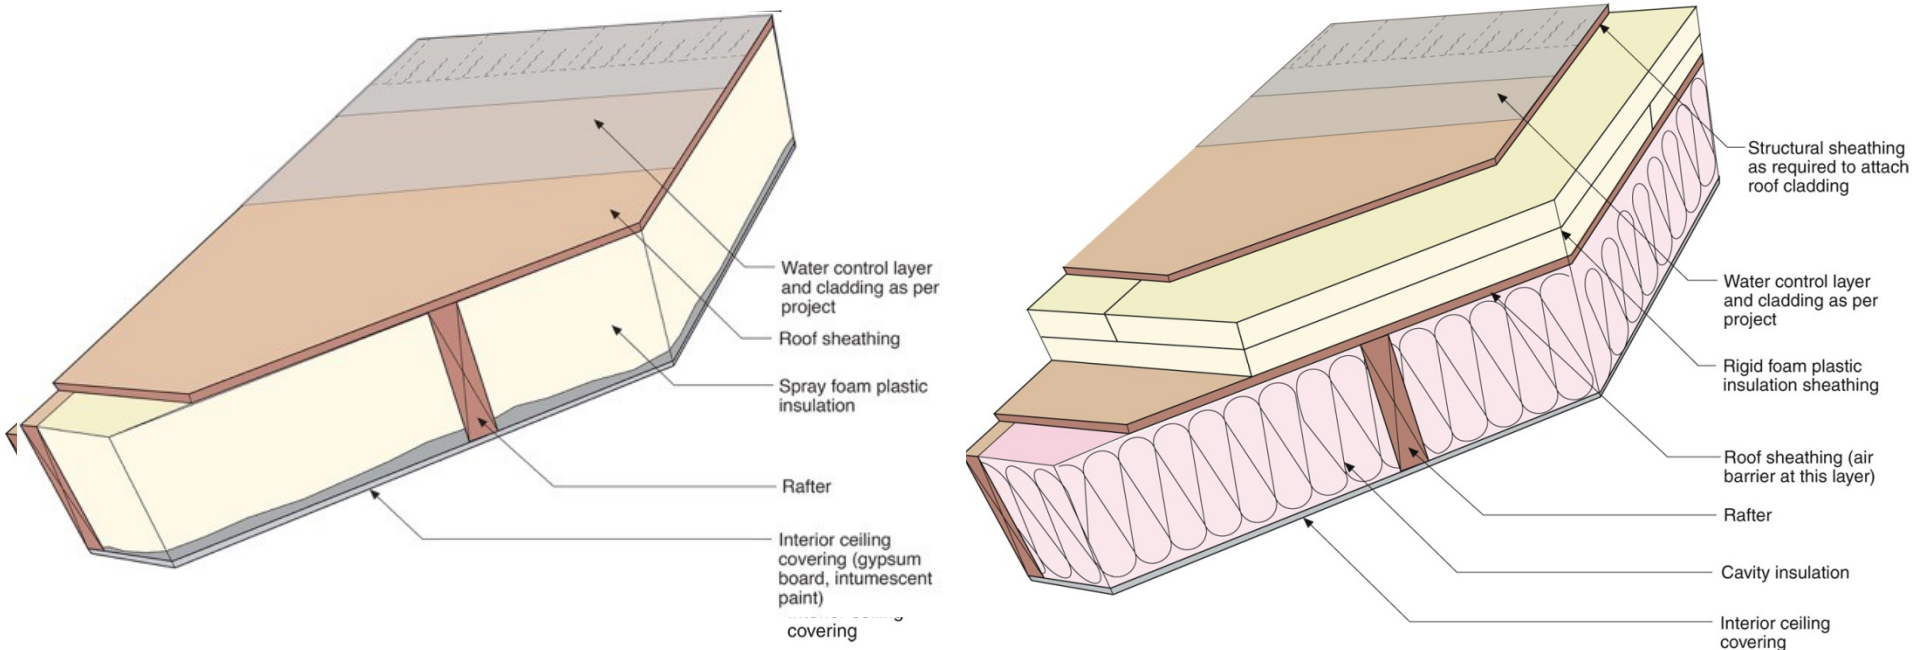
- 2006 IRC: §R806.4/5 Unvented attic assemblies
- Minimum R-value of “air impermeable insulation”
  - Actually ratio of R-values (BSI-100 Hybrid Assemblies)
- Nail base needed with rigid foam on roof deck

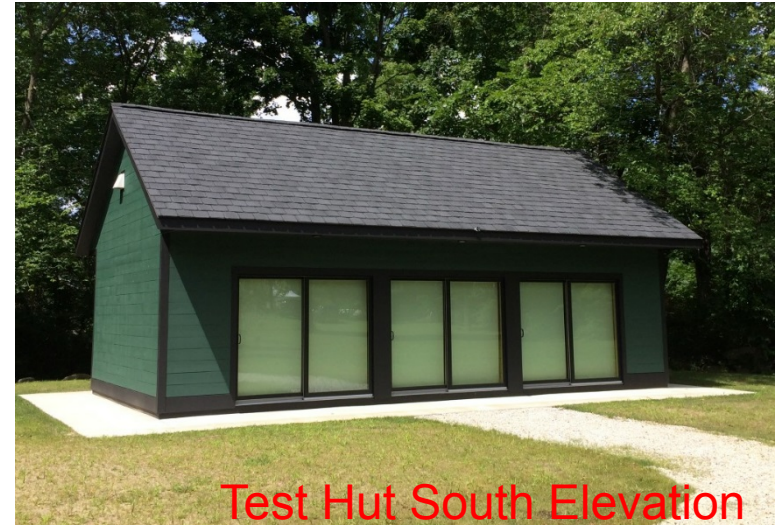
- Climate Zone 5A test hut
- Eight north-south roof bays
- $\pm R-50$  (14- $\frac{3}{4}$ " framing, 2012 IECC)
- Test variables:
  - Vapor retarder: variable perm vs. fixed perm
  - Diffusion vent at ridge vs. ~~no diffusion vent~~ "small" or "tight" DV
  - Fiberglass vs. cellulose
  - "Control" comparison §R806.4 spray foam + fibrous
- Varying interior boundary conditions
  - Winter 1: "Normal" interior conditions
  - Winter 2: Elevated RH (50% constant)
  - Winter 3: Air leakage into rafter bays

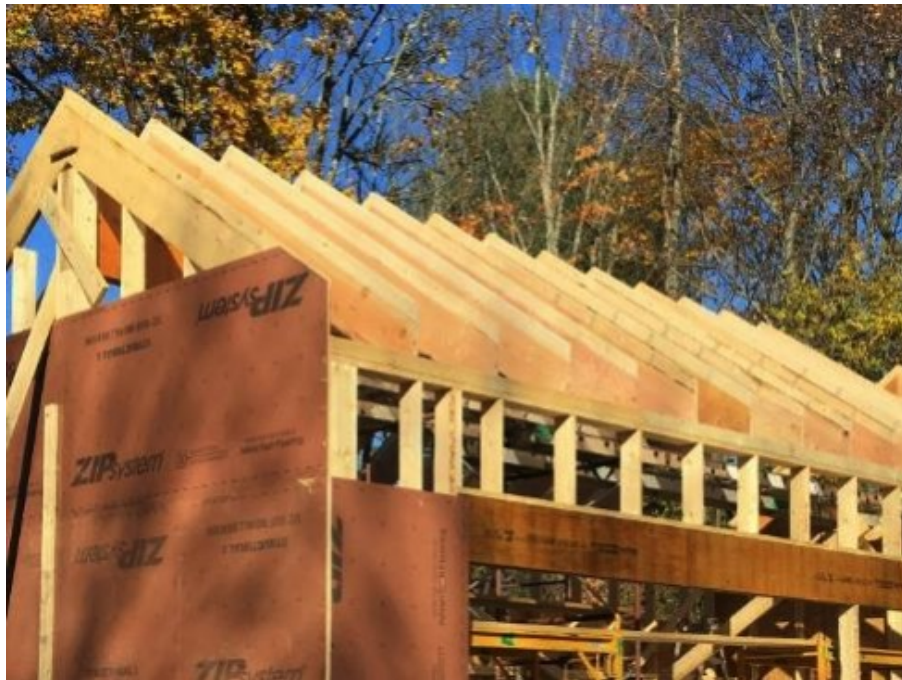
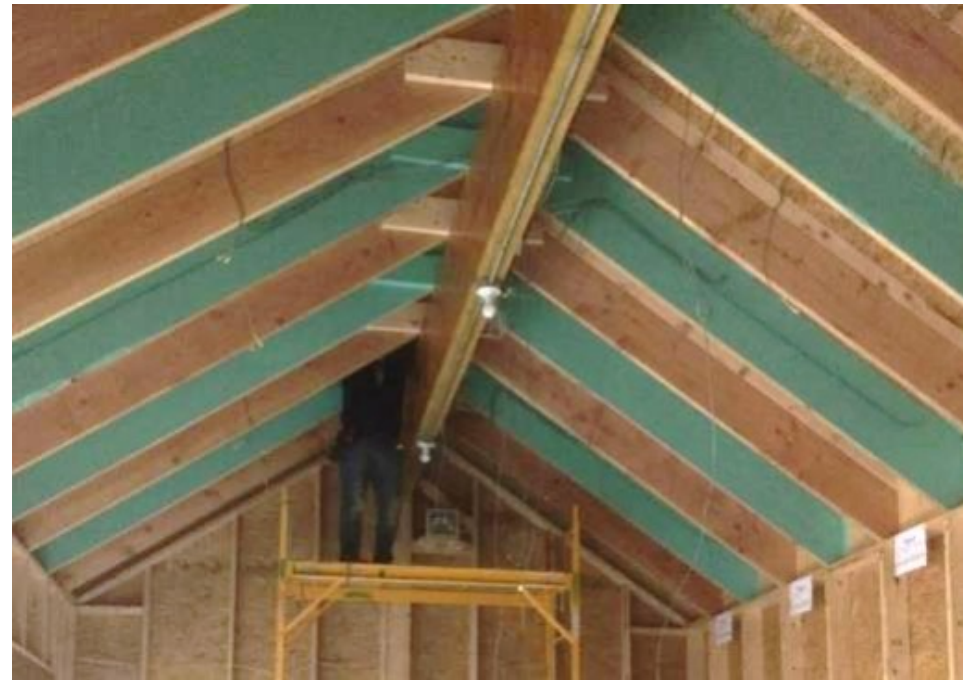
# Test Hut Construction

- Roof bays 24" o.c.
- Guard bays between experimental bays (“flash and blow” ccSPF + cellulose)
- Fluid-applied air and vapor barrier at guard bays

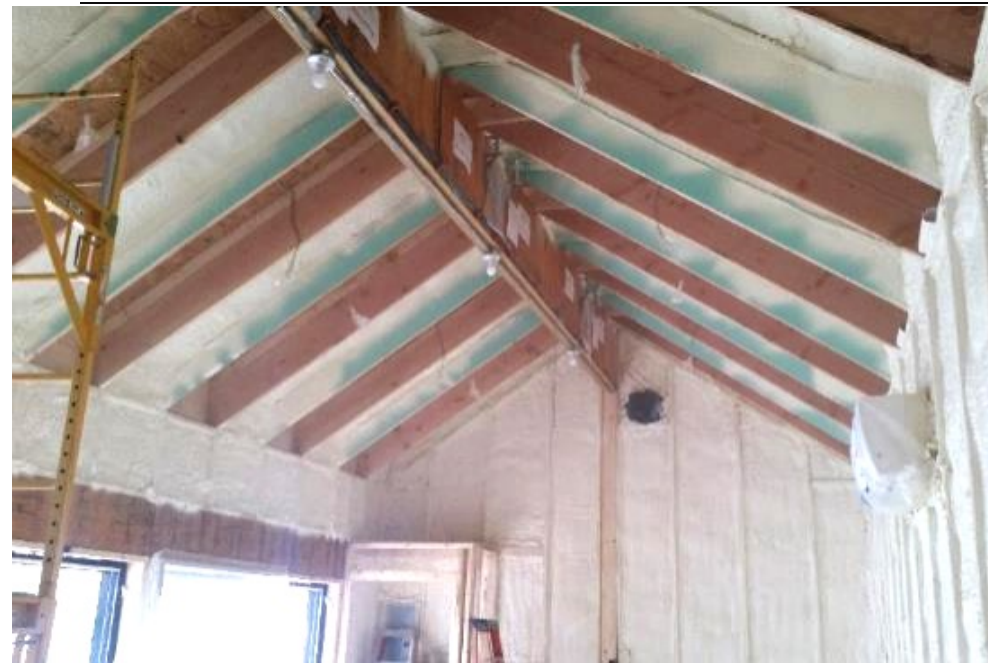
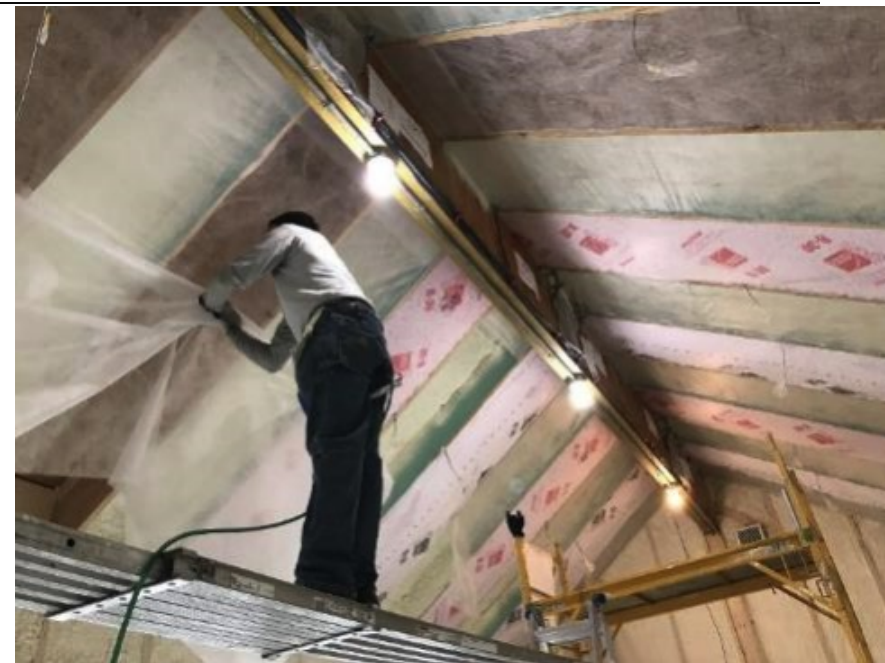
# Test Hut Construction

- Flash and blow bays (ccSPF shown)
  - ccSPF completes air barrier between bays, wiring holes
- Insulation netted & blown

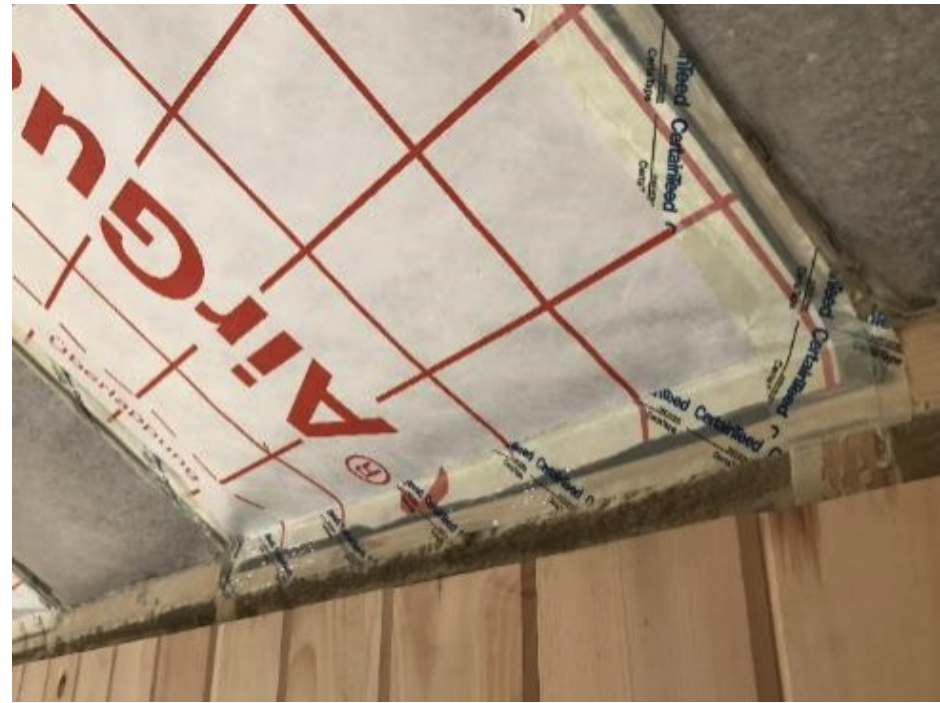
# Test Hut Construction

- Interior air barrier & vapor retarder membrane
- Double tape seal (double-sided tape + housewrap tape)

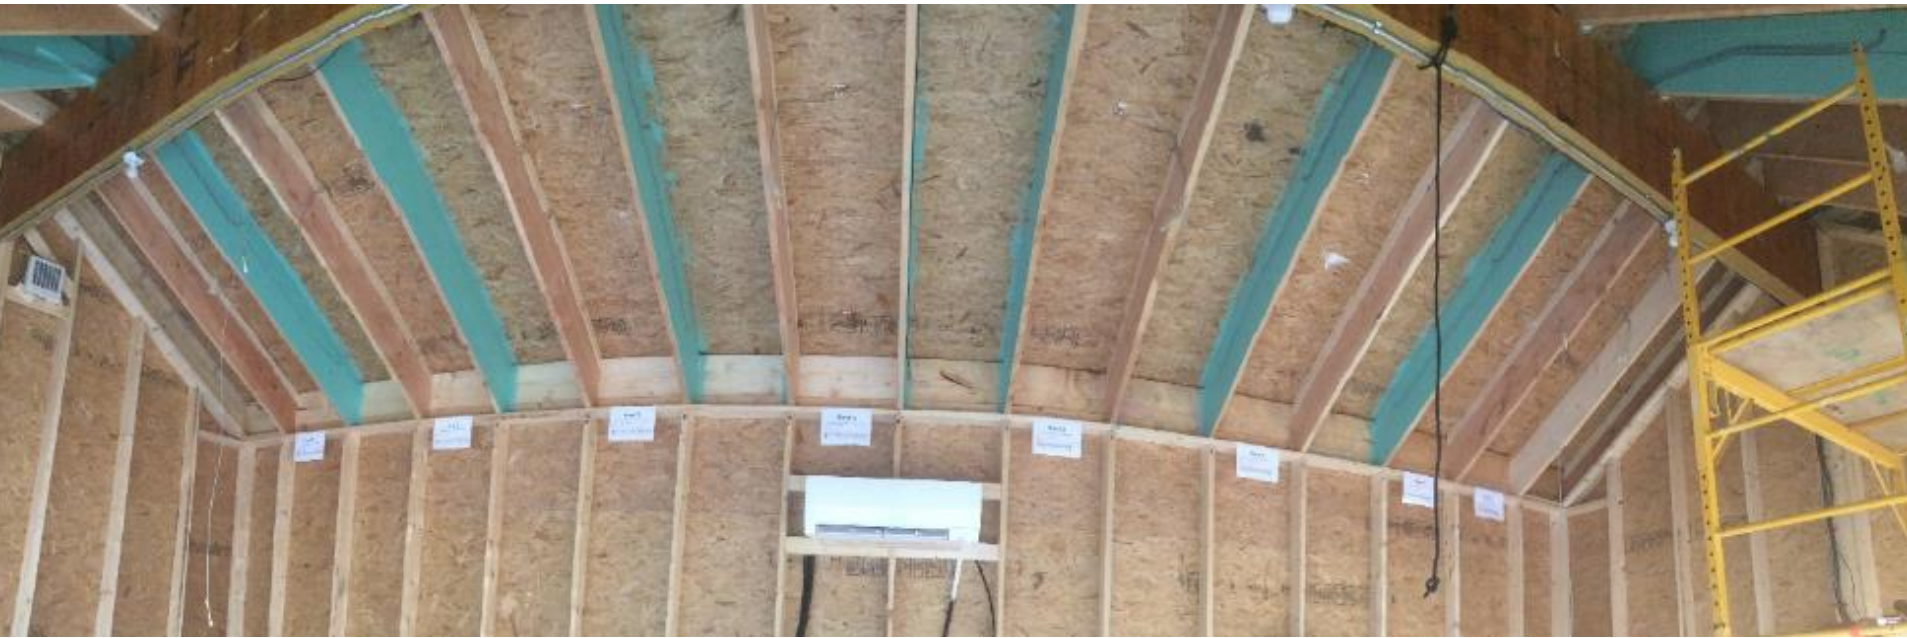
# Test Hut Construction

- Instrumentation completion

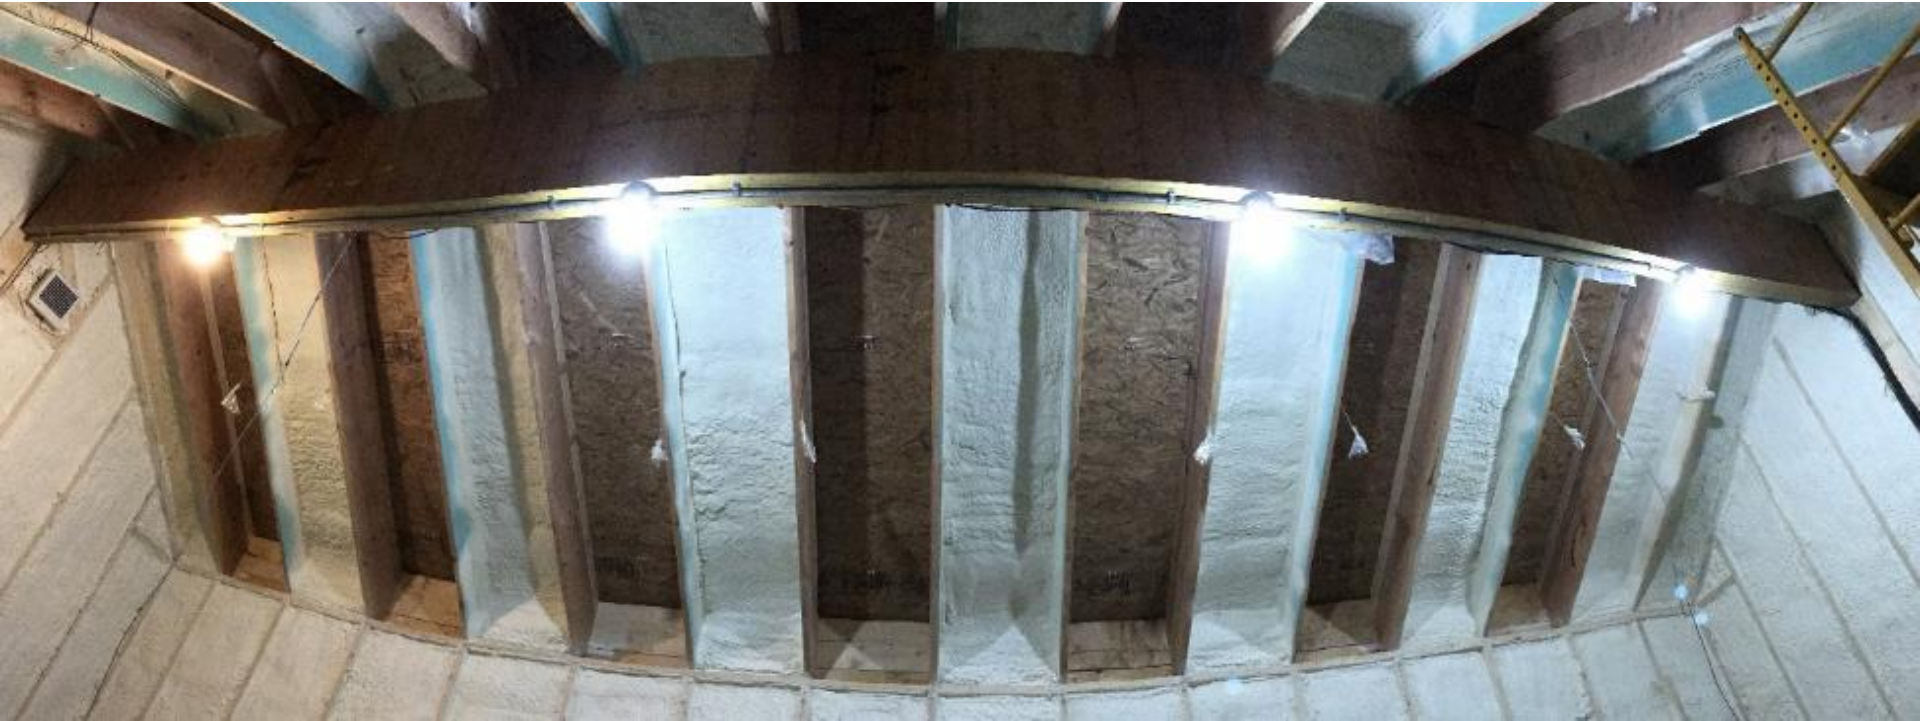
- ccSPF in guard bays and walls

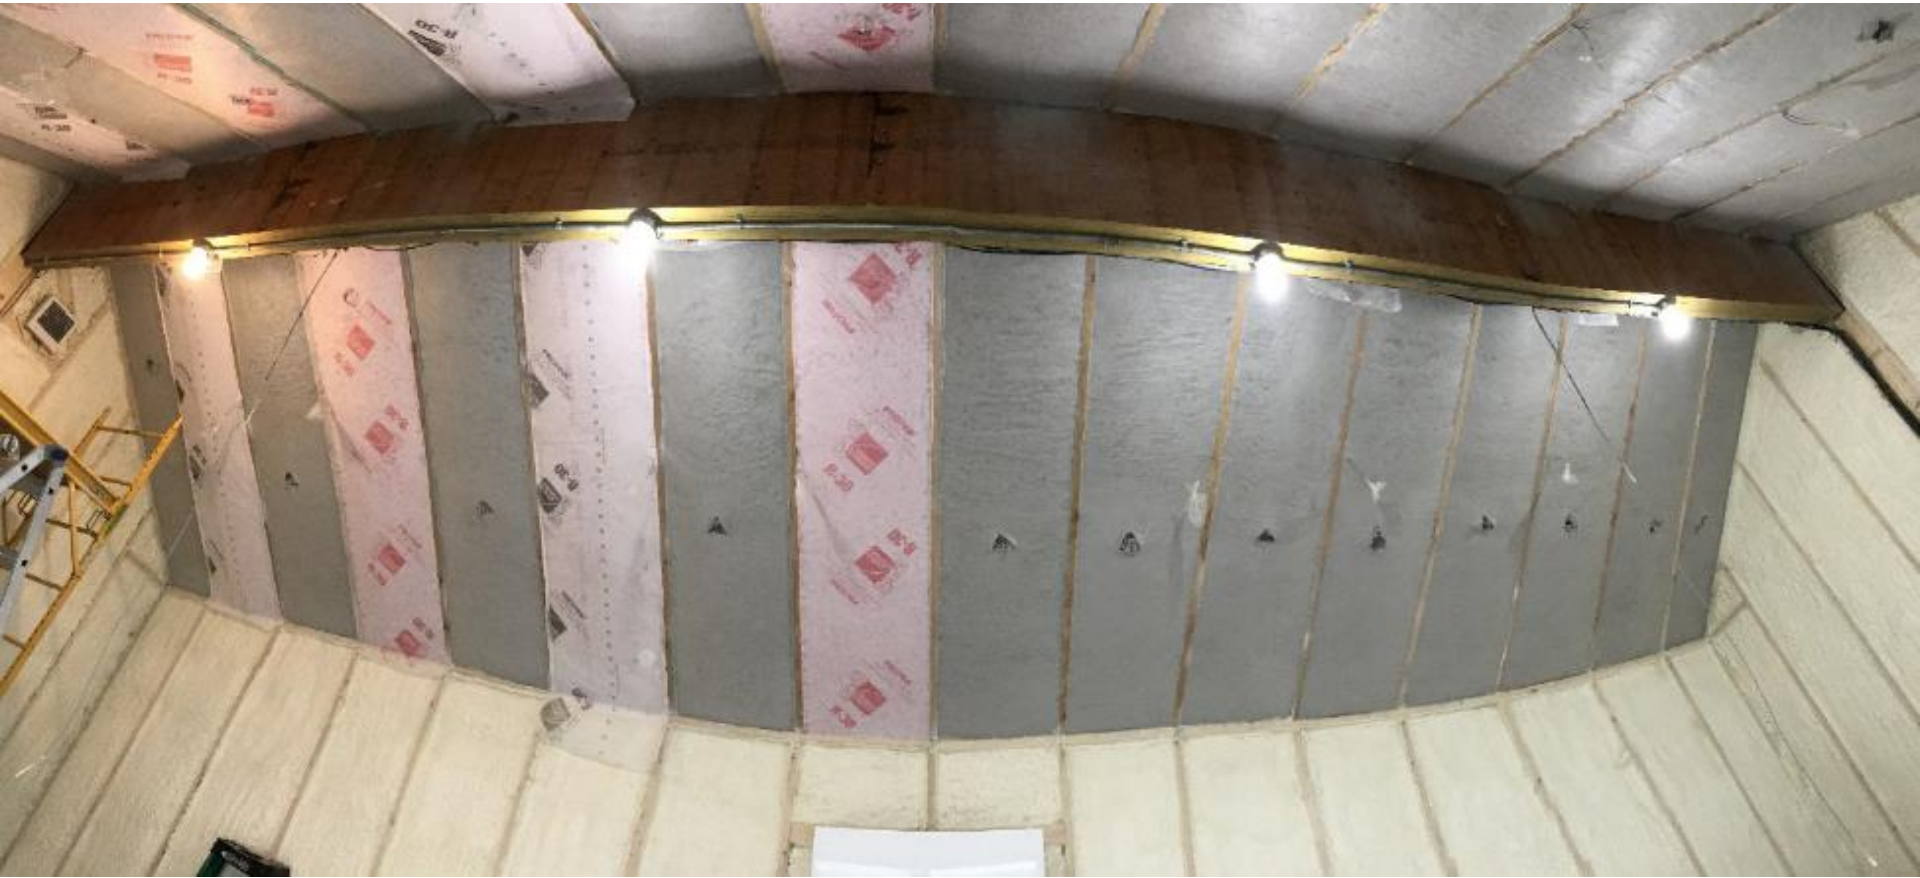
- Fibrous insulation installed

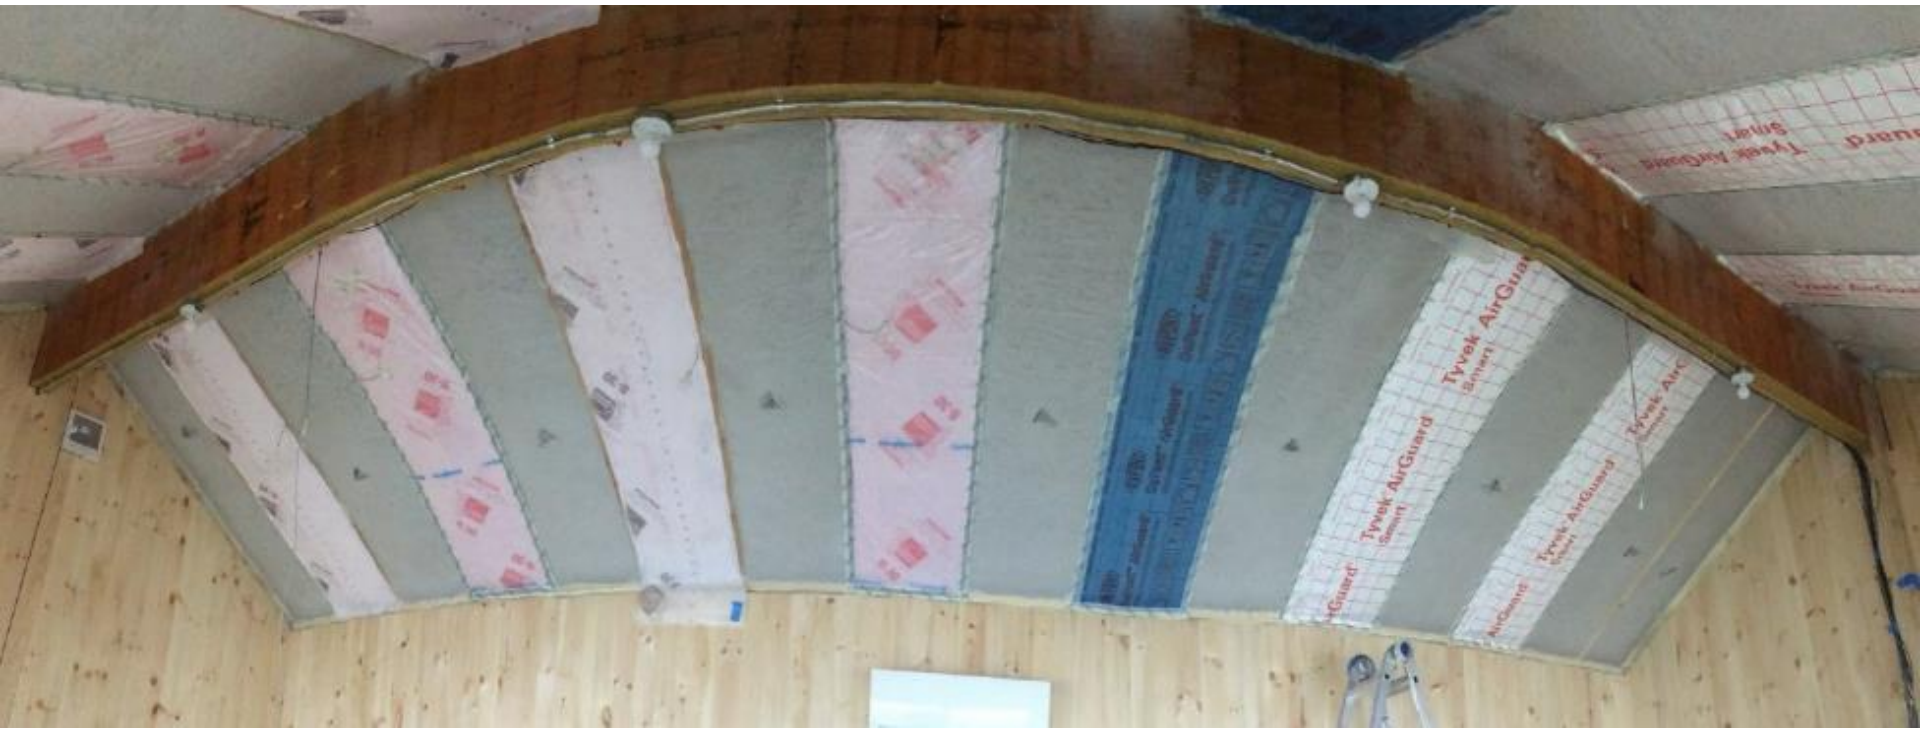
- Interior air/vapor control installed

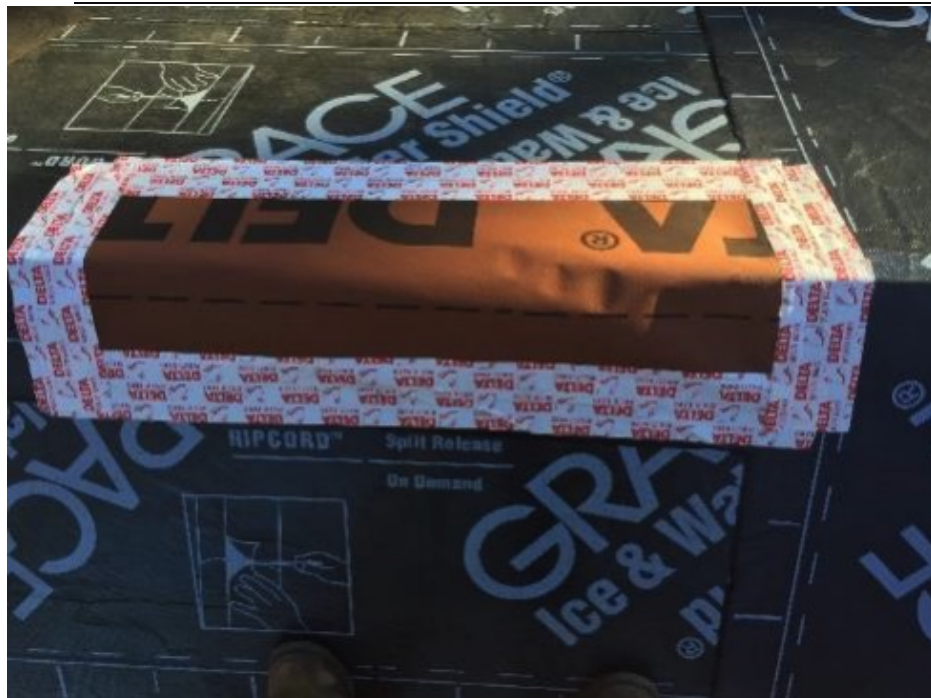
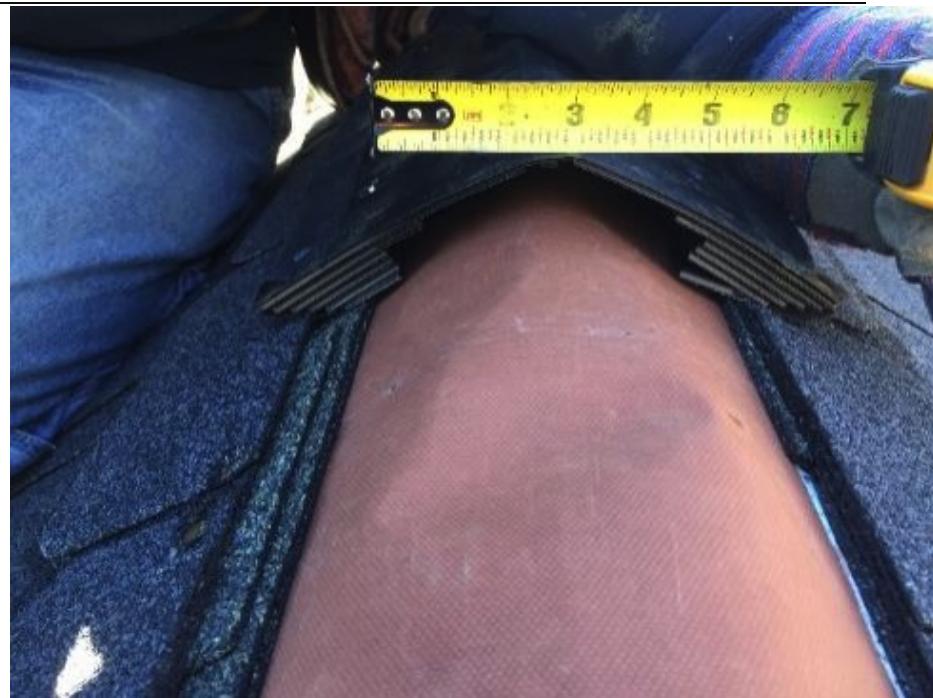
# Experimental Approach: Diffusion Vent

- $\pm 6$  in. opening (fits under typical ridge cap)
- Cosella-Dörken Delta-Foxx (214 perms dry cup, 550 perms wet cup)

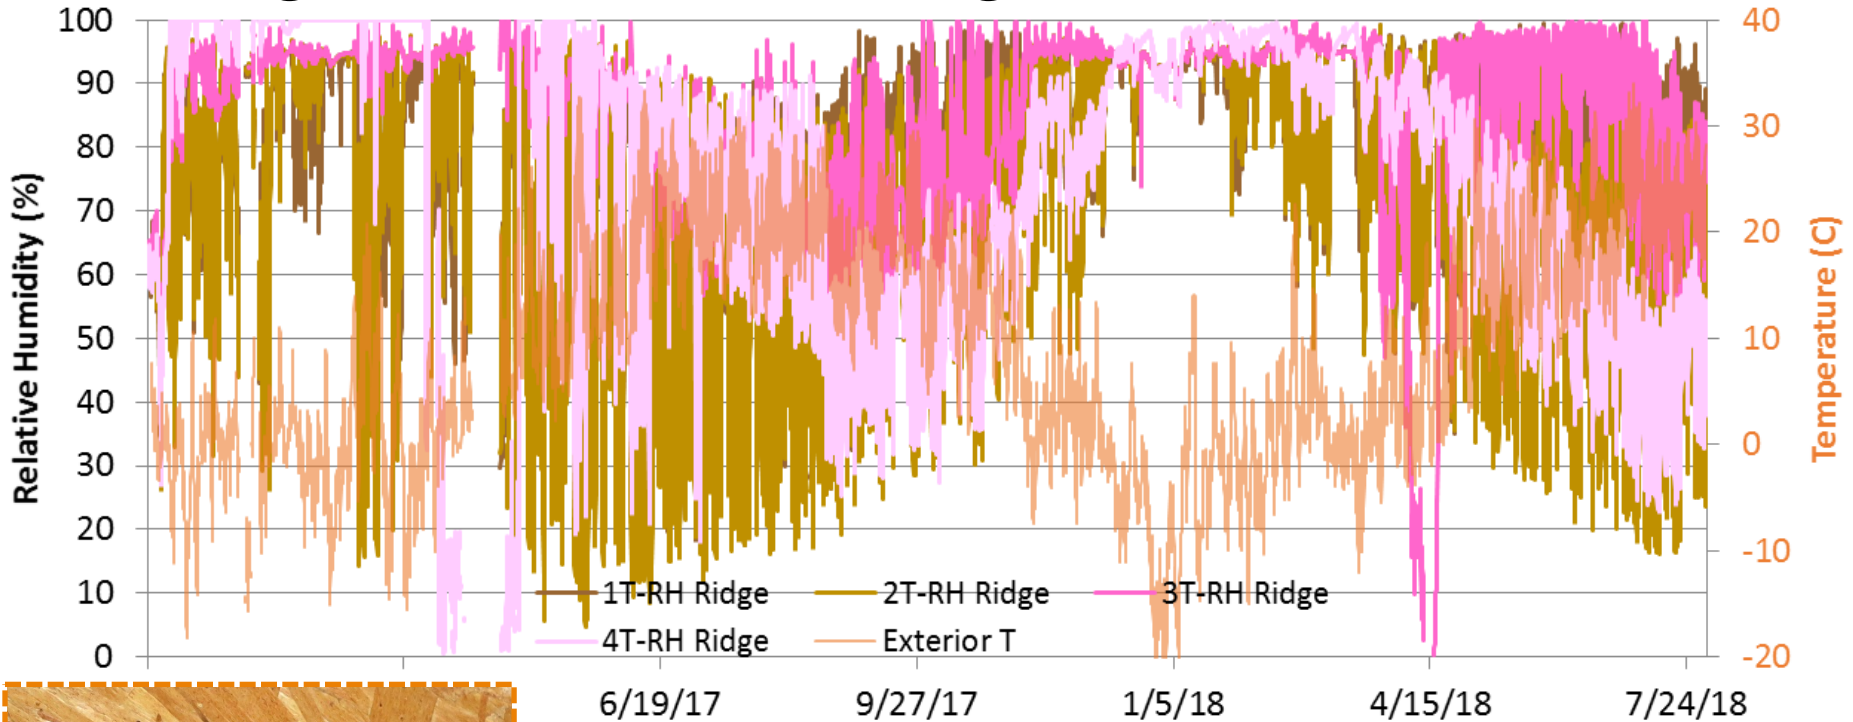
) > 95% RH most of Winter

) next highest RHs

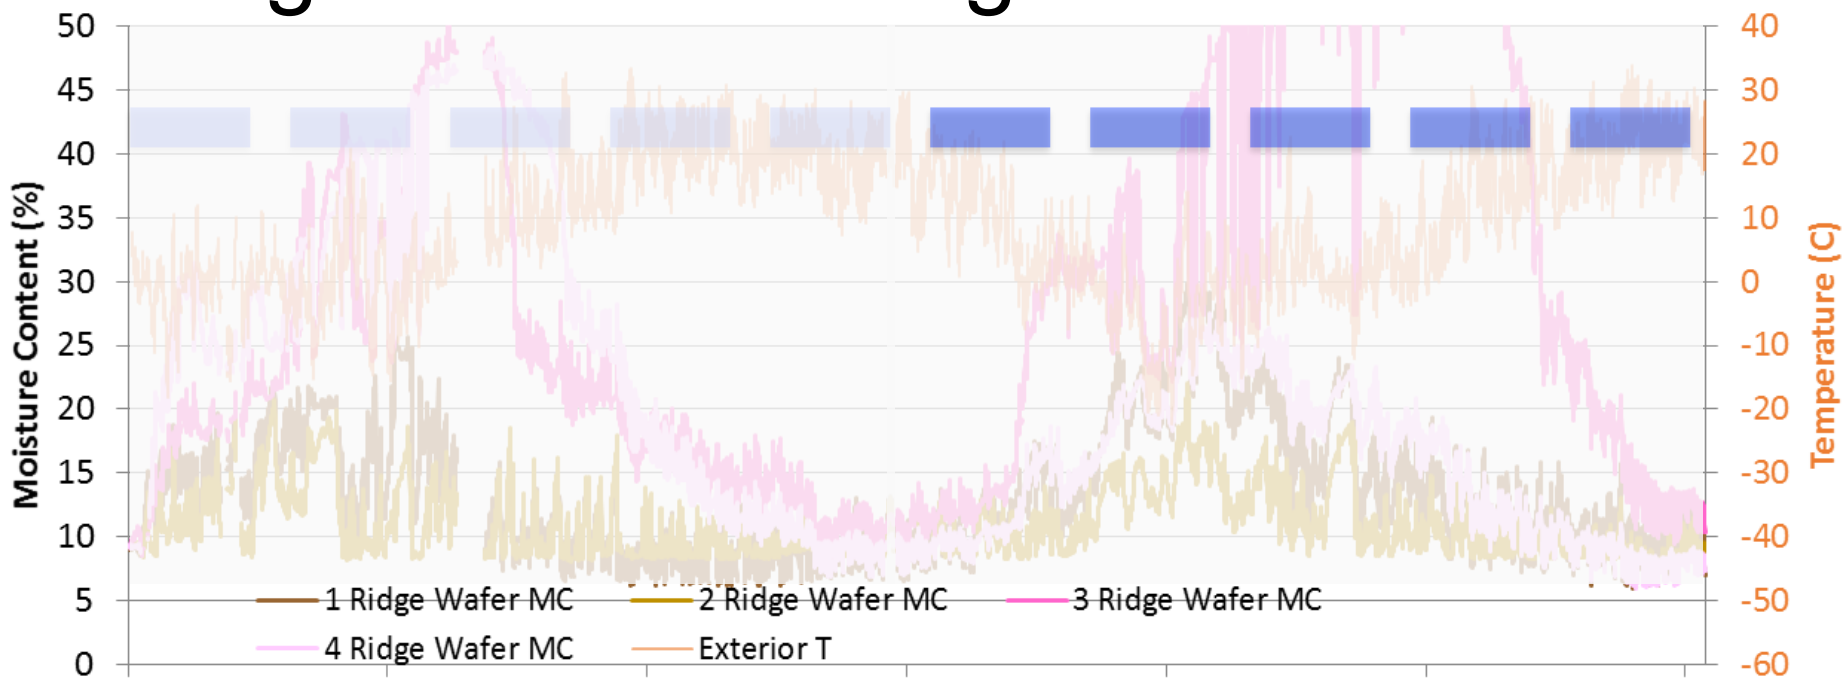
**Roof 3 & 4 (nDV) > 40% MC**  
 Ridge wafer calibrated ~40-45% MC  
 Unvented **Roofs 1 & 2** stay drier <25%  
**Roof 3** (tDV) soaking wet ridge  
**Roofs 1, 2 & 4** (DV) 20-30% MC

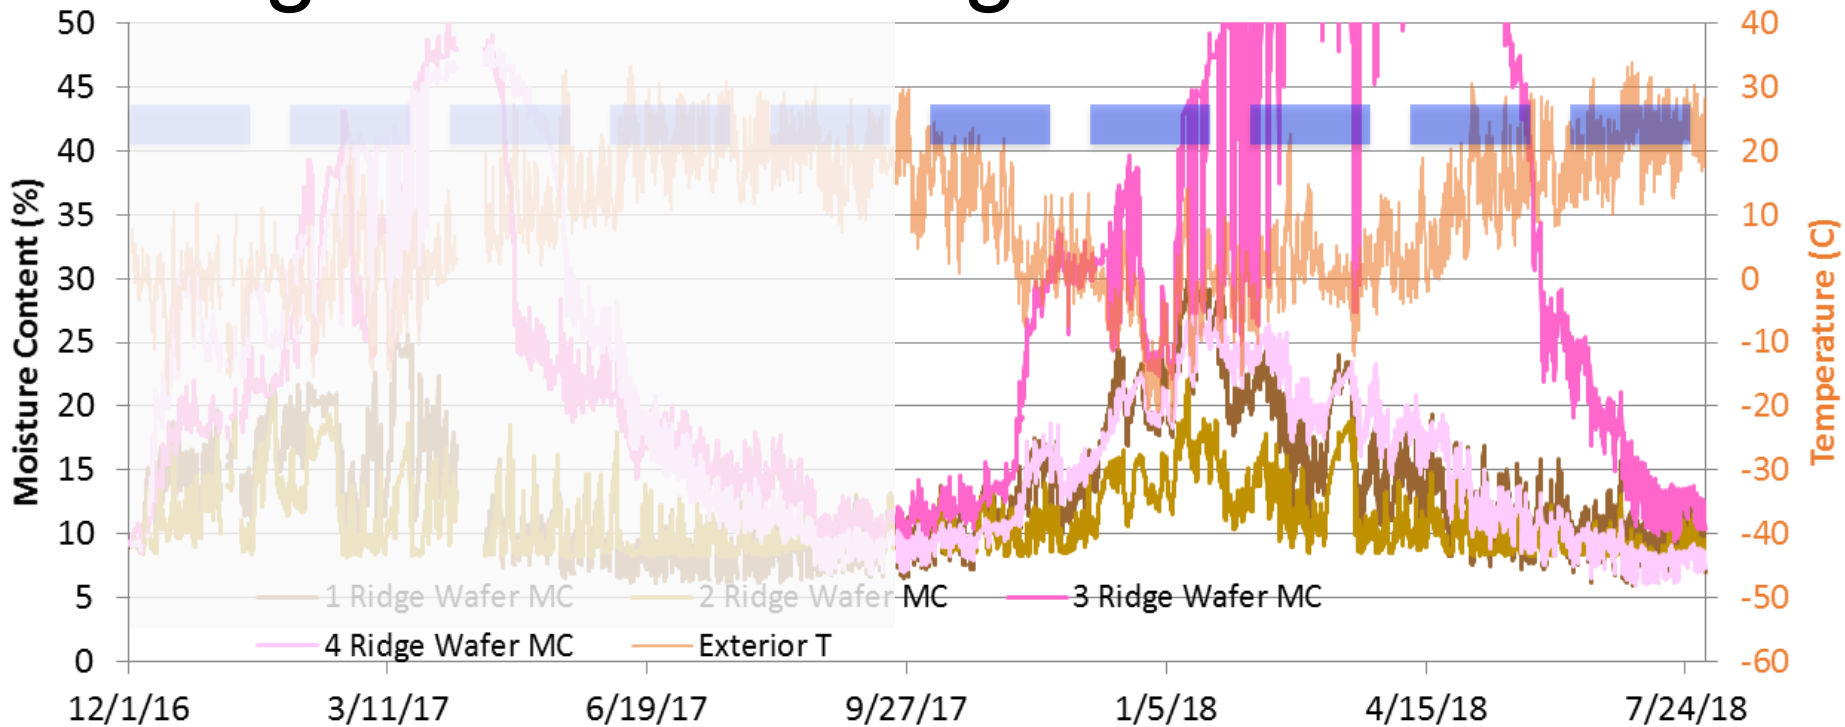
- **Roof 3** indicates 25 perms not enough
- **Roofs 1, 2 & 4** (DV) differences not clear
  - **Roof 4** (sDV) restricted, **Roofs 1** VB vs SVR?
- All dry down in summer, **Roof 3** delayed

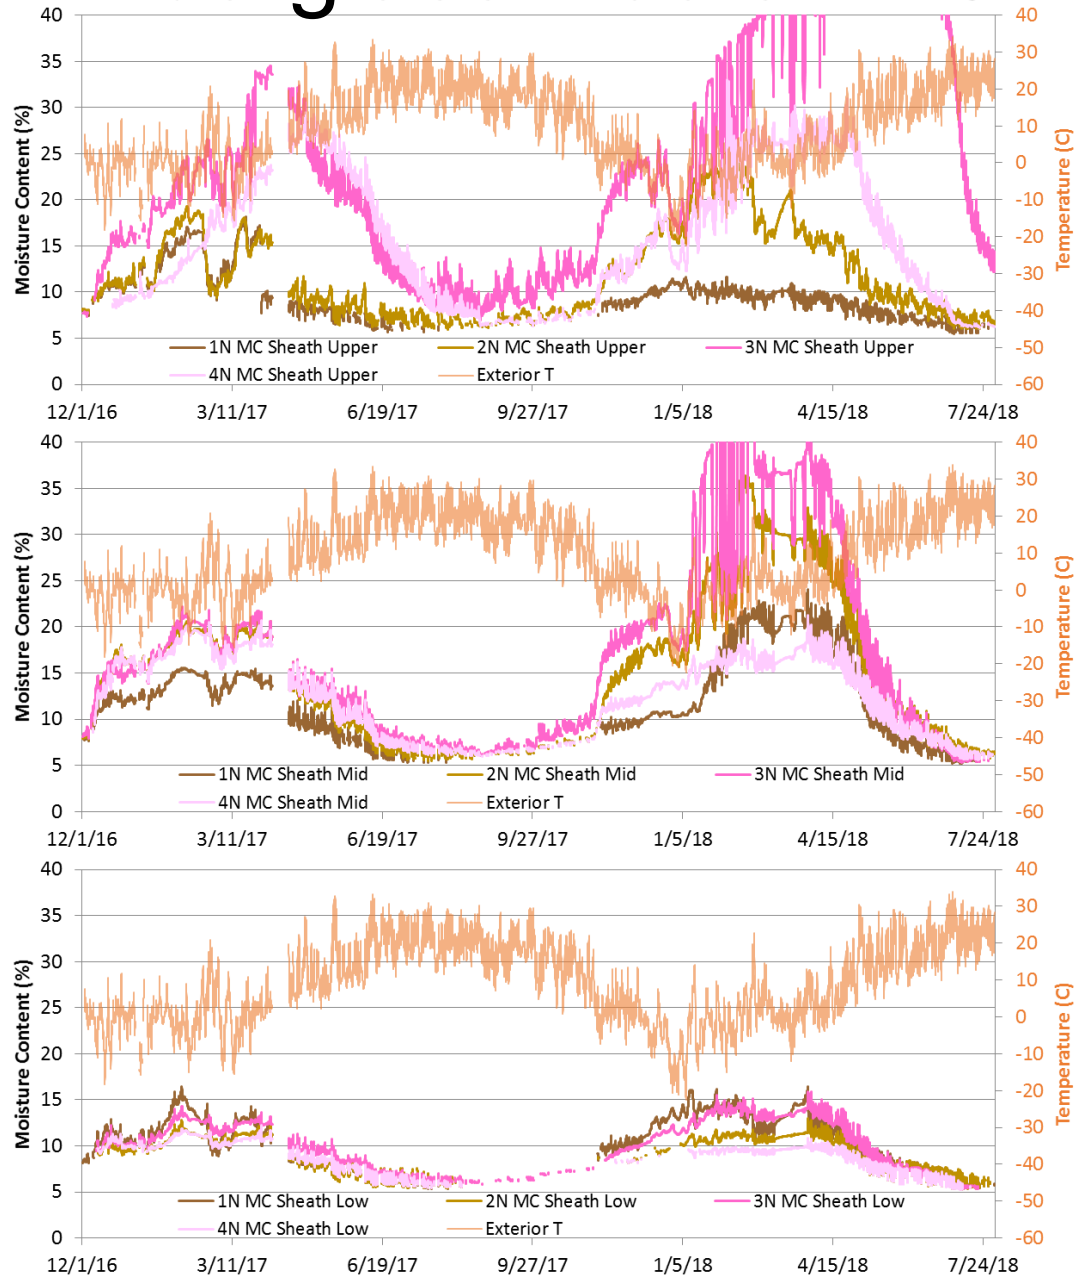
- North sheathing MCs
- High-Mid-Low
- Gradient of MCs (highest near ridge, lowest near eaves)
- Much higher MCs in Winter 2
- Many over 20% at mid-height sheathing
- “Low” location still safe (below 15%)

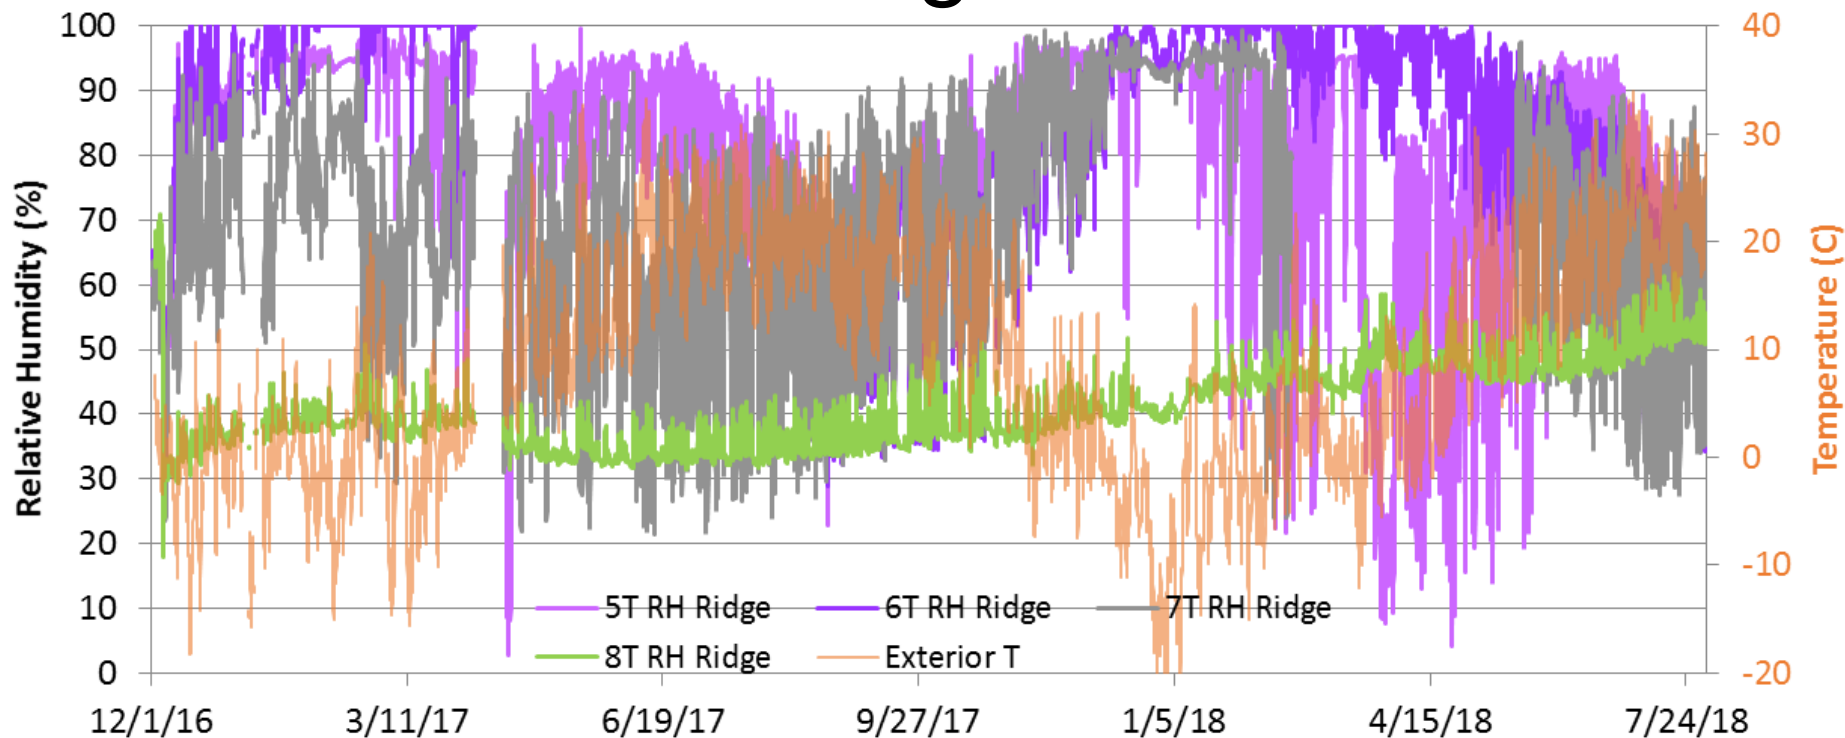
- Difficult to differentiate
- RH sensor failures: **Roof 6** (2017), **Roof 5** (unrealistic data 2018), **Roof 7** (2018)

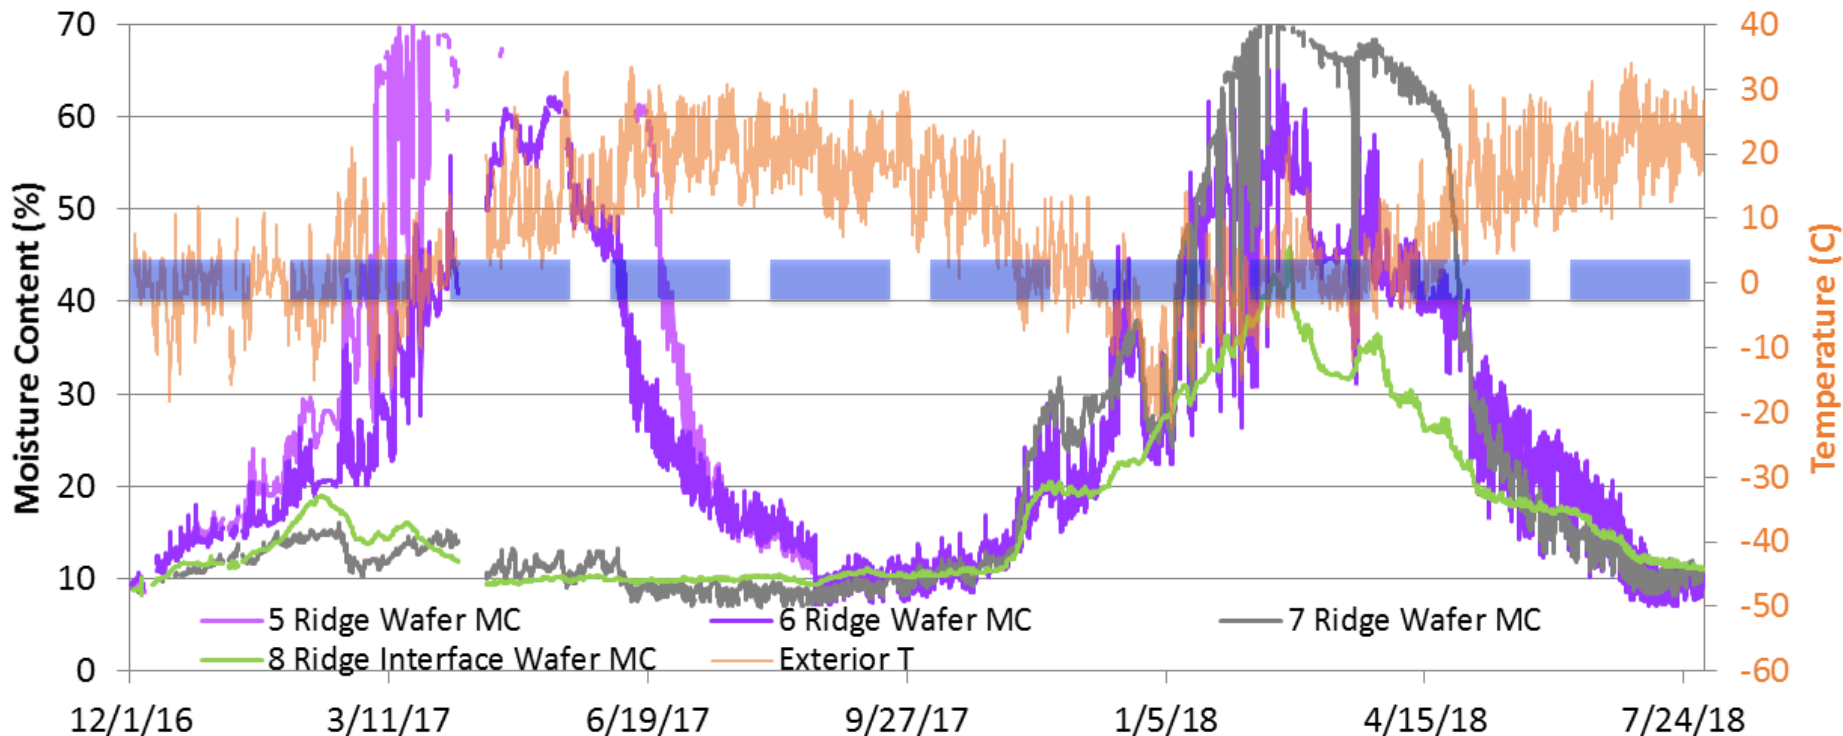
- Unrealistic MCs: condensation, borate migration
- **Roof 5** no data Winter 2 (unspliceable)
- **Roof 6** drier than **Roof 7**?
- **Roof 7** dries down faster (larger DV)

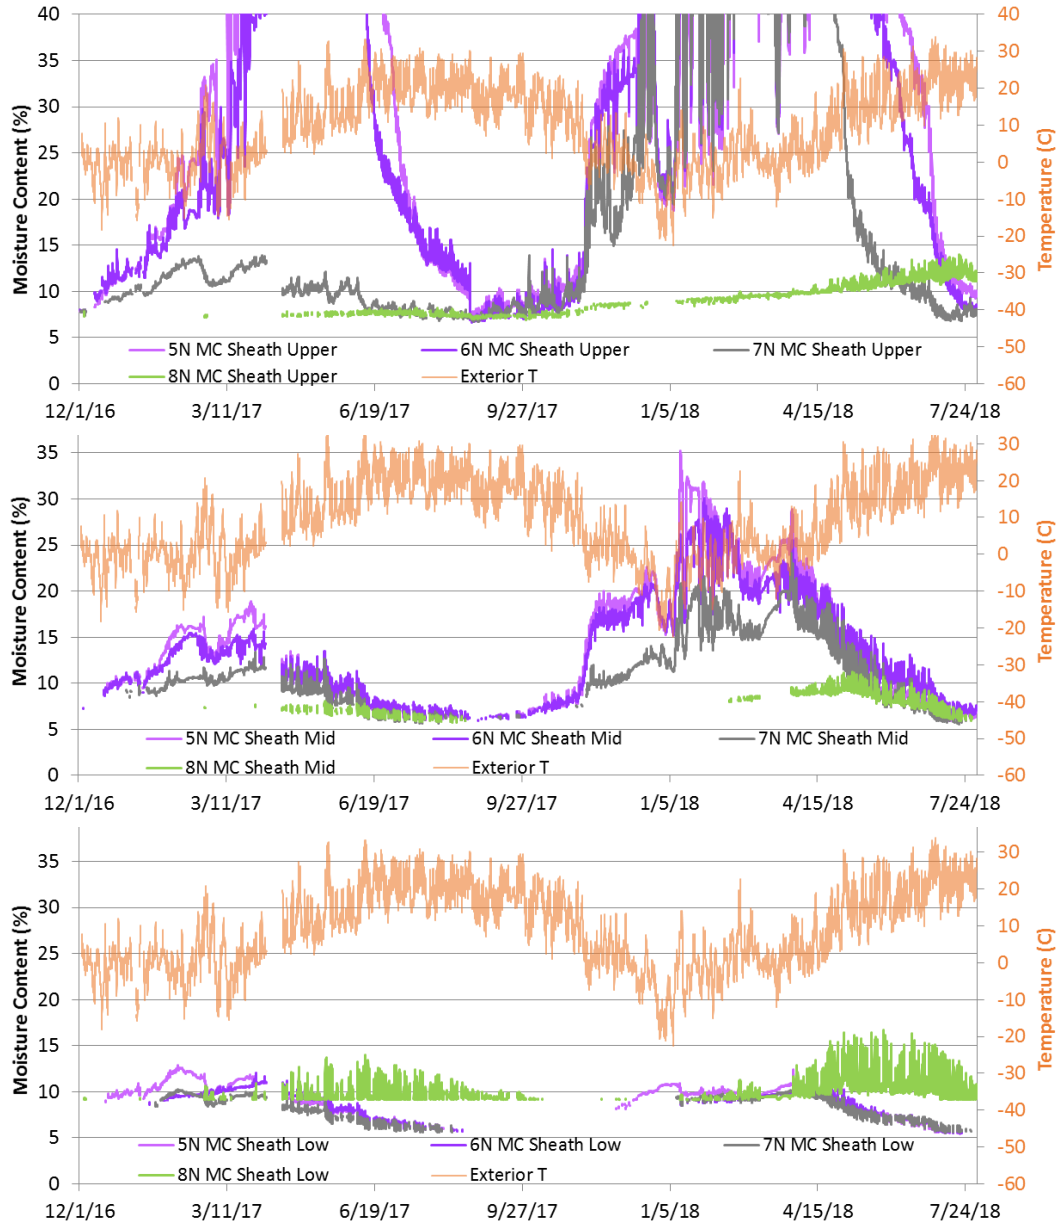
- North sheathing MCs
- High-Mid-Low
- Upper: condensation & borate migration
- 50% RH much more challenging-many over 20% MC (“Mid”)
- “Low” MCs safe
- **Roof 8** (hybrid) MCs below 15%-safe

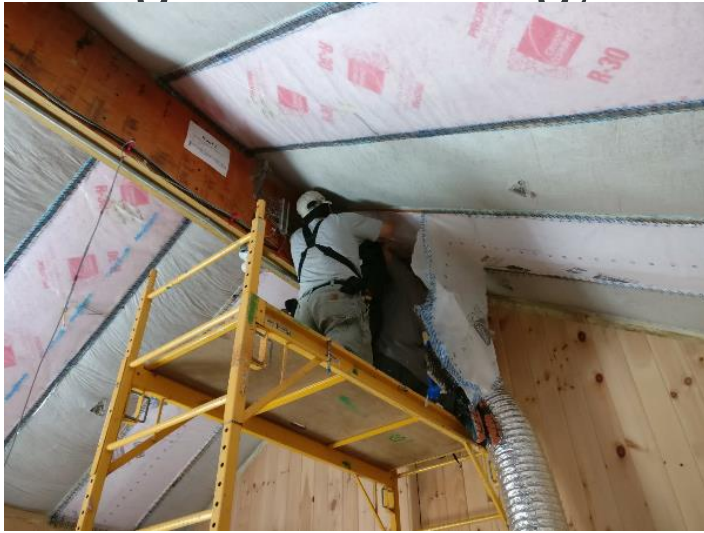
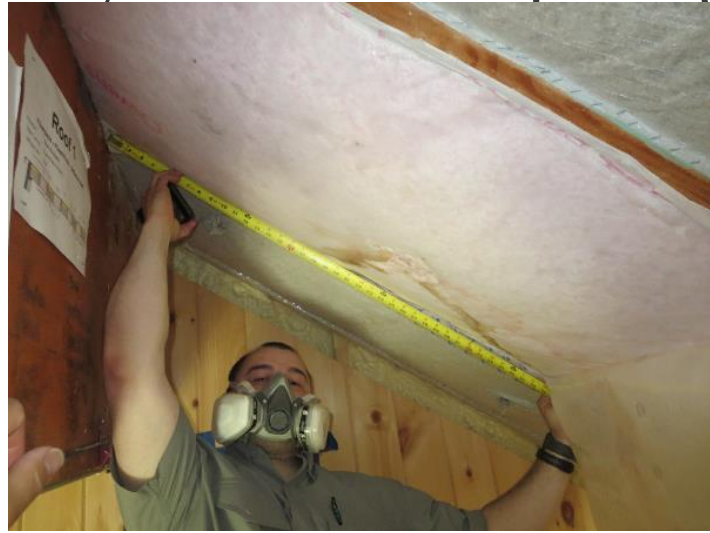
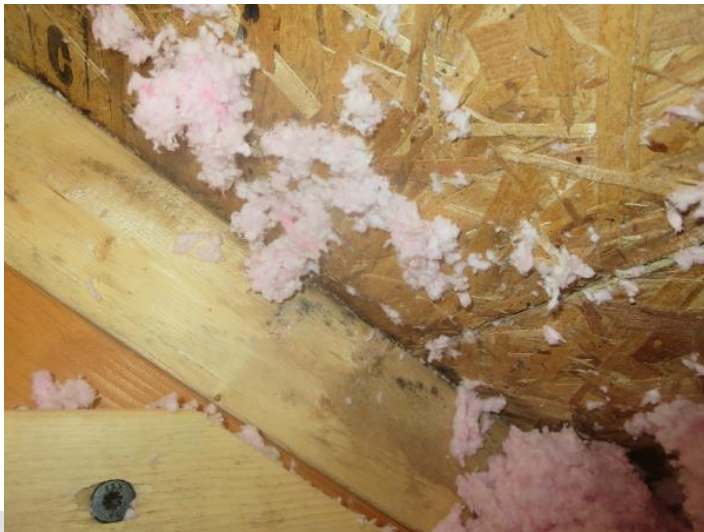
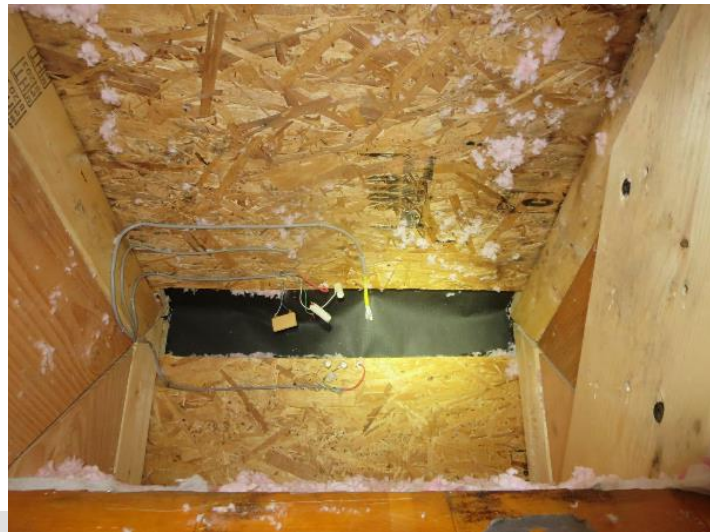
- Fiberglass: staining, rundown, some mold spotting
