Kohta Ueno and Joseph Lstiburek

# Unvented Roof Without Spray Foam:

## The Latest Building America Research

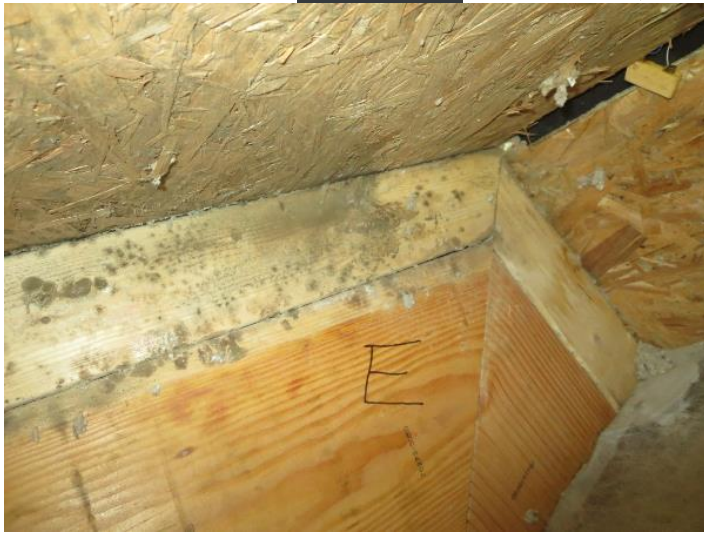
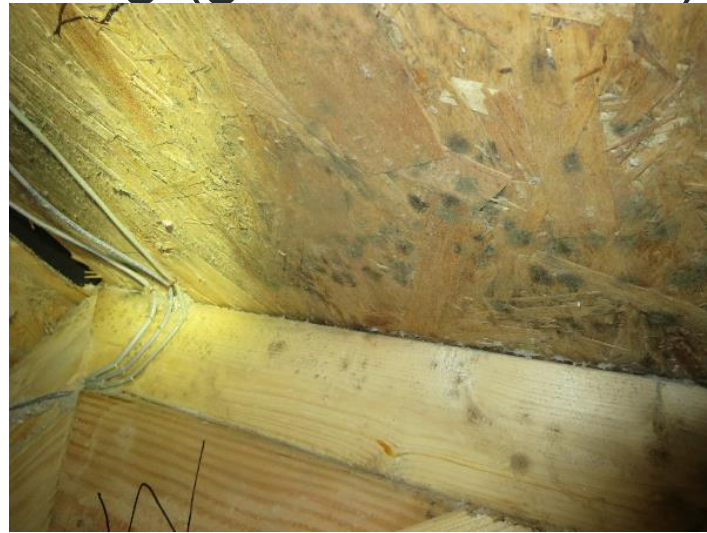
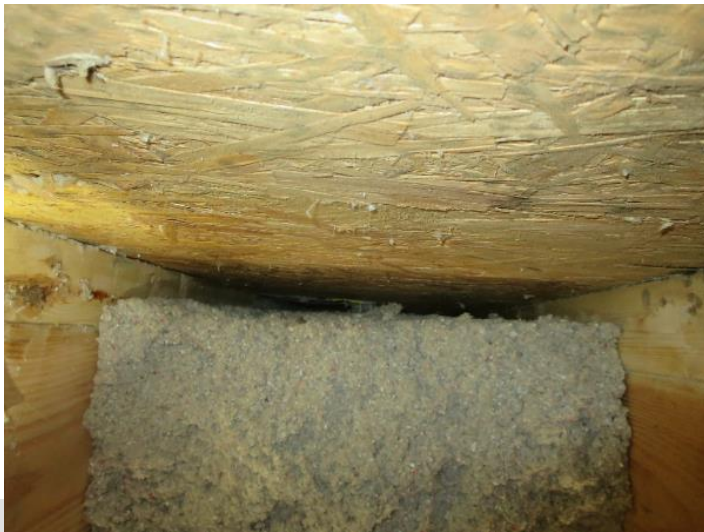
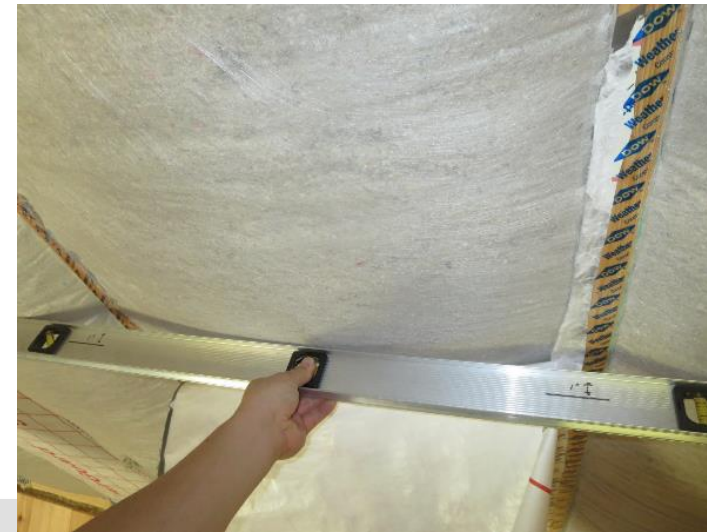
# Summer 2 Ridge Disassembly Work

- Fiberglass: staining, rundown, some mold spotting

- Cellulose: worst mold, settling (greater at north)

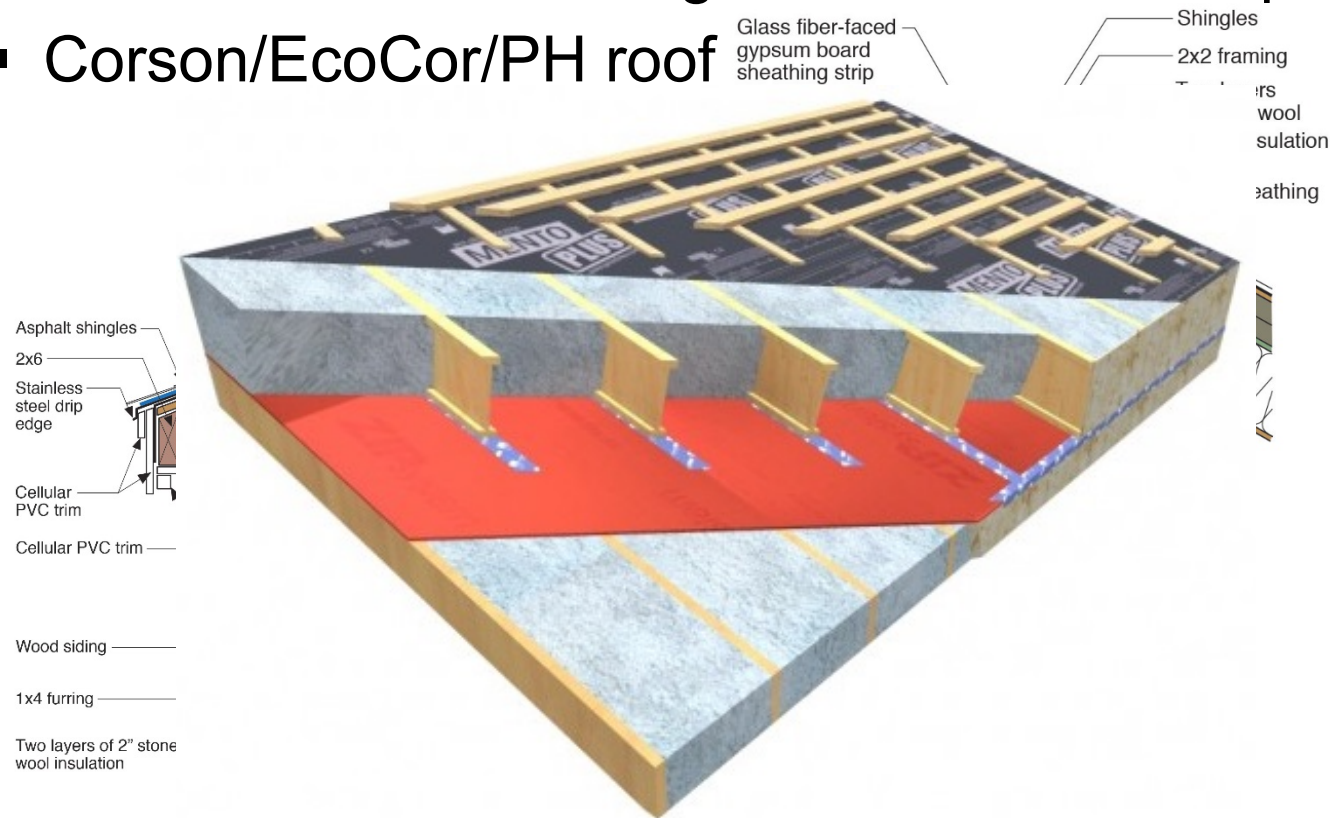
- Code-compliant (IRC §R806.5) still safest (spray foam or exterior rigid insulation)
  - Mineral fiber exterior rigid insulation is an option
  - Corson/EcoCor/PH roof

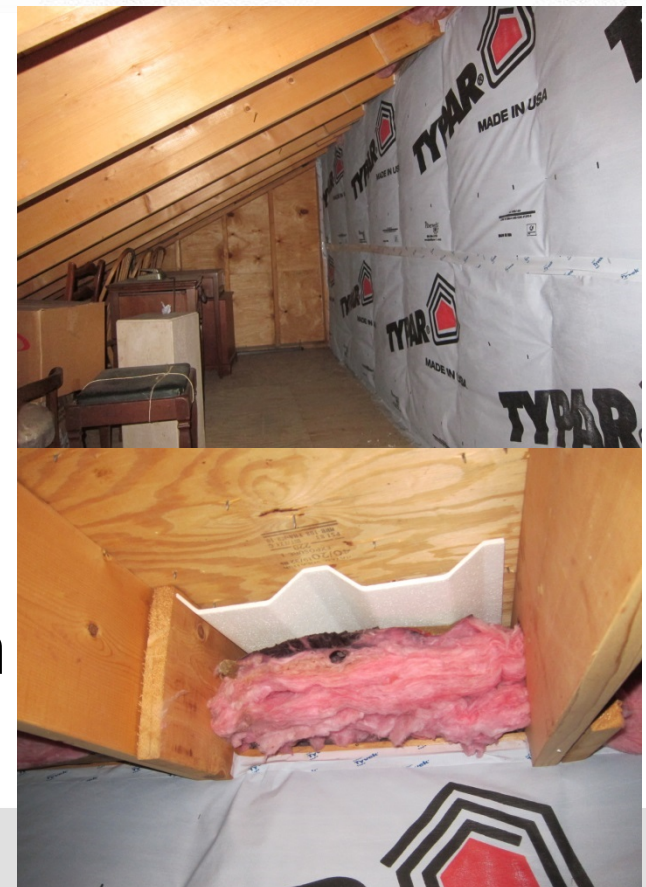
- Possible application to retrofitting “short slope” of kneewall attic geometry
- Eliminates “chute,” possible to retrofit longer runs
- Higher R-value in limited cavity
- Not proven by this research, but this is “lower half of roof” geometry (low risk portion)
- Rafter bay has “full-size diffusion vent” to vented attic above

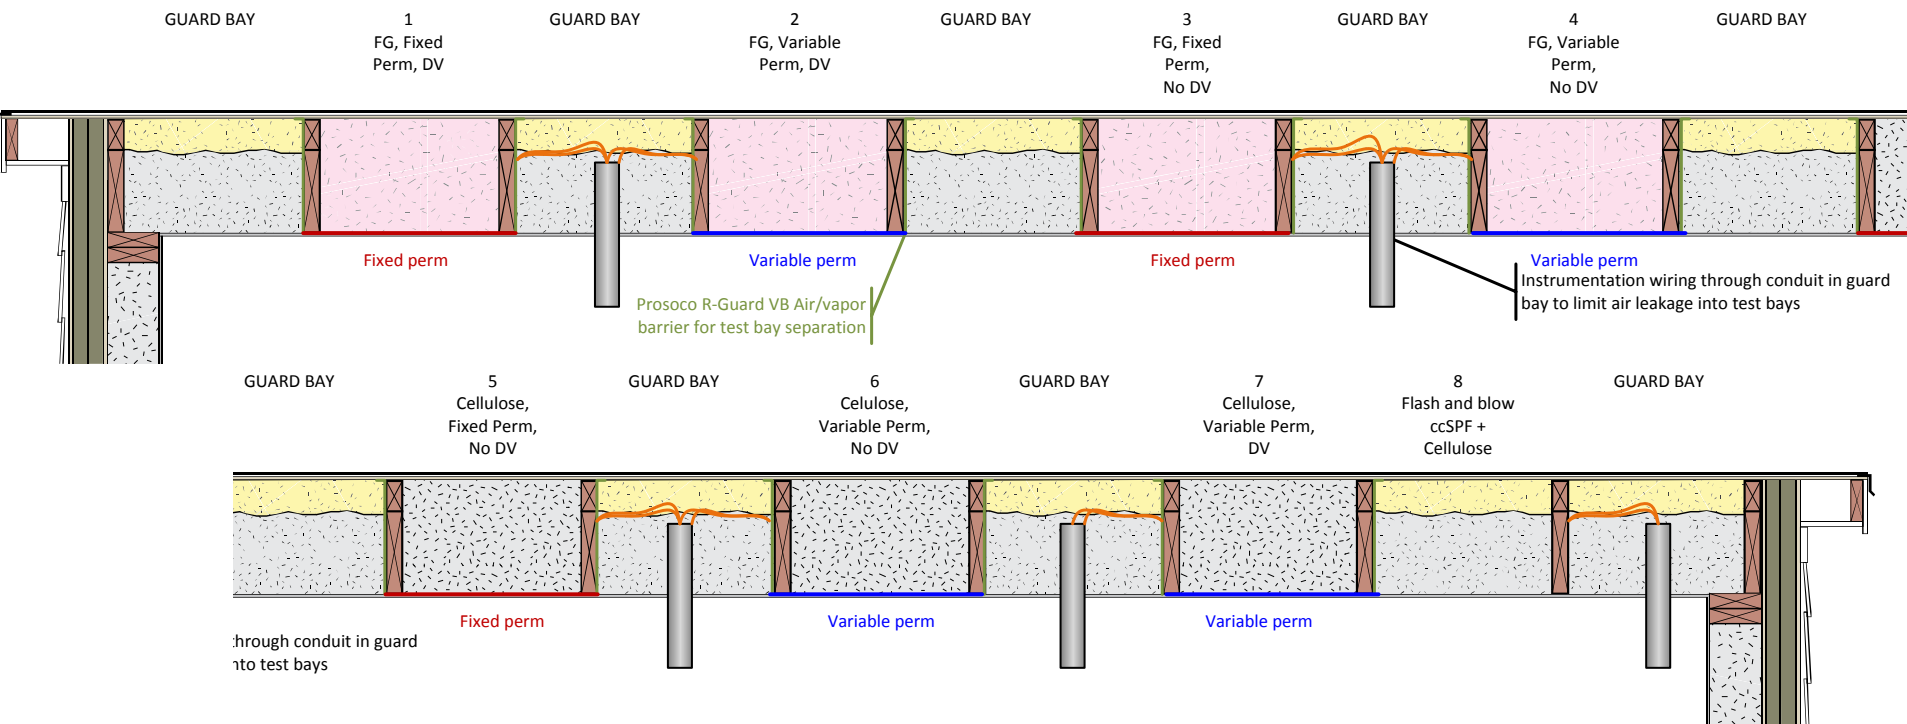
- 4 fiberglass bays
- 3 cellulose bays
- 1 “flash and blow” control comparison

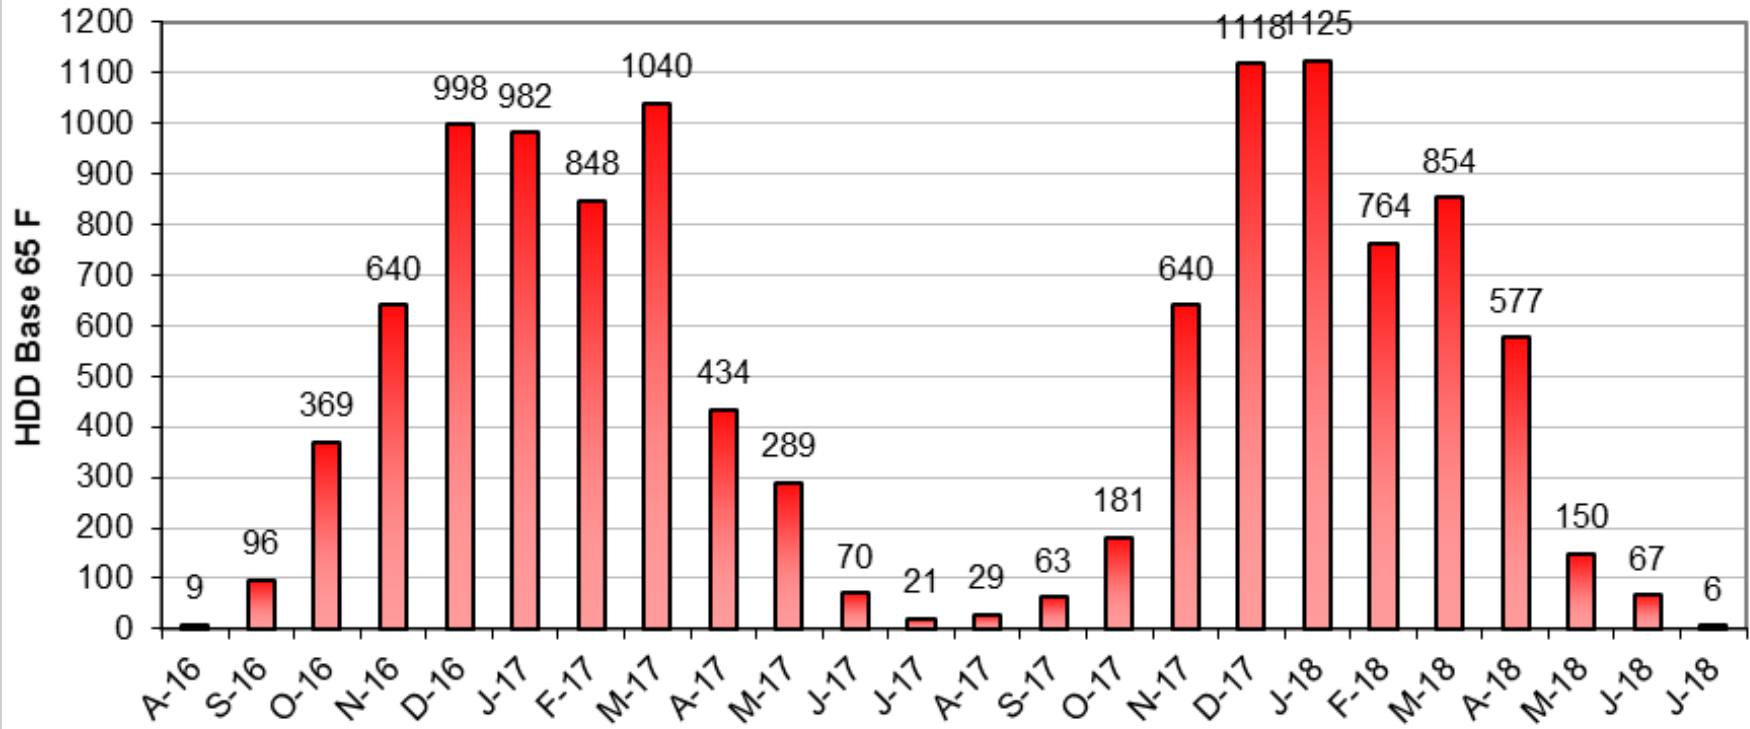
- KLWM (Lawrence MA) airport HDD data
- Winter 2016-2017: 5796 HDD (89% of normal)
- Winter 2017-2018: 5574 HDD (85% of normal)
- KBOS weather 94% & 96% of normal

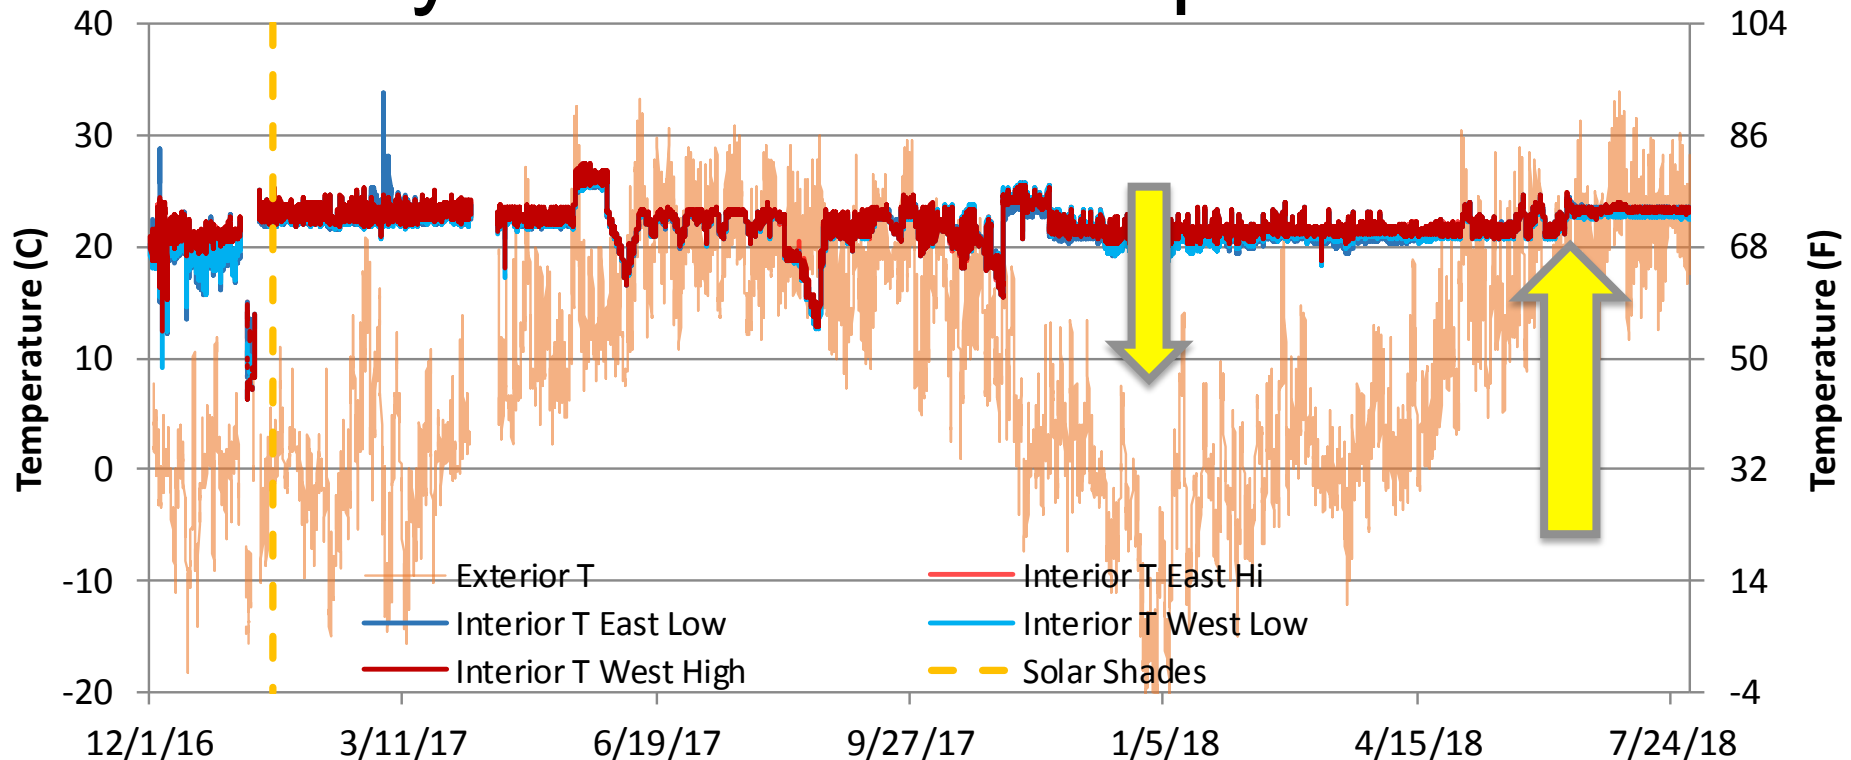
- Data collected December 2016-July 2018
- Winter 2017-2018 similar HDD, more extreme cold
- Interior temperature held near-constant

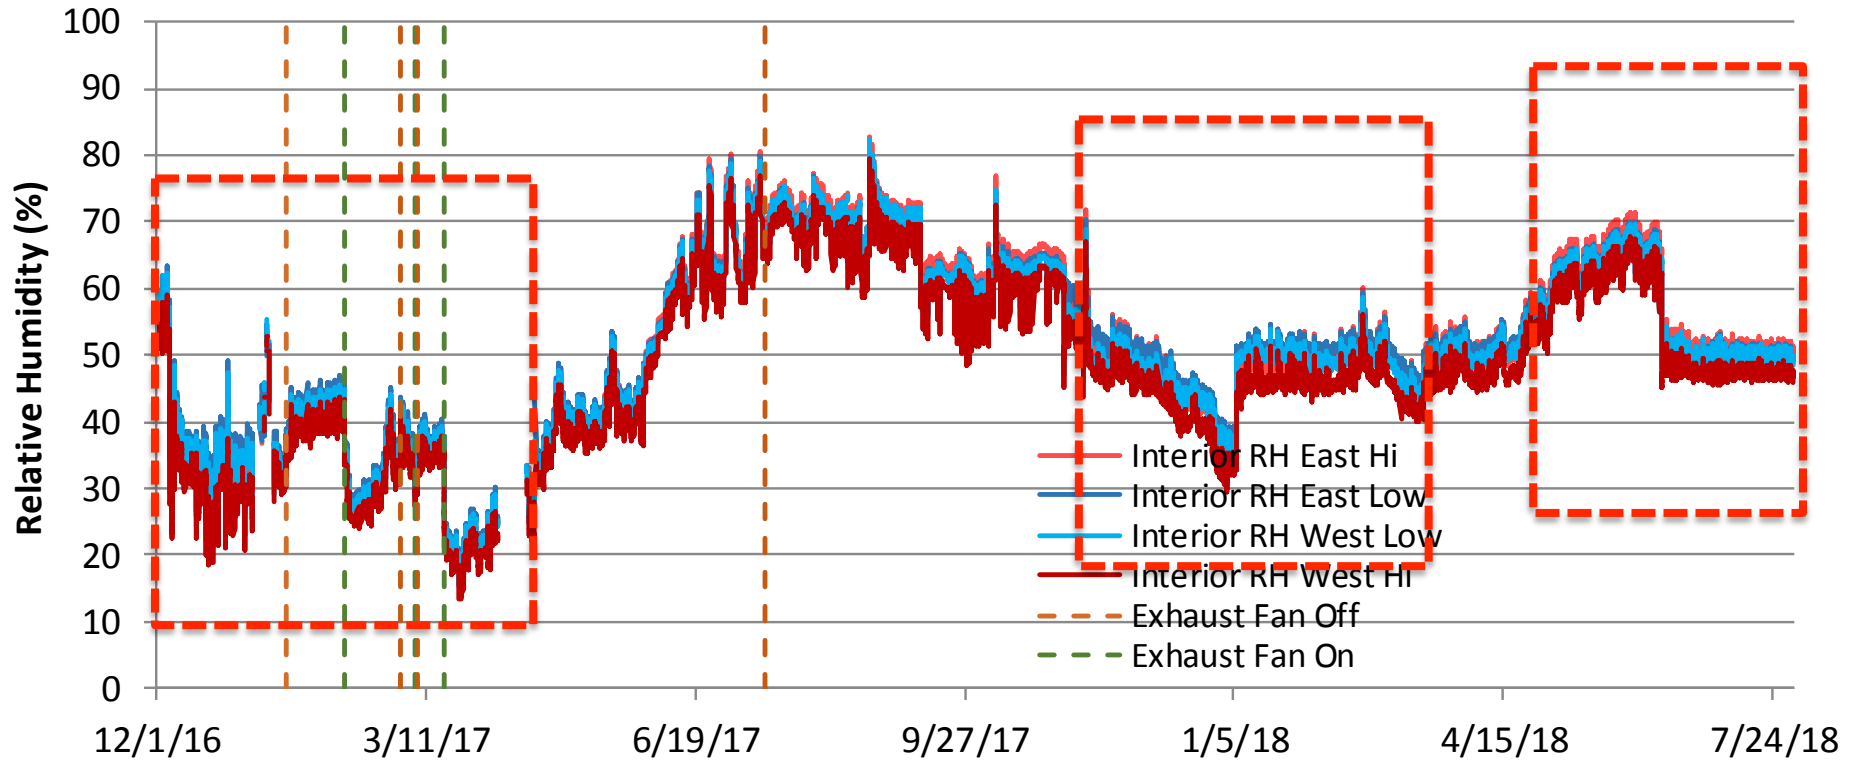
- Winter 1 RHs varied 25% to 45% (exhaust fan)
- Winter 2 RH 50% after early January
- Spring/Summer 2018 added dehumidifier (50% RH)

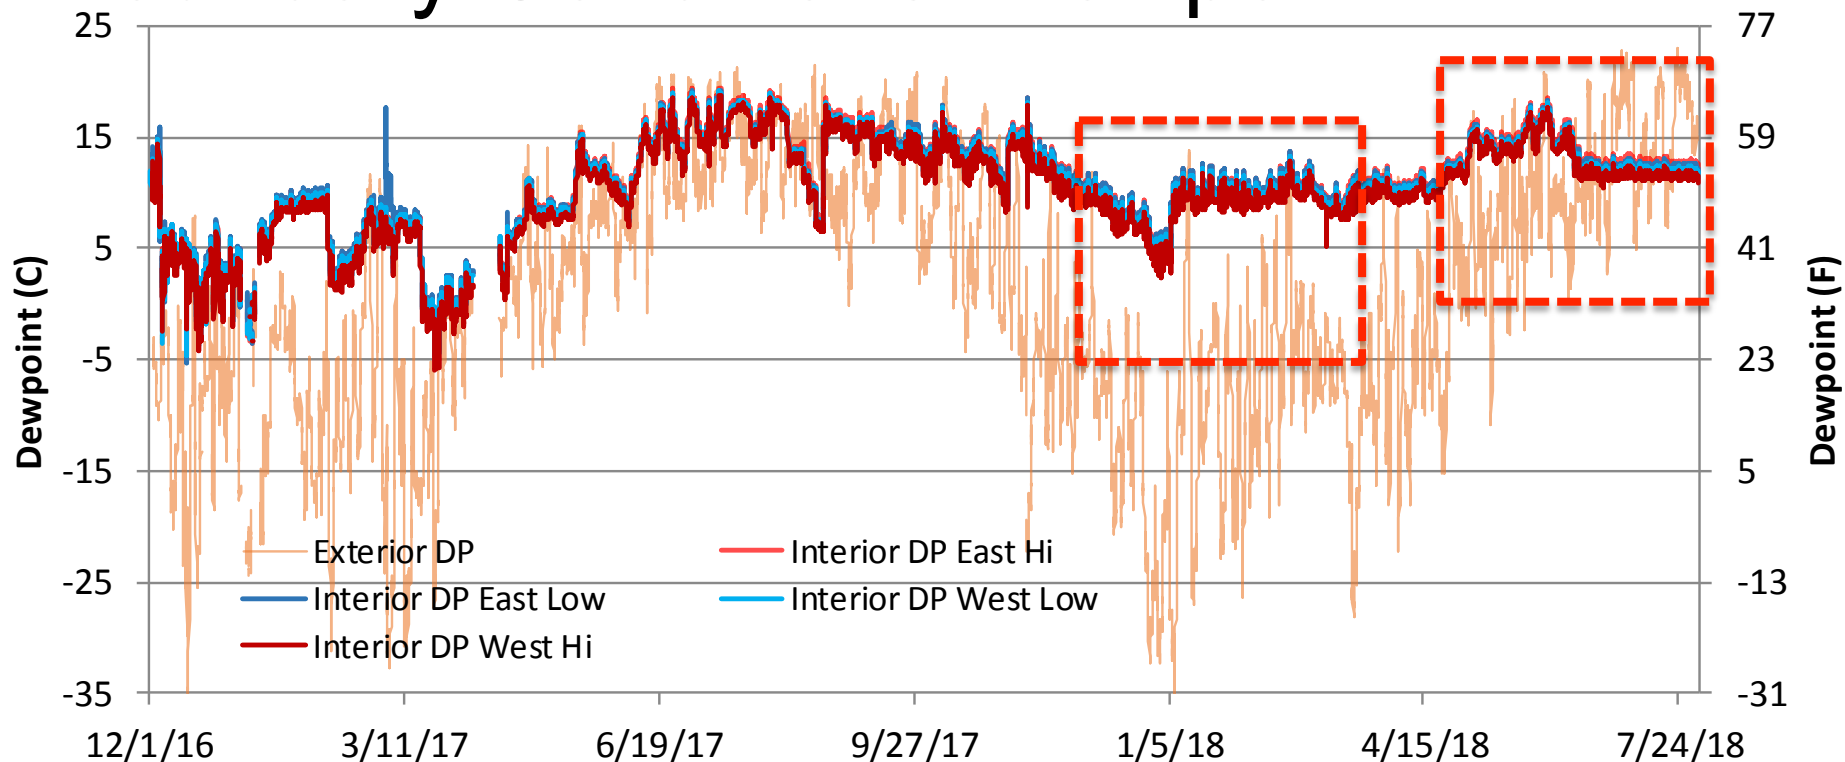
- Humidification operation
- Dehumidification operation

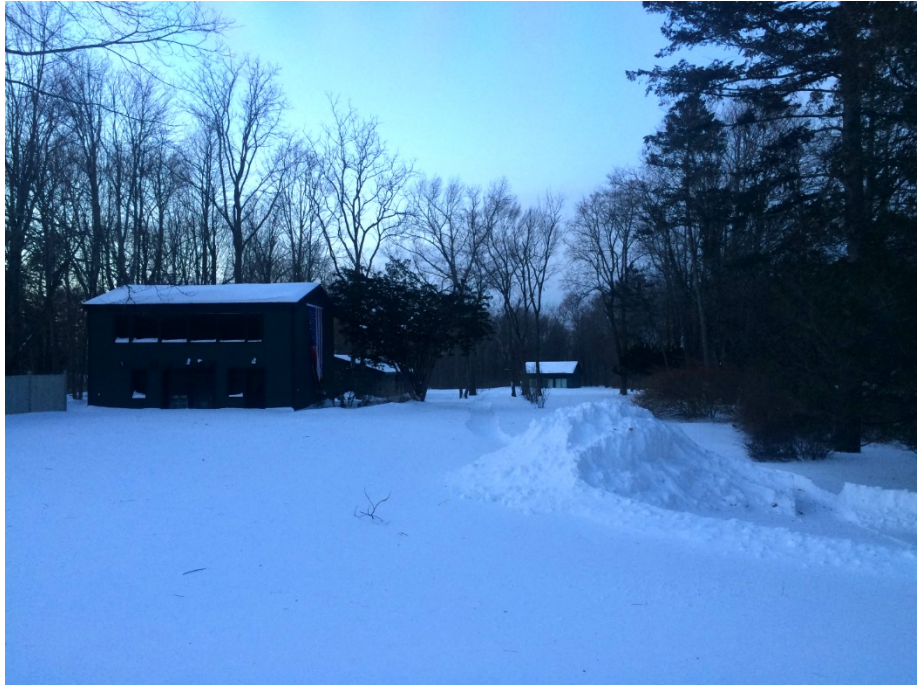
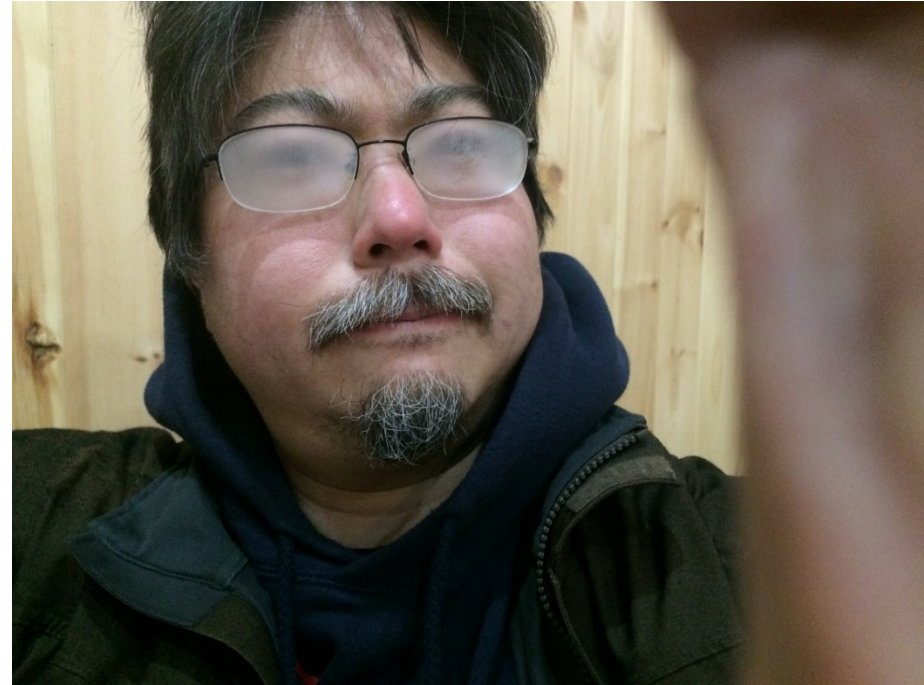
# Humidification

- Humidification confirmed via direct measurement and experience

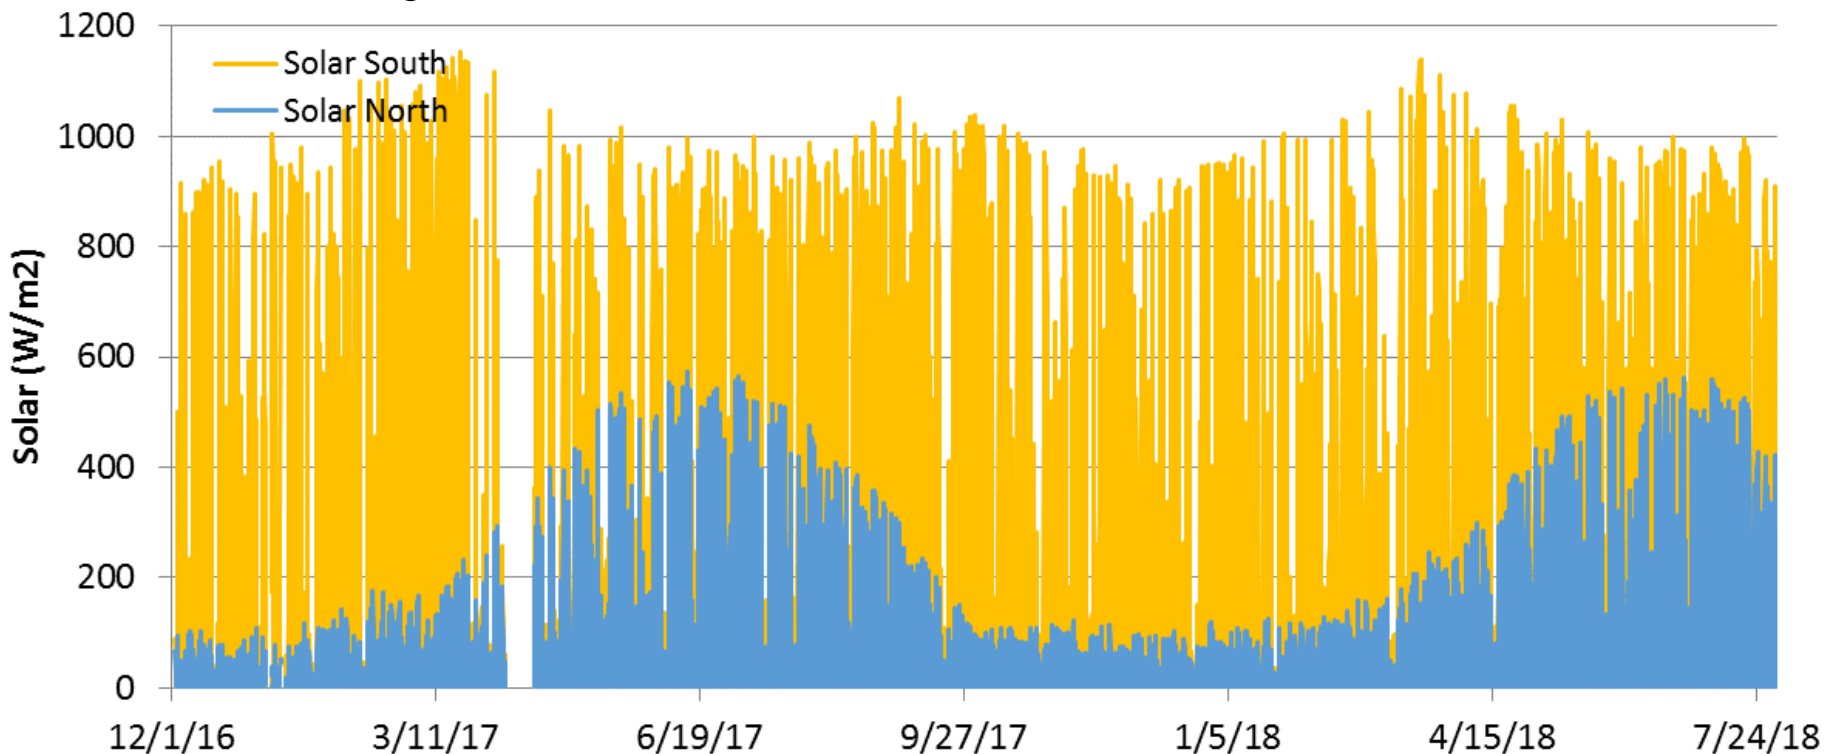
- Solar data primary collected if future modeling work, correlation with events
- North solar on 8:12 roof in MA

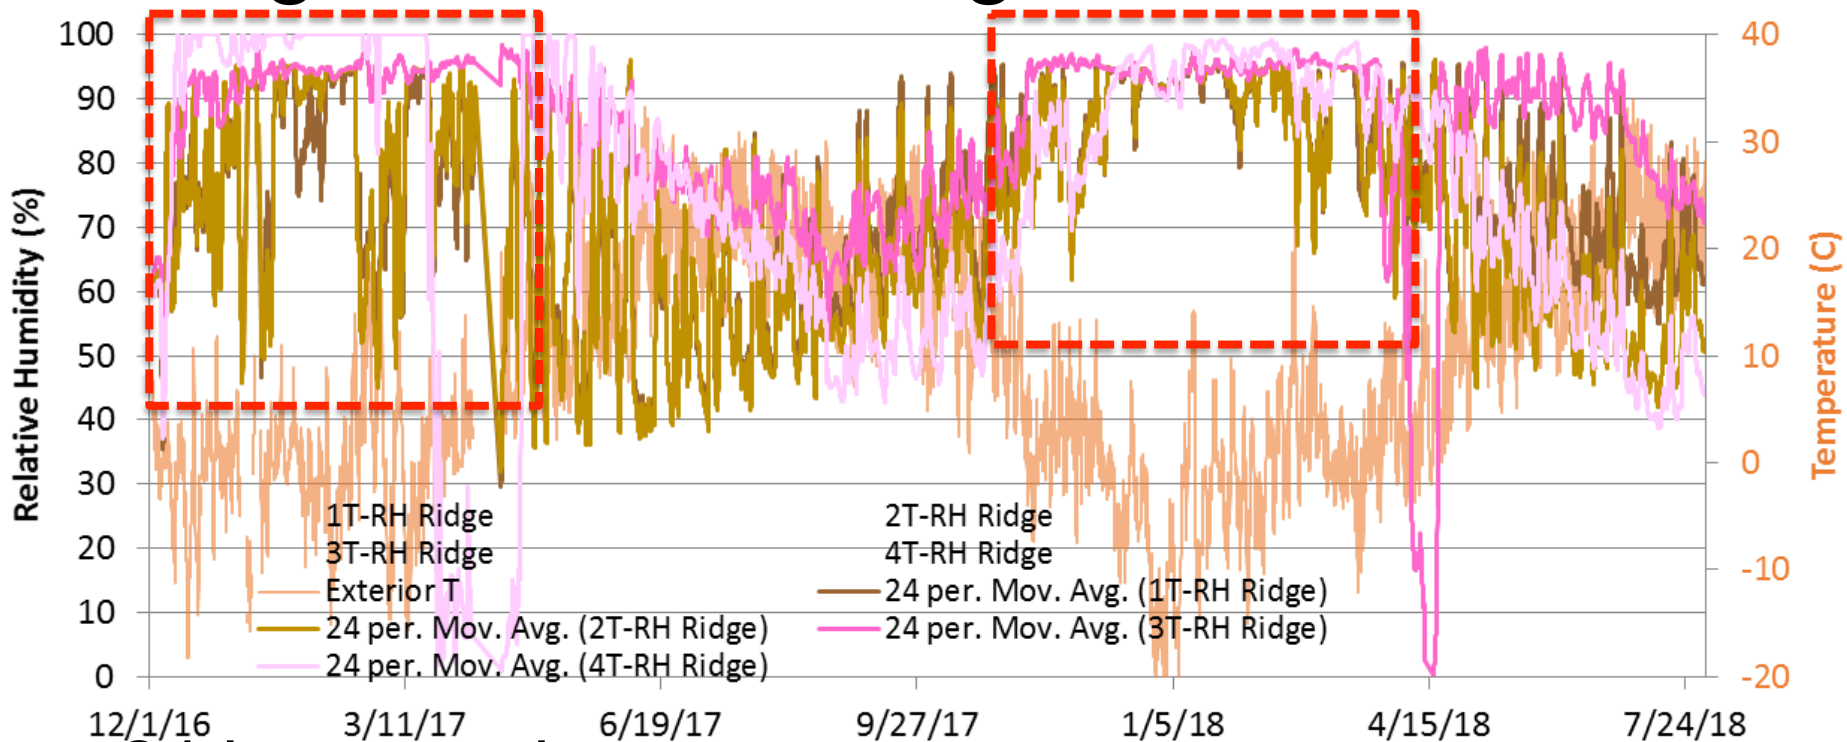
- 24 hour moving average
- **Roof 3** (tDV) & **Roof 4** (sDV) wettest
- **Roof 3** (tDV) stays wet into spring
- **Roofs 1 & 2** higher RHs than Winter 1

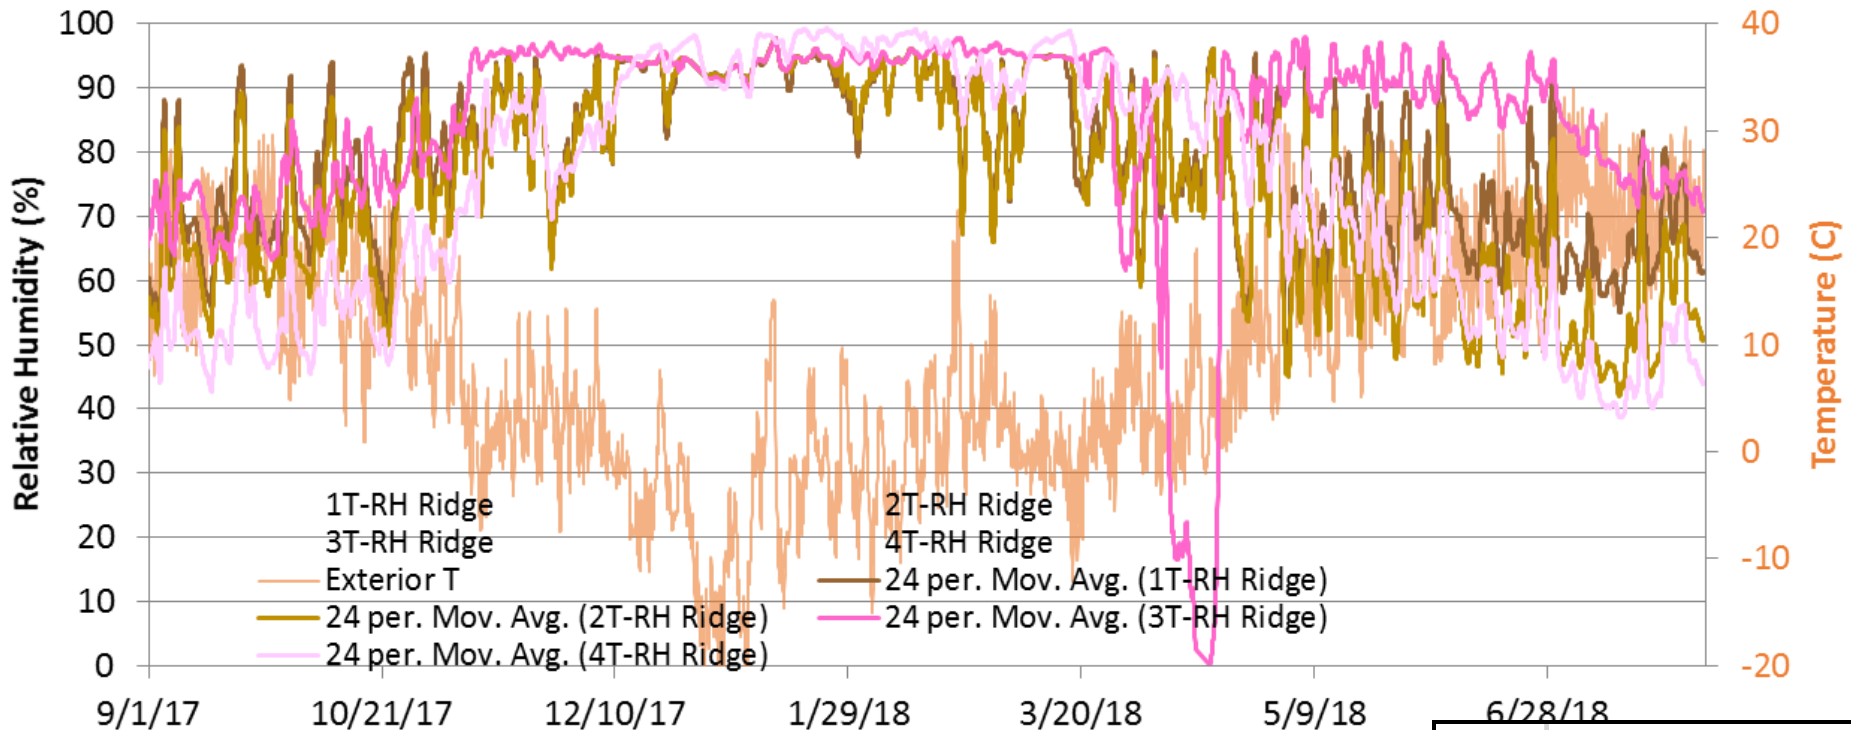
- Zoom in on Winter 2
- **Roof 3** (tDV) RH sensor failure, wet
- **Roof 1** (VB) stays wetter in summer
  - Inward drying season-constricted?

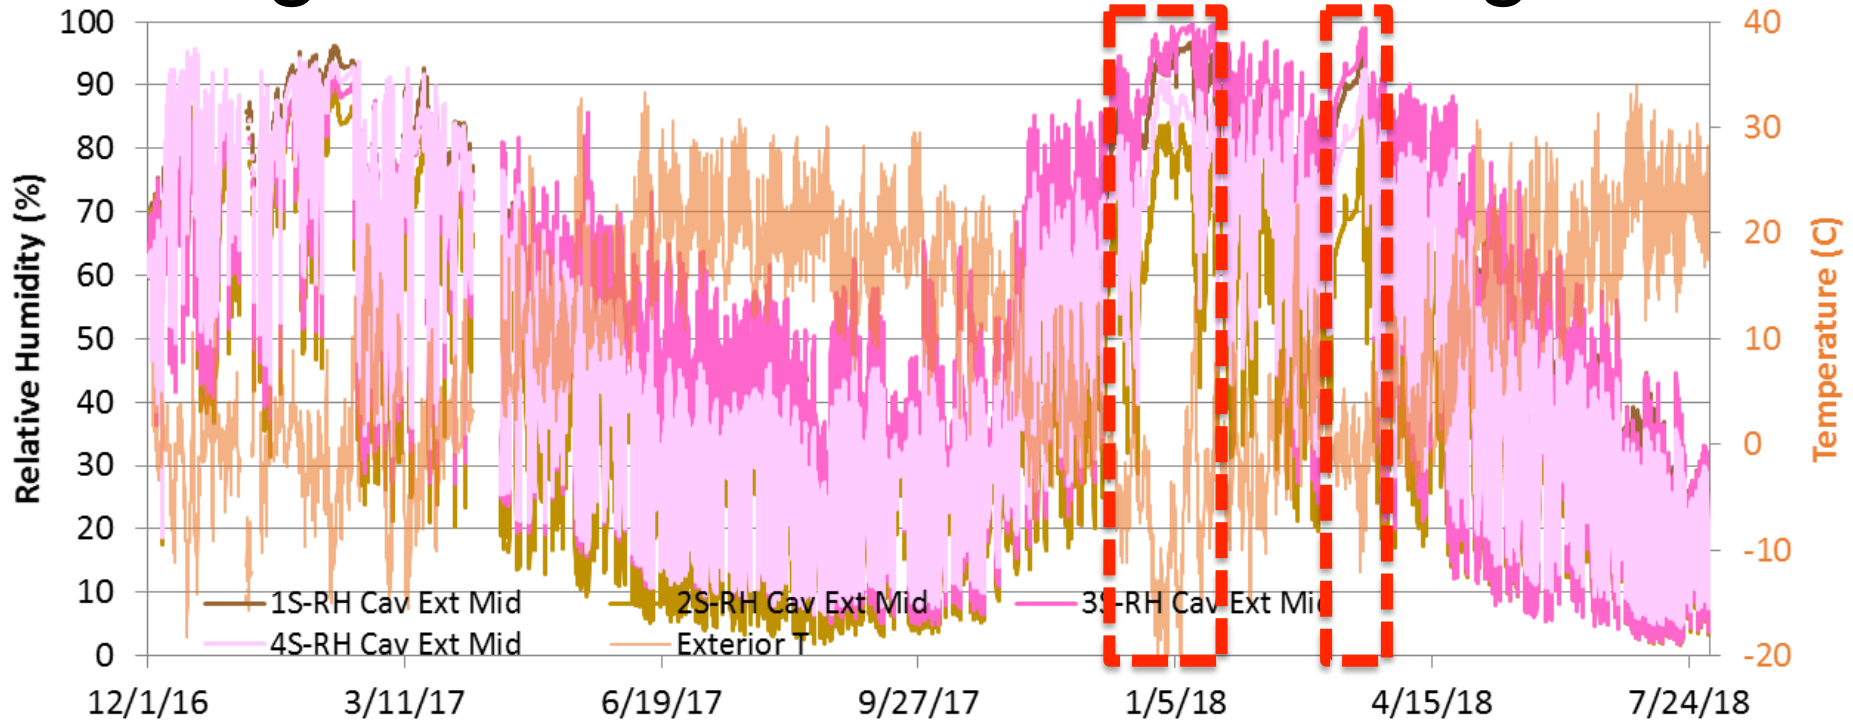
- S roofs drier than N roofs (solar warming)
- Diurnal variations/swings (solar gain)
  - Stable periods = snow cover
- Can't differentiate roofs (swings)

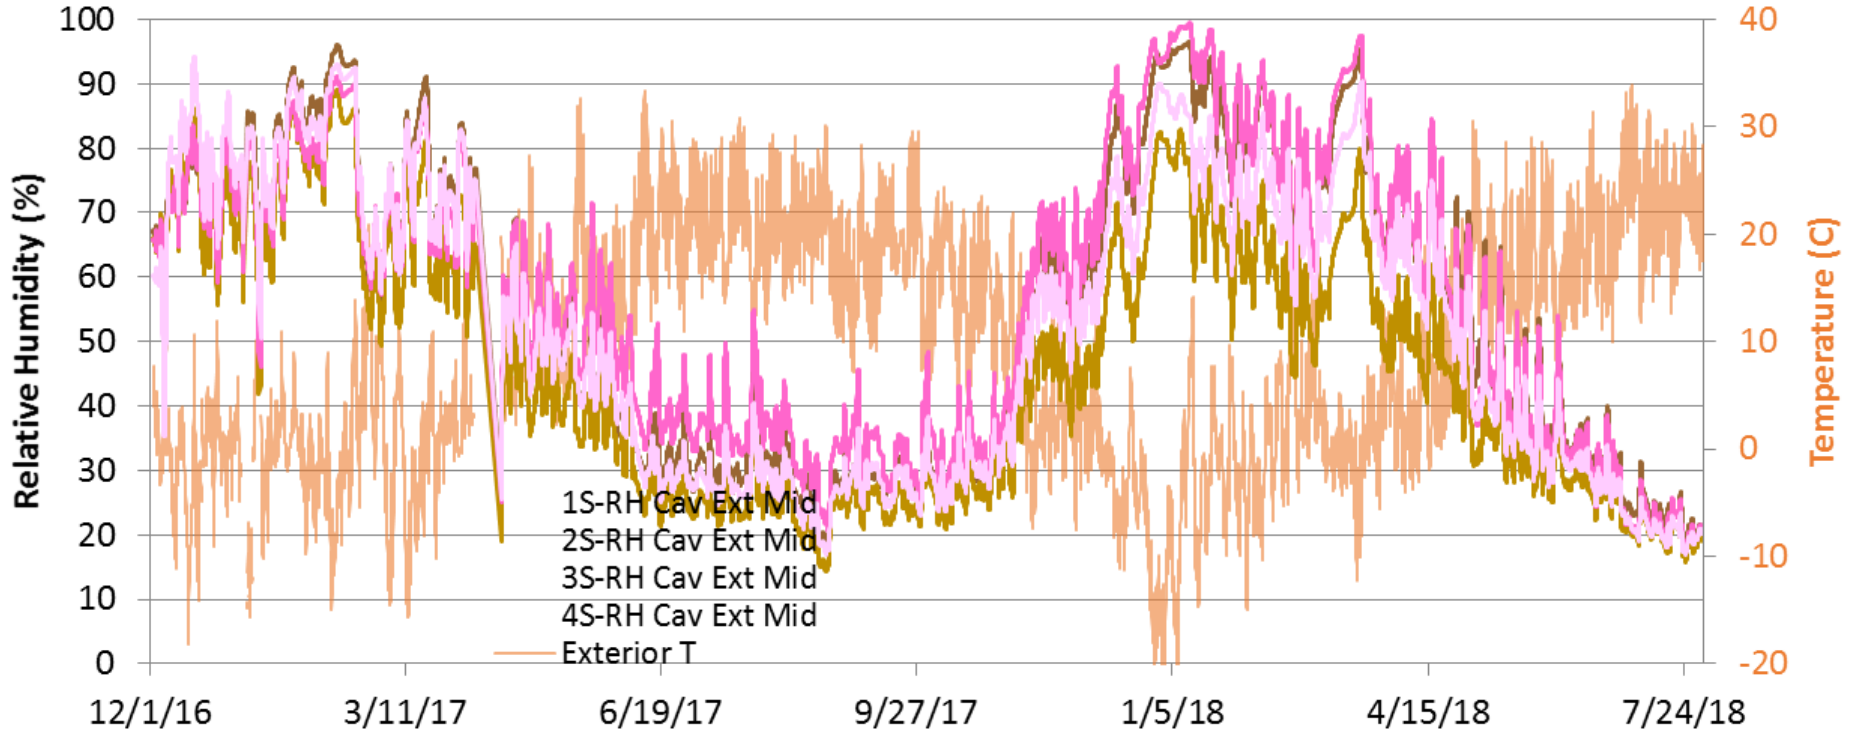
- 24 hour moving average RH data
- **Roof 3** (tDV) appears wettest
- **Roof 2** (SVR/DV) appears driest

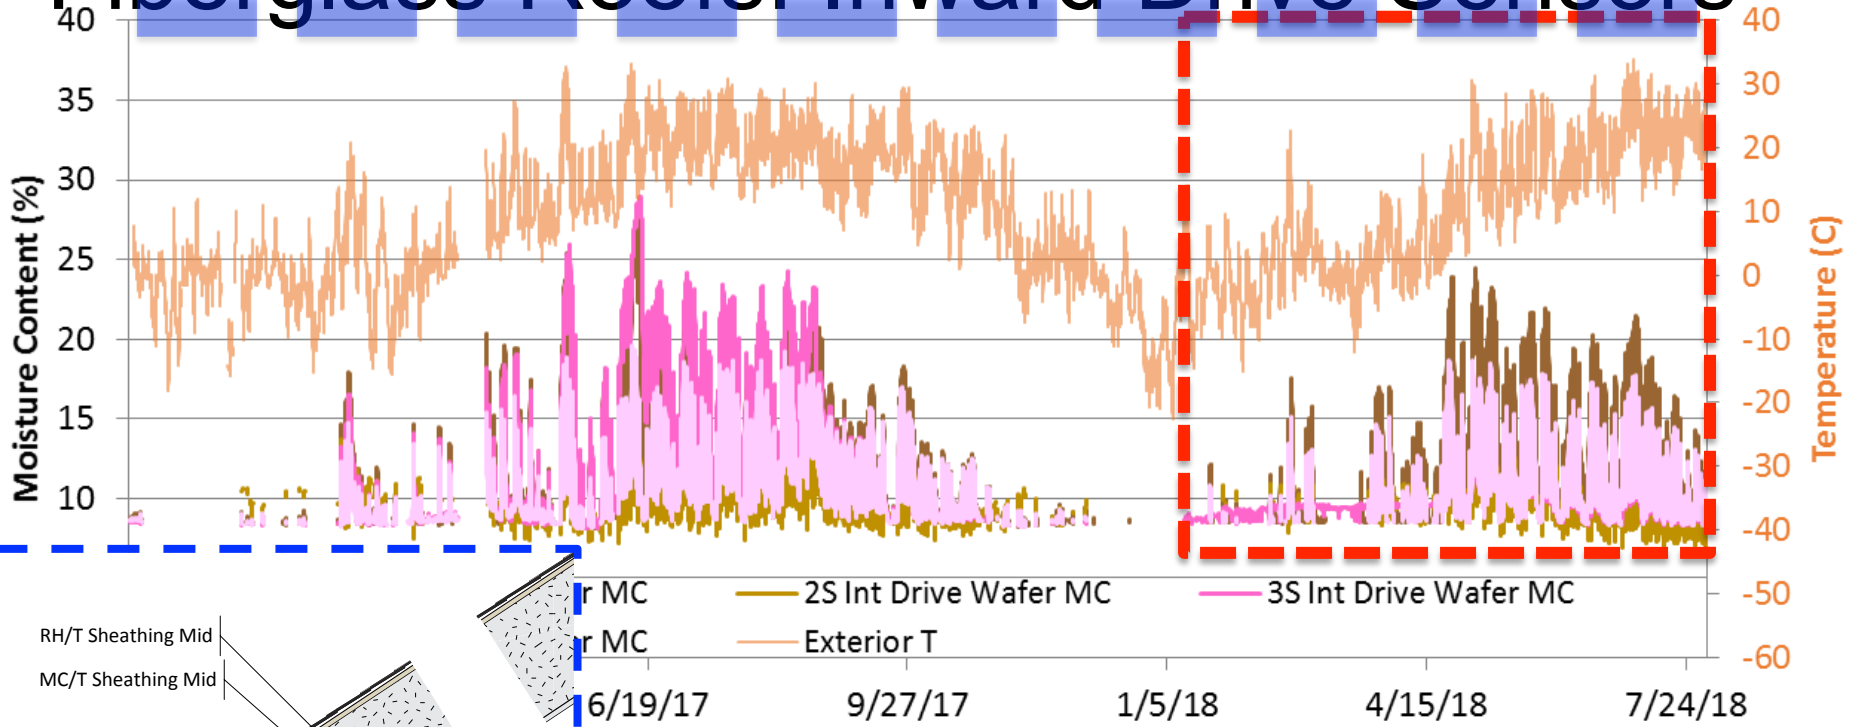
Roofs 1 worst (fixed VB)

5% MC condensation level

not worst-case for inward drive!

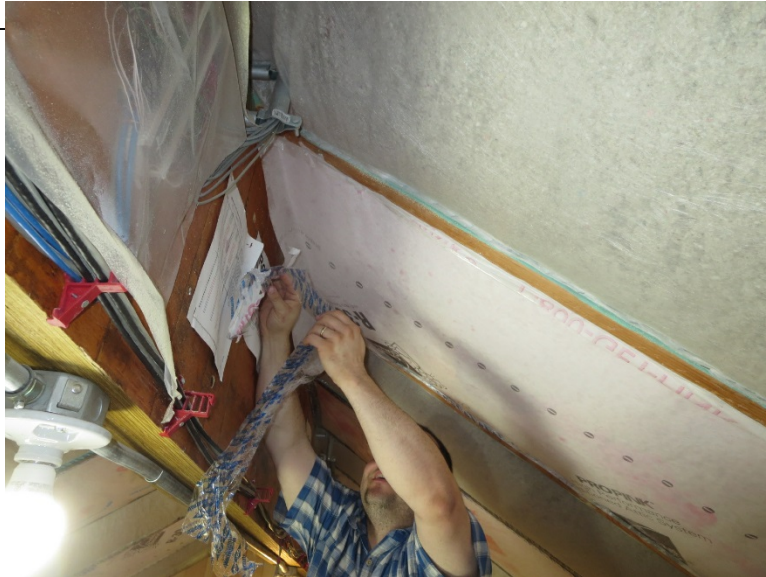
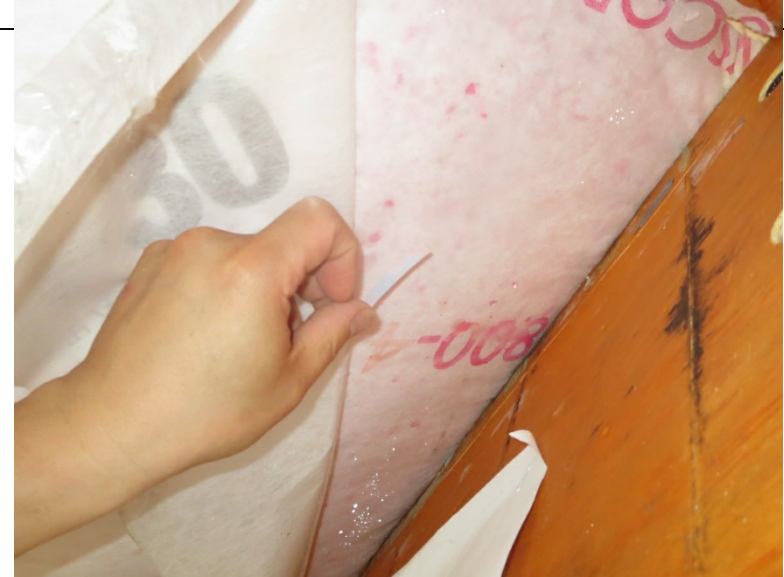
# Summertime Inward Drive

**Inward vapor drive does matter—  
we were just measuring in the  
wrong location!**

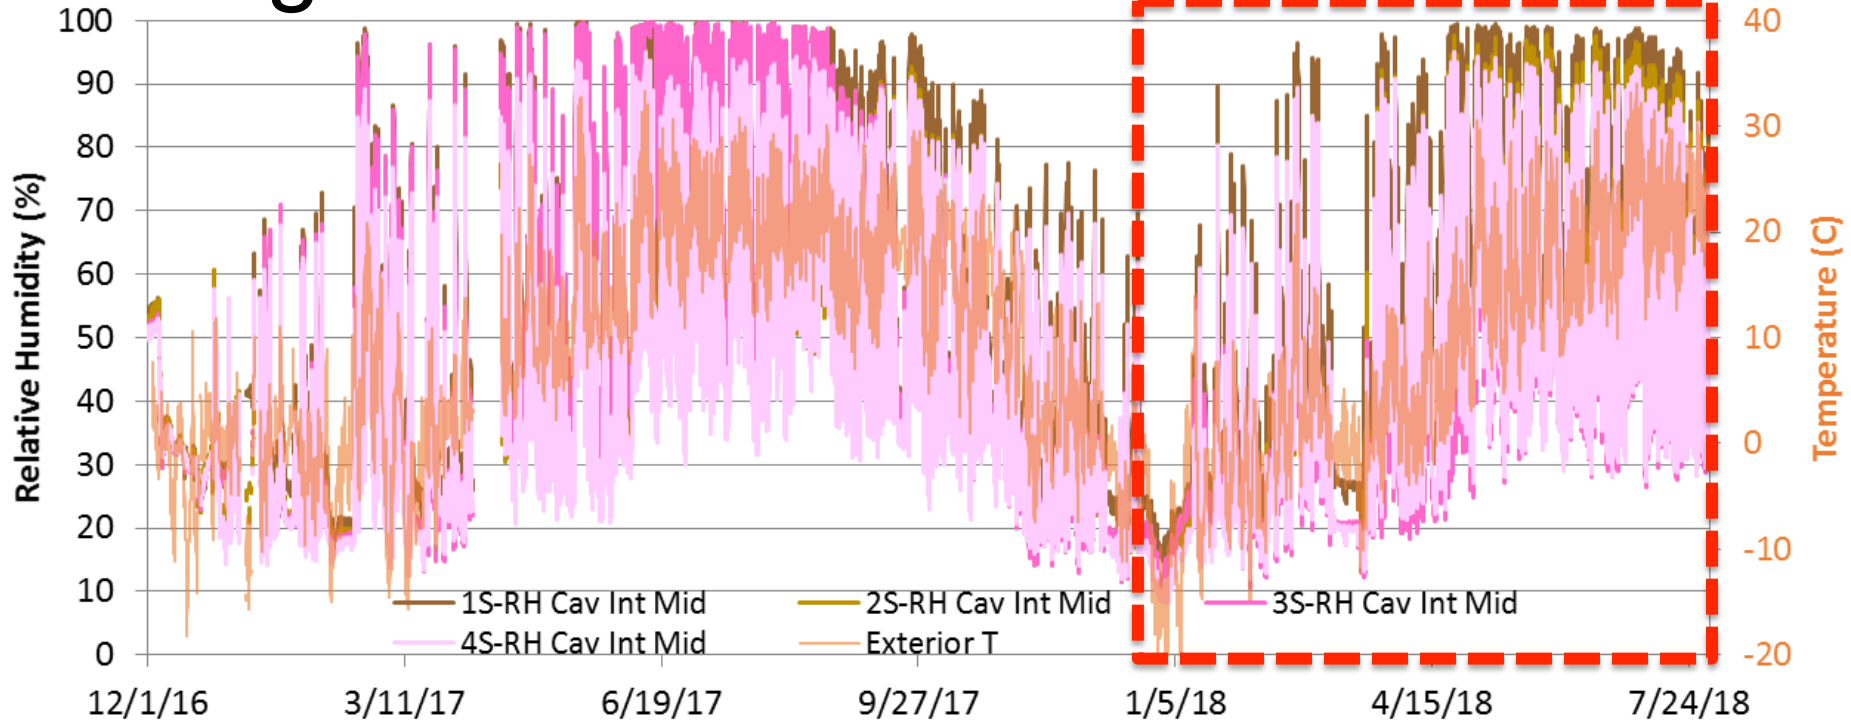
- Difficult to differentiate
- **Roofs 1** (fixed VB) appears to be worst performer (moisture accumulation)
