Kohta Ueno and Joseph Lstiburek

# Unvented Roof Without Spray Foam:

## The Latest Building America Research

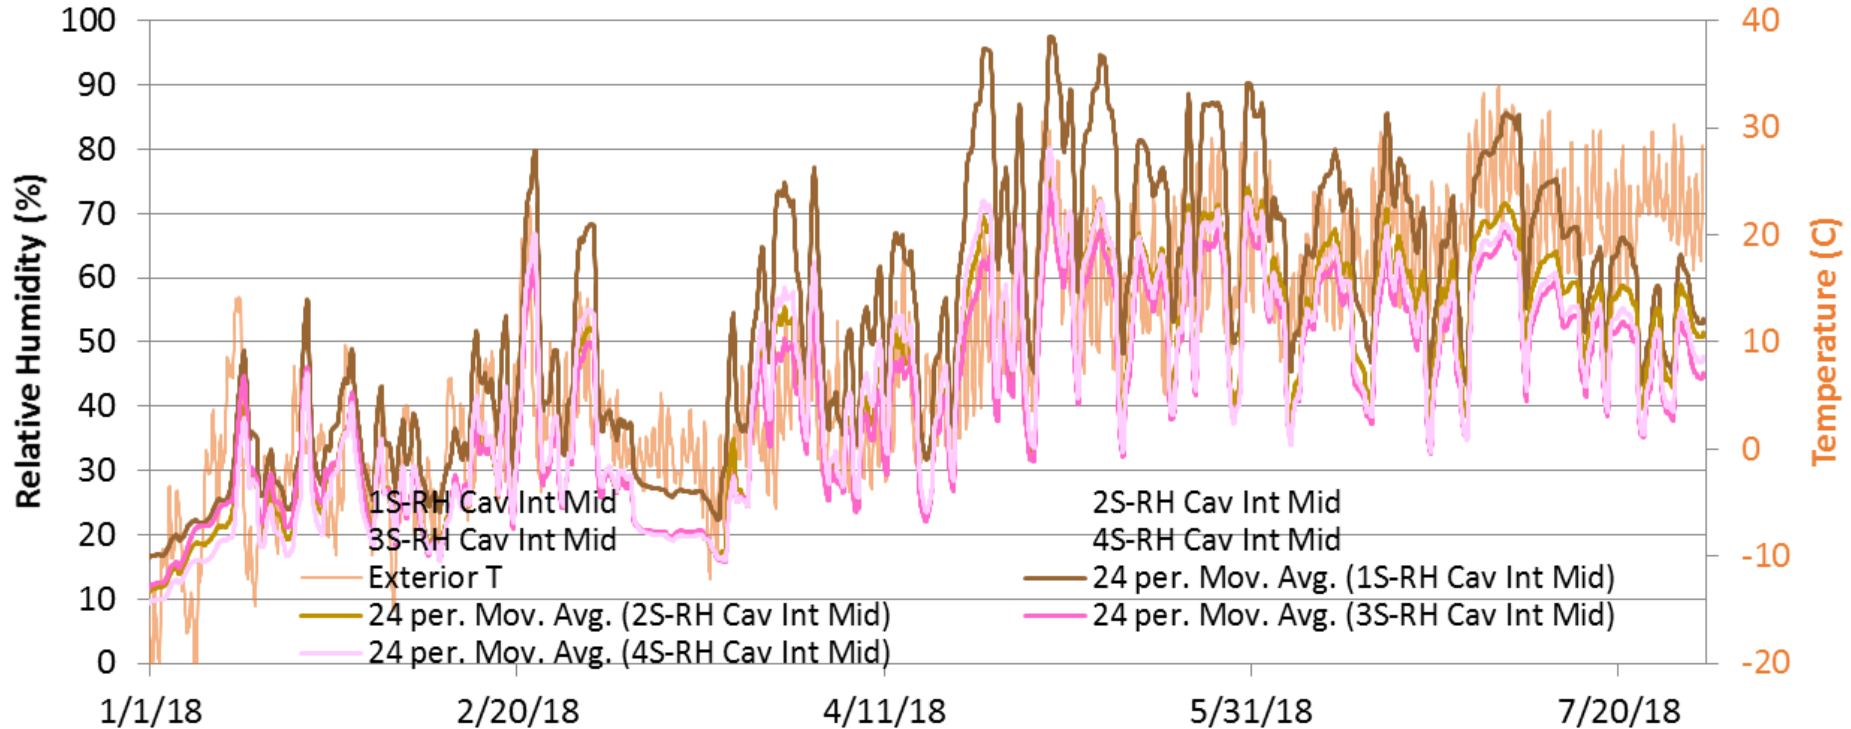
- 24 hour moving averages, 2018
- **Roof 1** (fixed VB) is outlier, greater summertime accumulation/higher RHs
- Peaks over 90% RH, brief periods

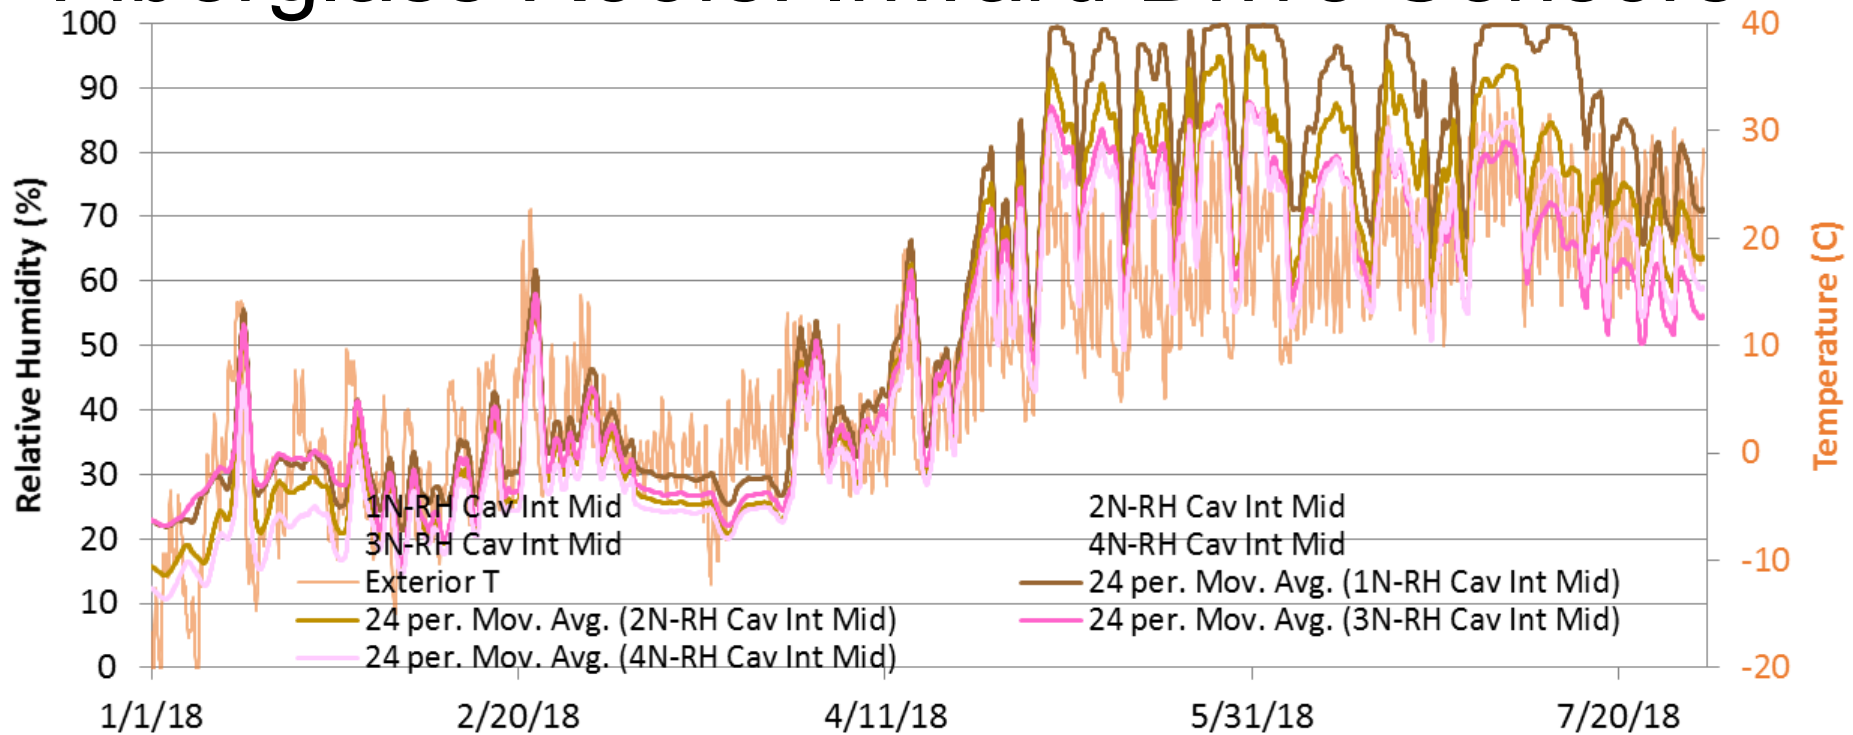
- North side RH sensors, 24 hour average, 2018
- Roof 1** (fixed VB) at extended 100% RH
- North worse inward drive than south side-more stored moisture?

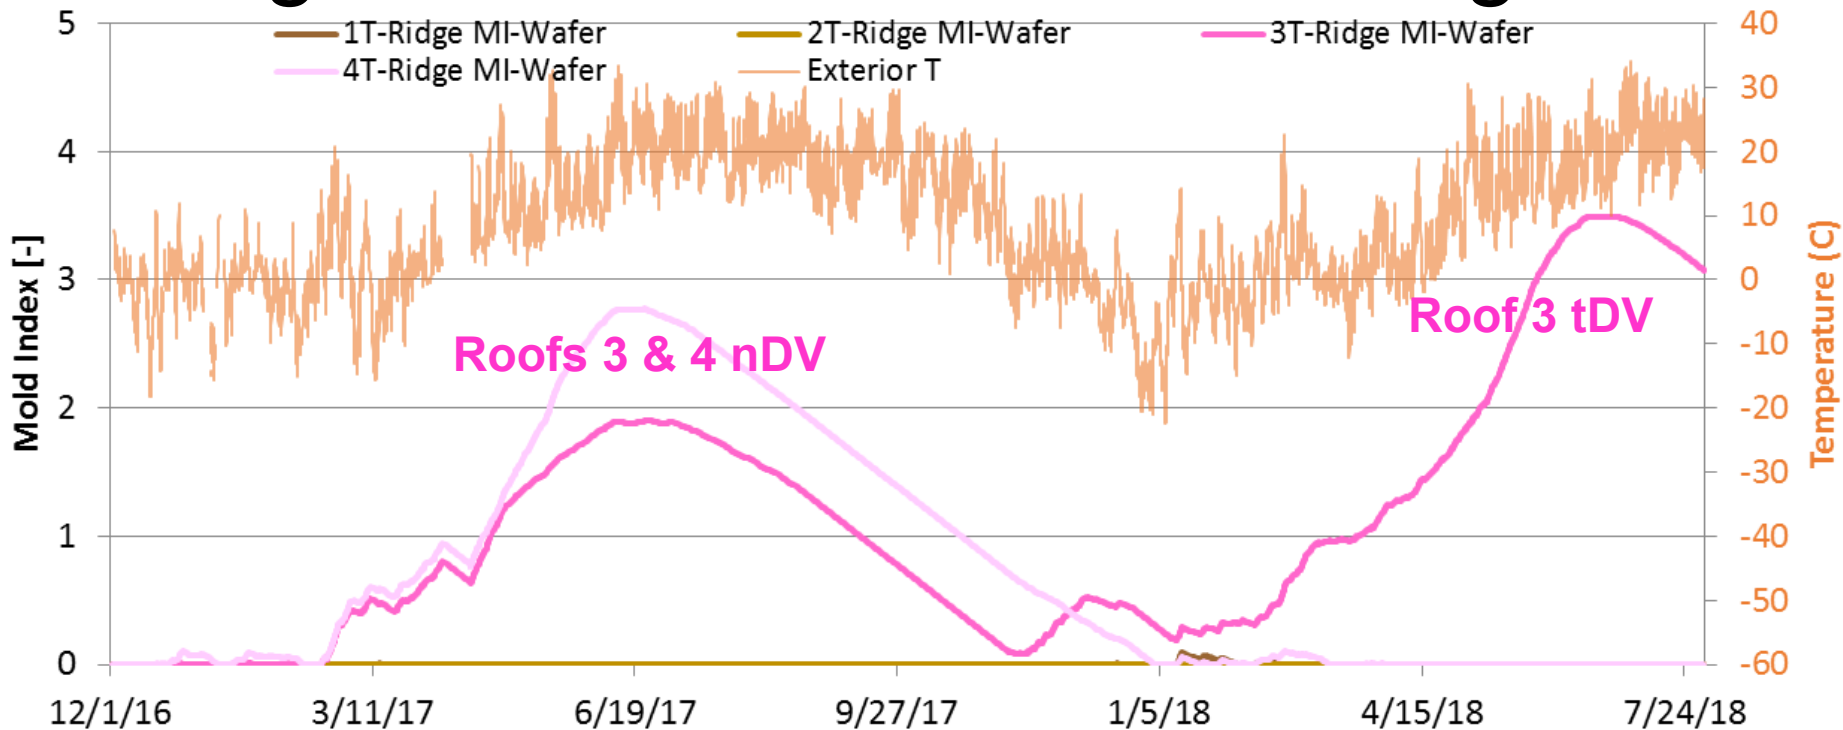
- Calculated RH from ridge wafer MC: higher MI #s
- Winter 1: **Roof 3** & **Roof 4** high MCs (no DV)
- Winter 2: **Roof 3** “tight” 25 perm DV
- Mold index over 3 in Winter 2 (wafer)

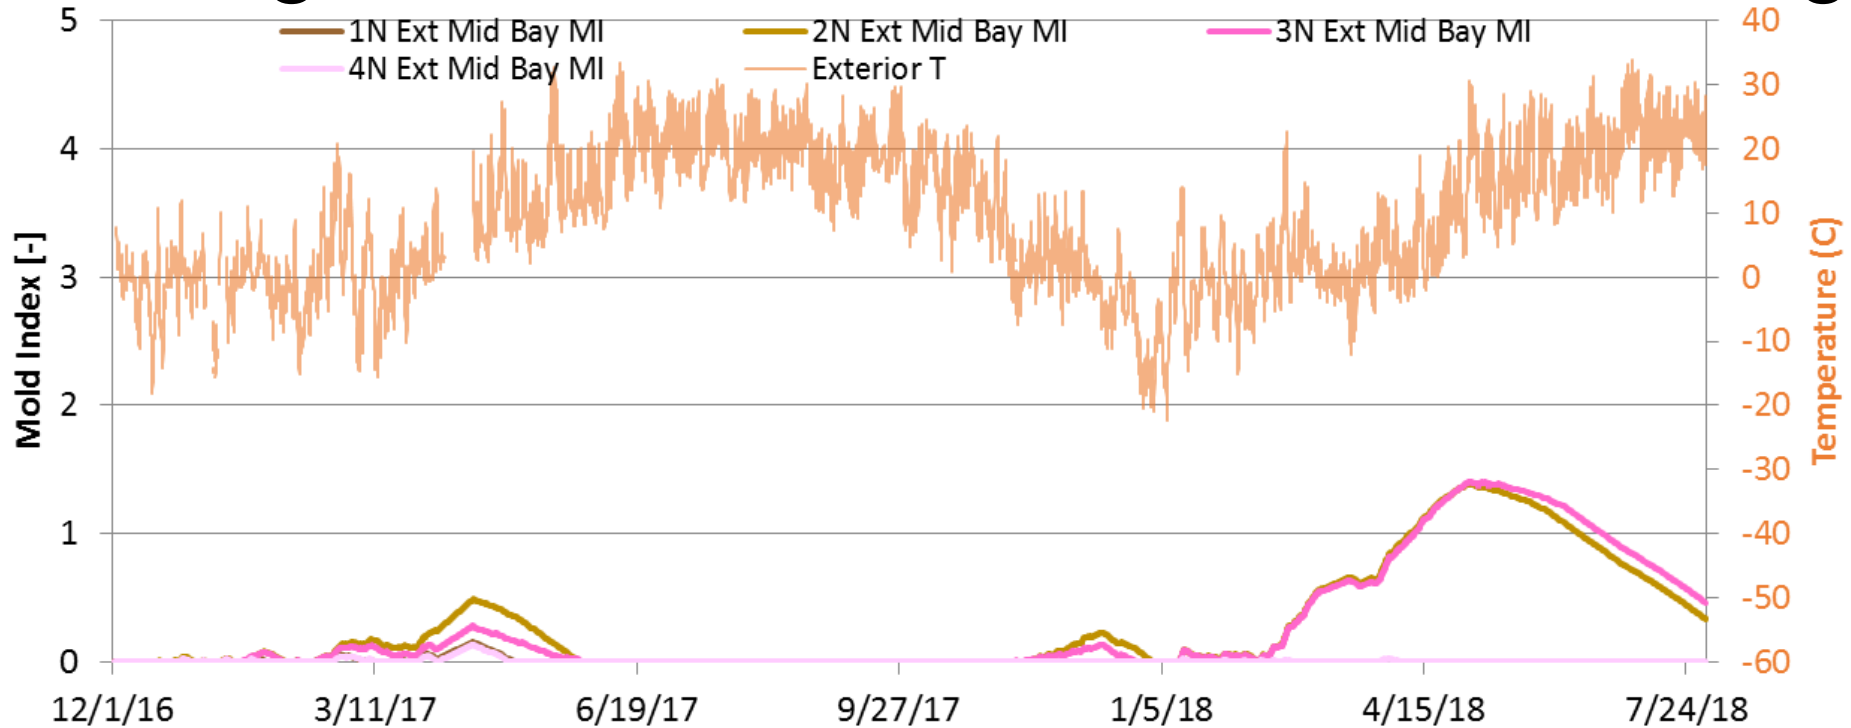
- Higher sheathing MCs Winter 2 (50% RH)
- **Roof 4** RH sensor was drier than 1/2/3 → low MI
  - Ascribed to sensor/installation anomaly
- Mold index remains below 2

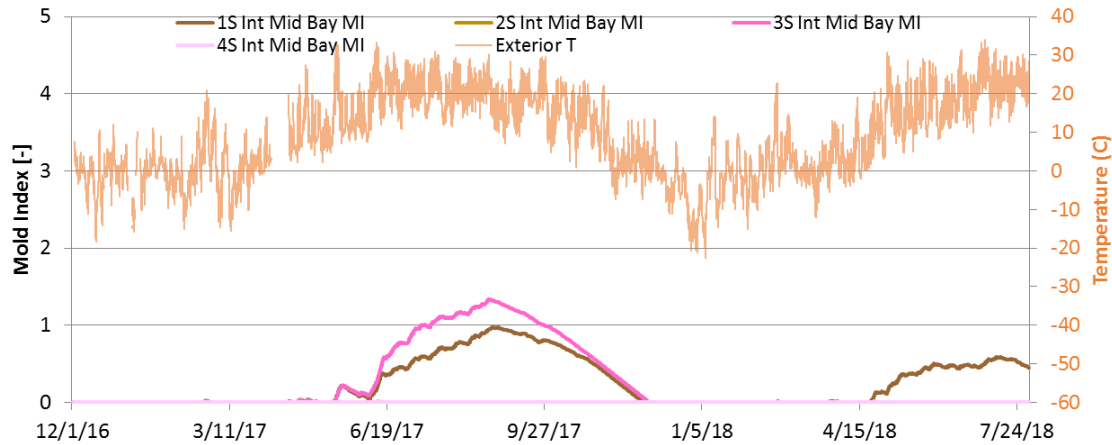
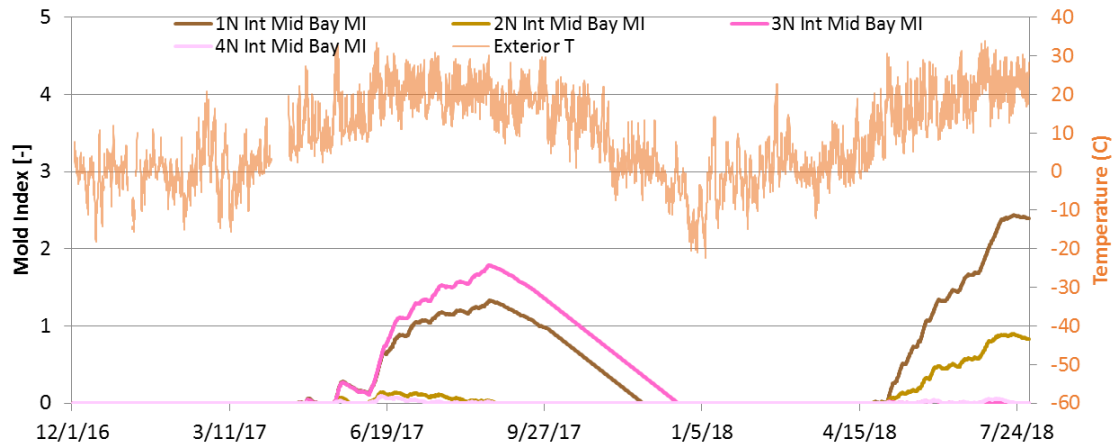
- **Roof 1** (fixed VB) only fixed perm in Winter 2
- Highest MI
- MI stays below 3- barely
- North shows higher peaks than south
  - Stored moisture?

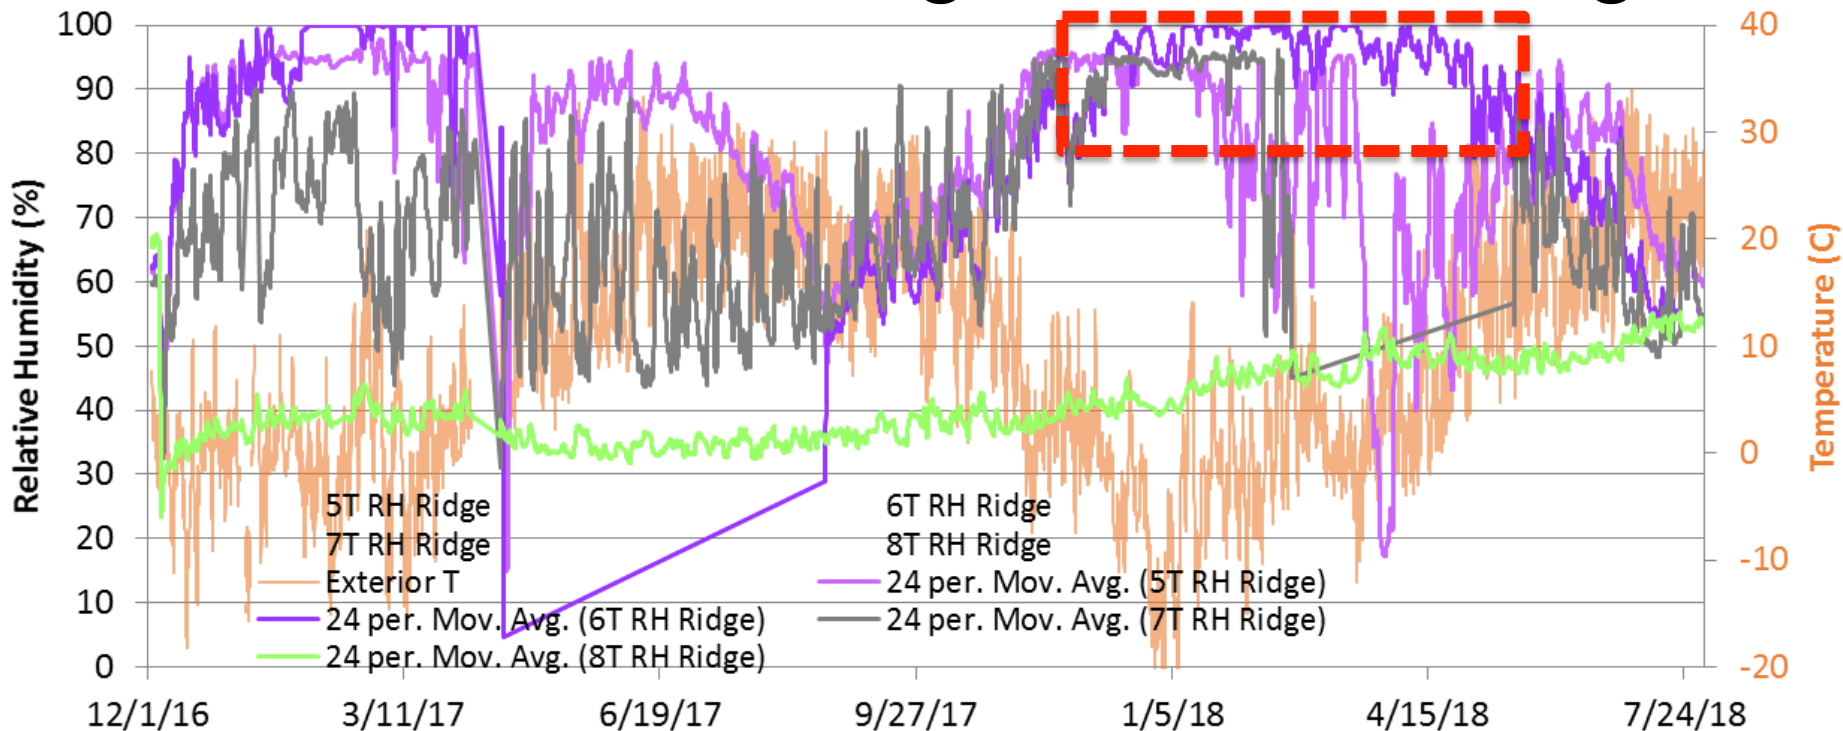
- **Roof 8** (hybrid) no issues @ 50% RH
- **Roof 5, Roof 6, Roof 7** all 95-100% RH thru Winter 2 (before sensor failure)
- **Roof 7** dries fastest? (biggest DV)

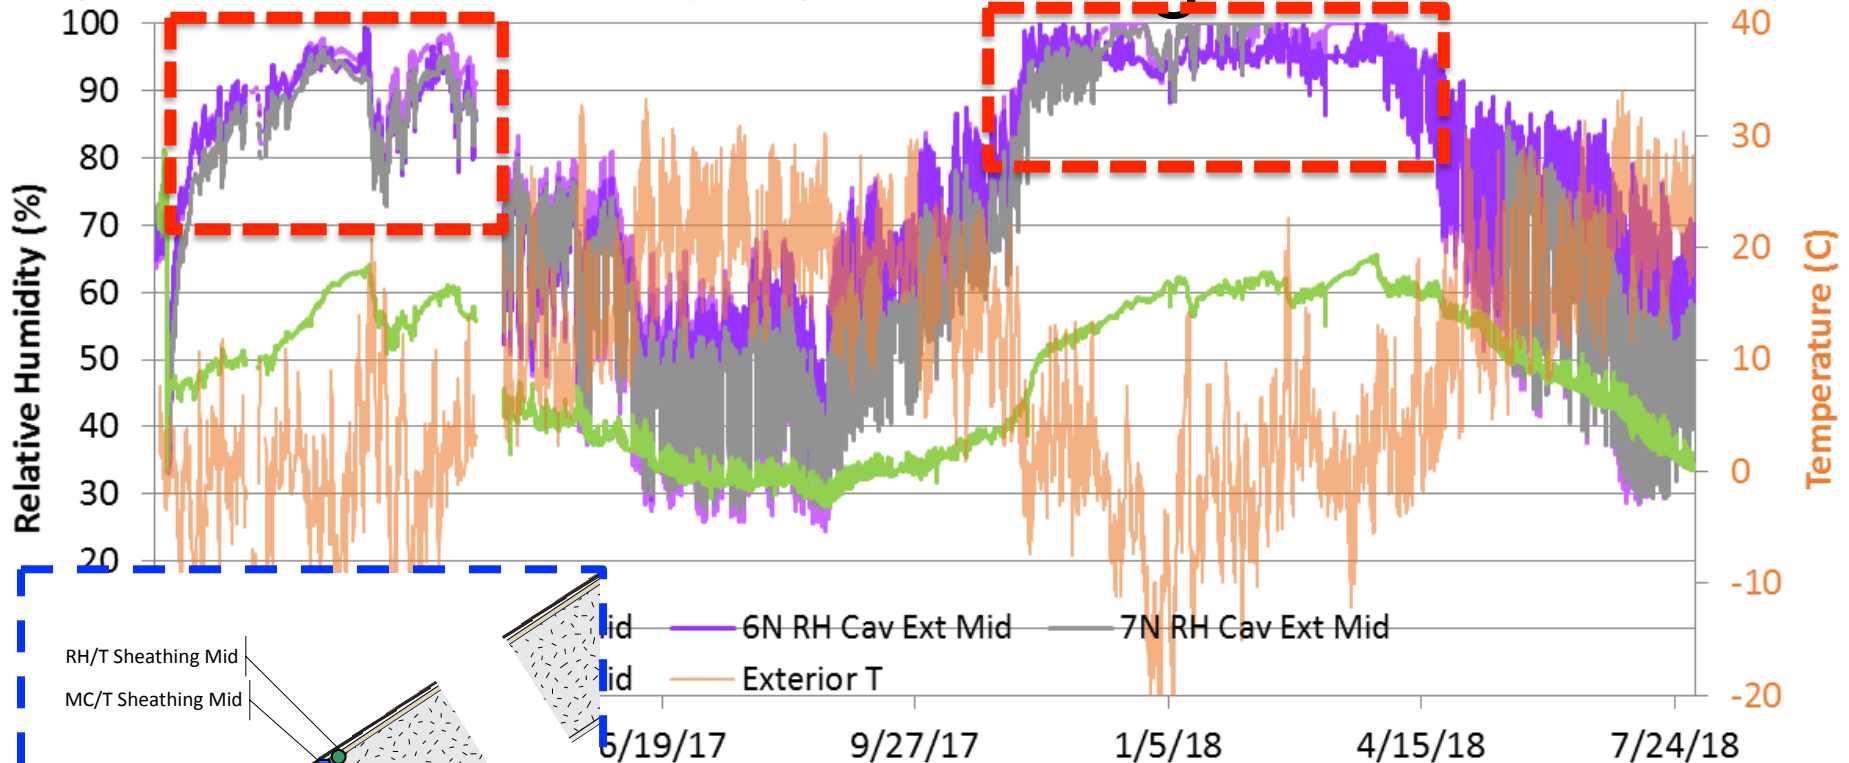
-100% RH most of Winter 2  
 Sustained RHs than Winter 1  
 Down faster (larger DV)  
 ) non-risky RH levels

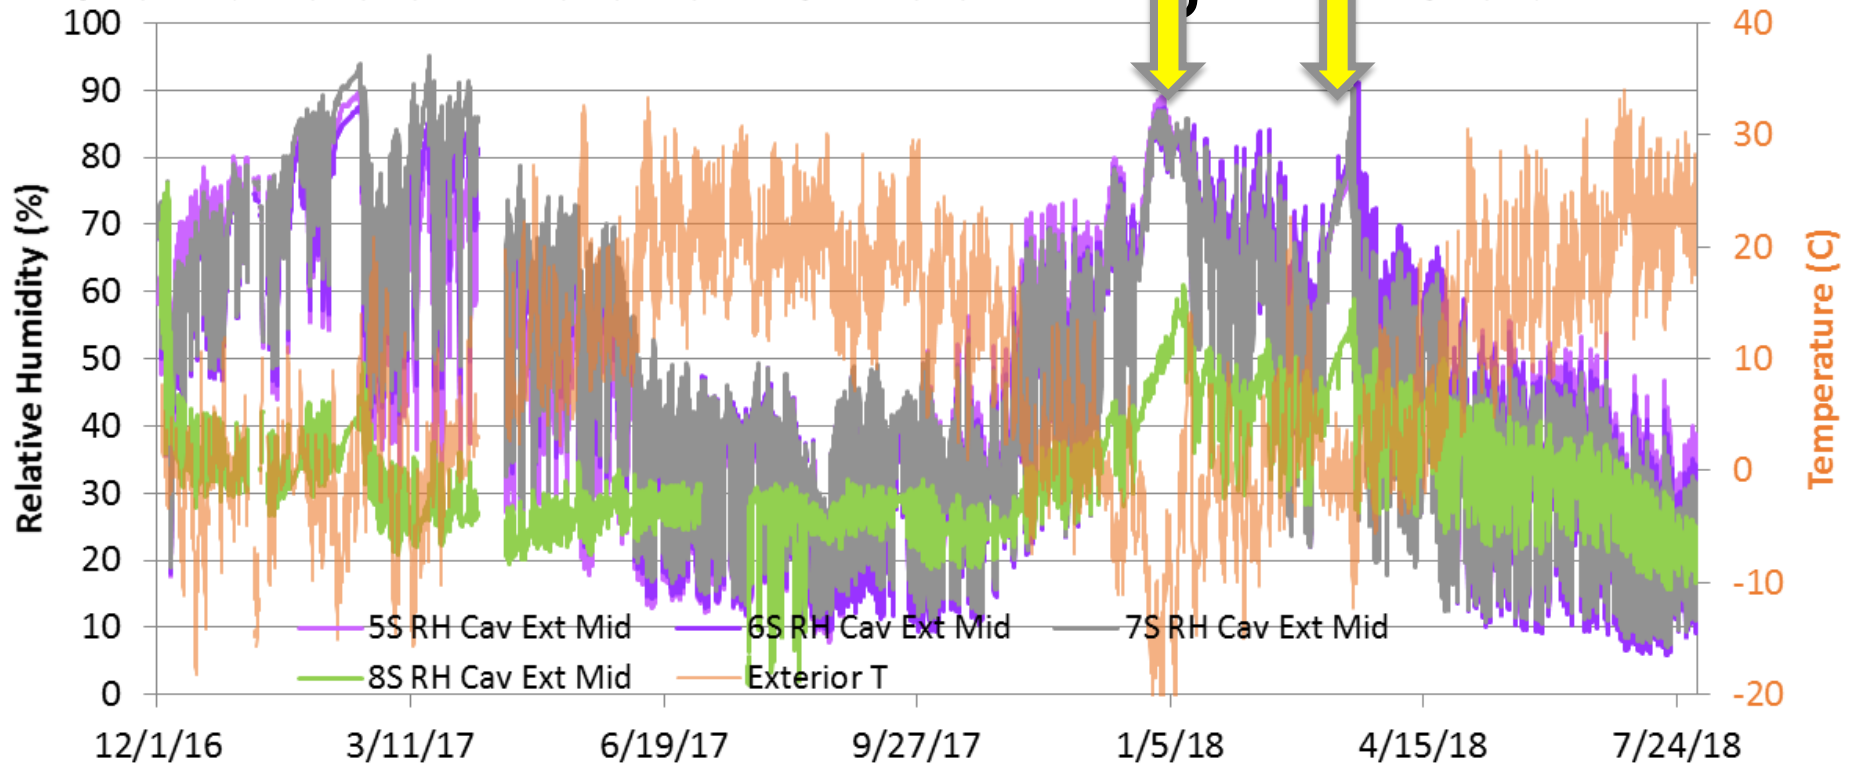
- Drier conditions south vs. north
- Diurnal variations (solar gain, snow)
- Winter 2 wetter than Winter 1
- Brief excursions over 90% RH

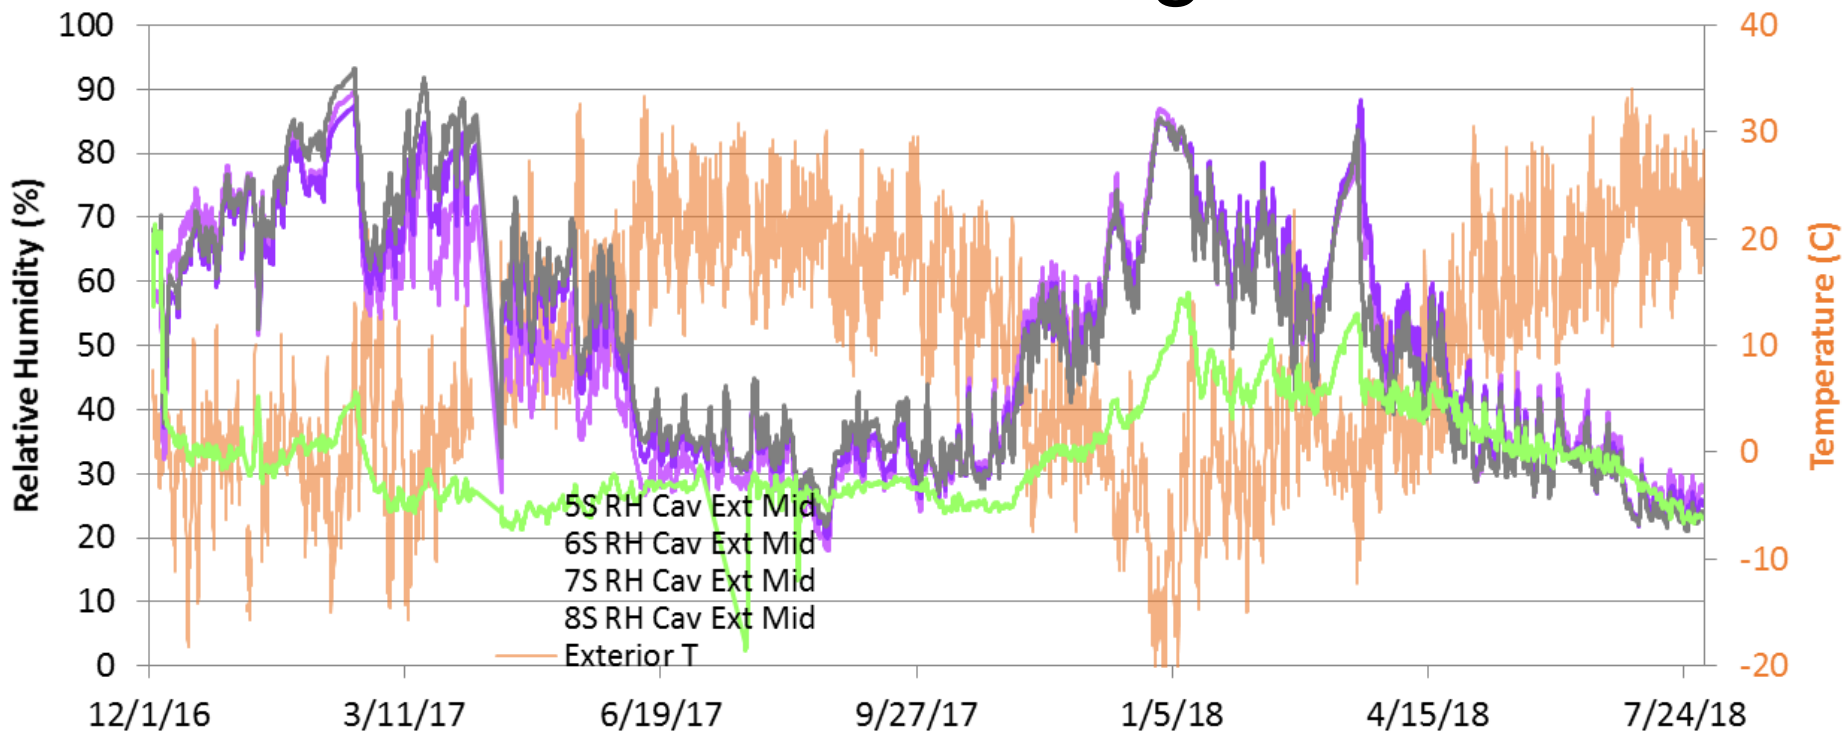
- 24 hour moving average
- Little differentiation Roofs 5-6-7
- **Roof 8** (hybrid) driest

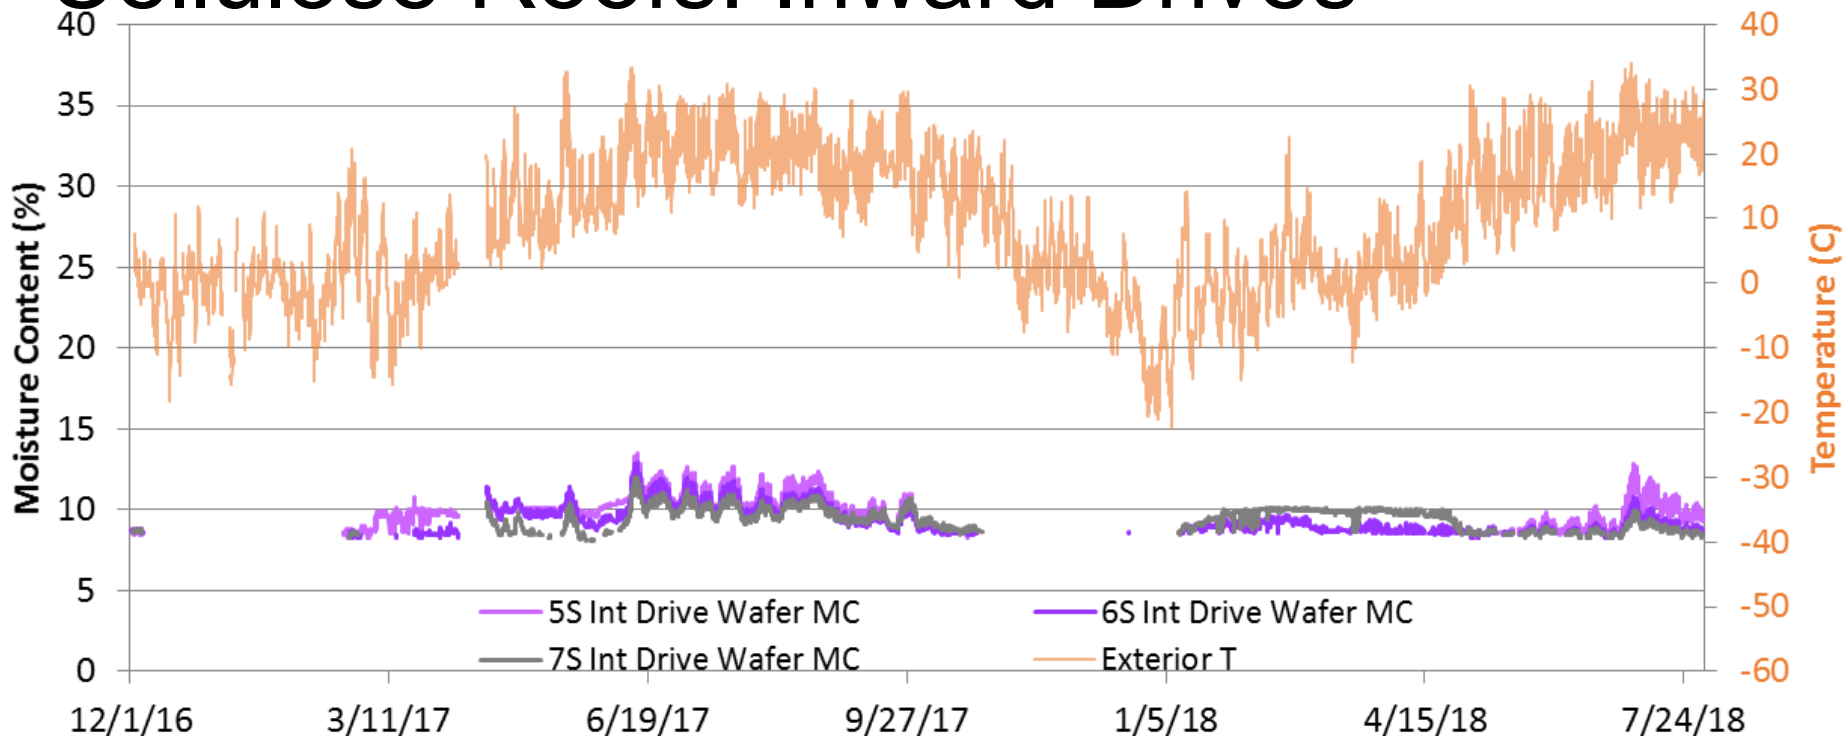
- Inward drive wafer, south
- All well below 15% MC (safe)

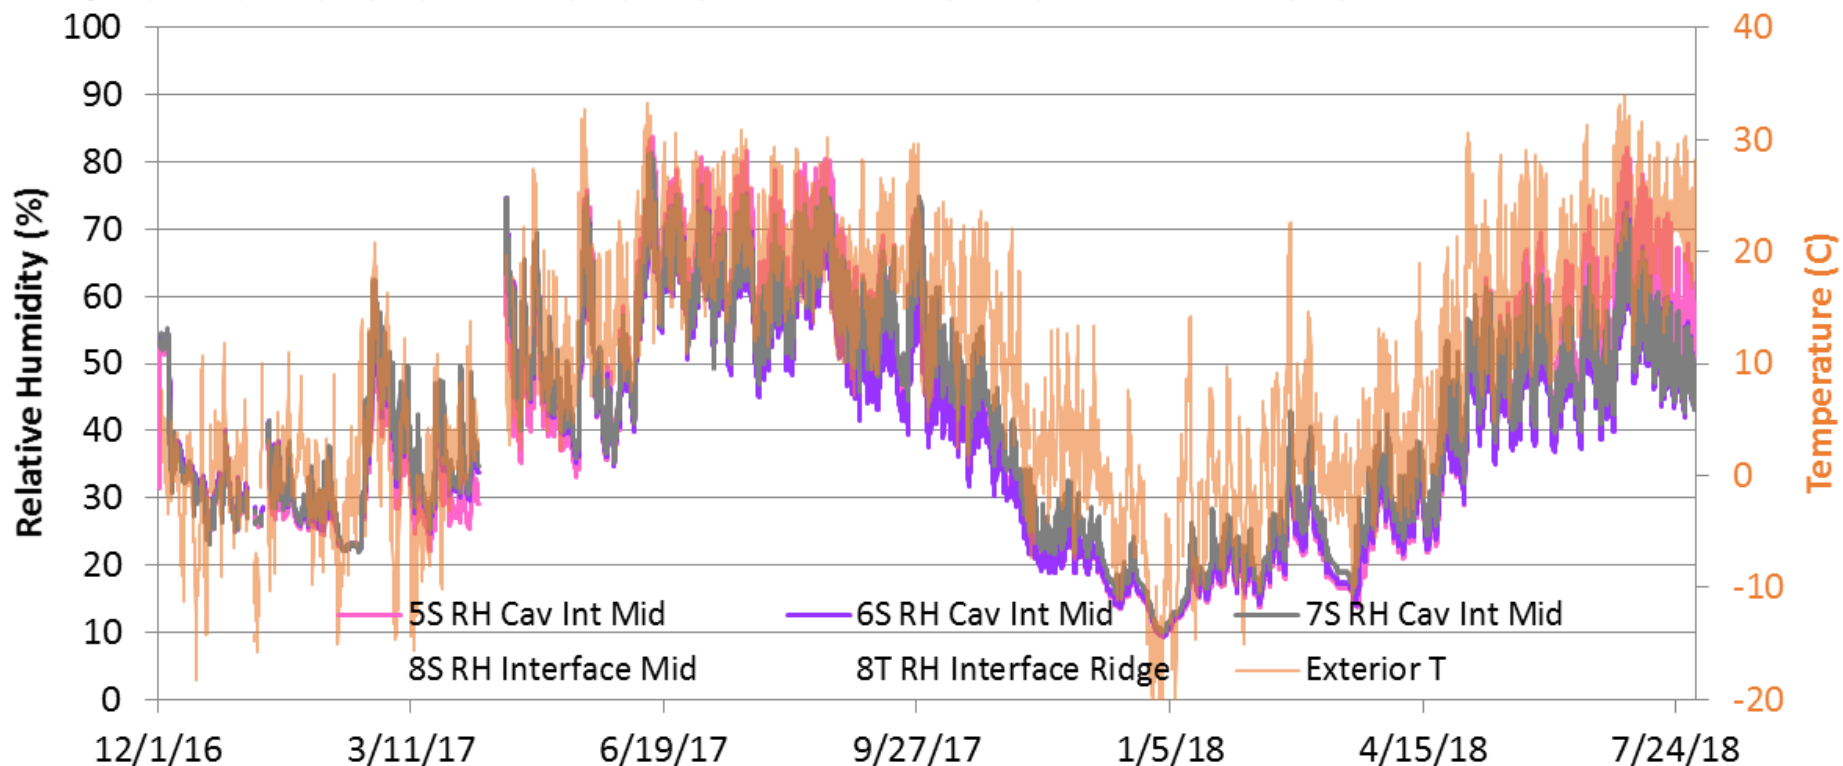
- Inward drive RH, south
- Peaks barely over 80% RH
- Roofs 5-6-7 all SVR interior

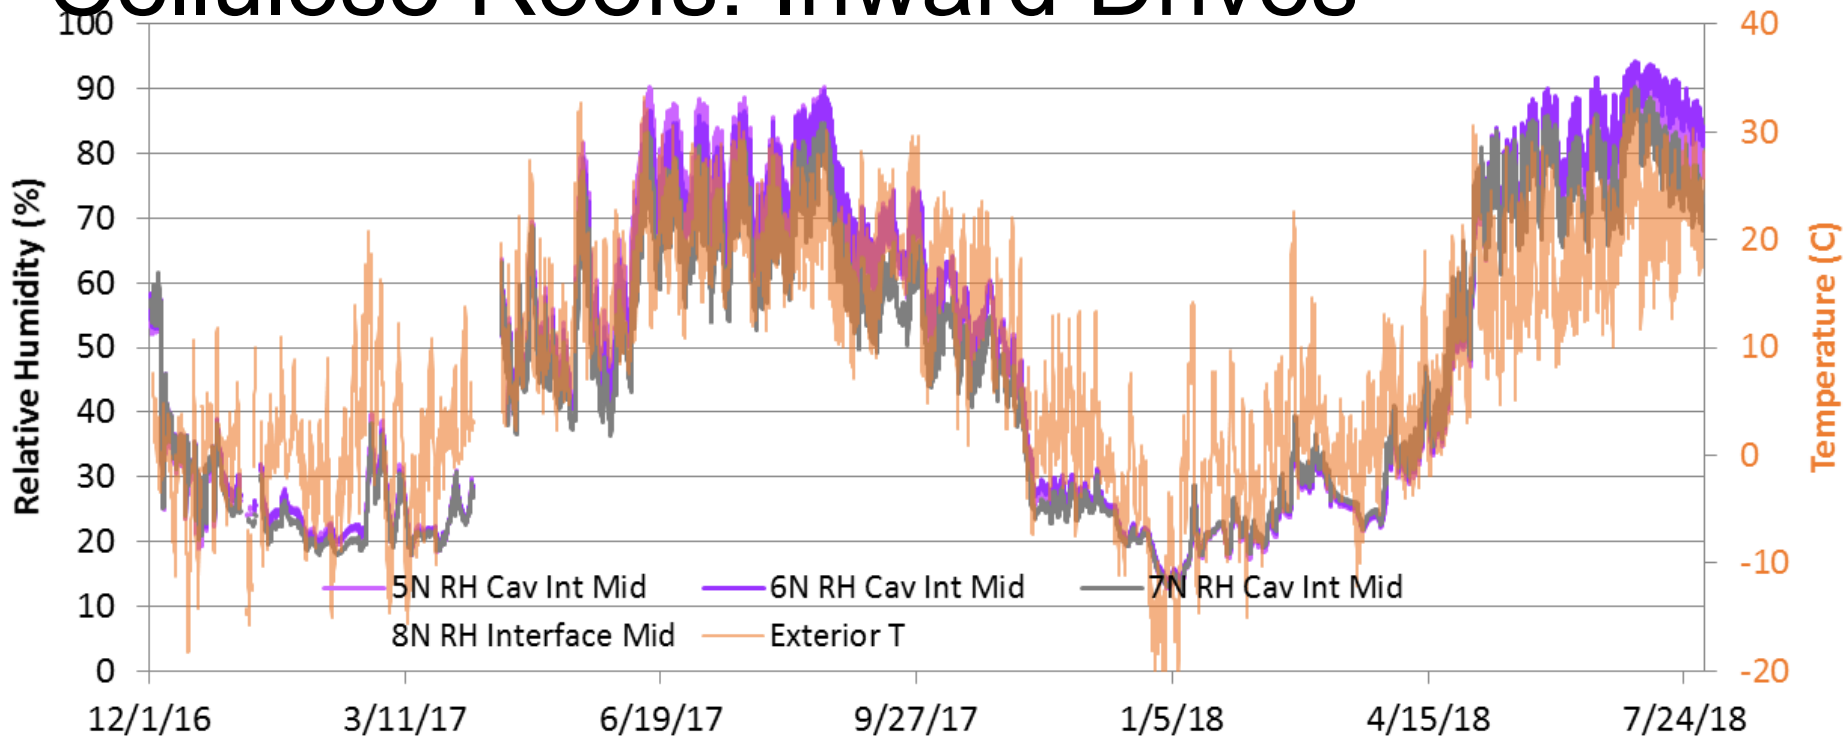
- Inward drive RH, north
- Peaks mostly under 90% RH
- Higher than south-stored moisture?

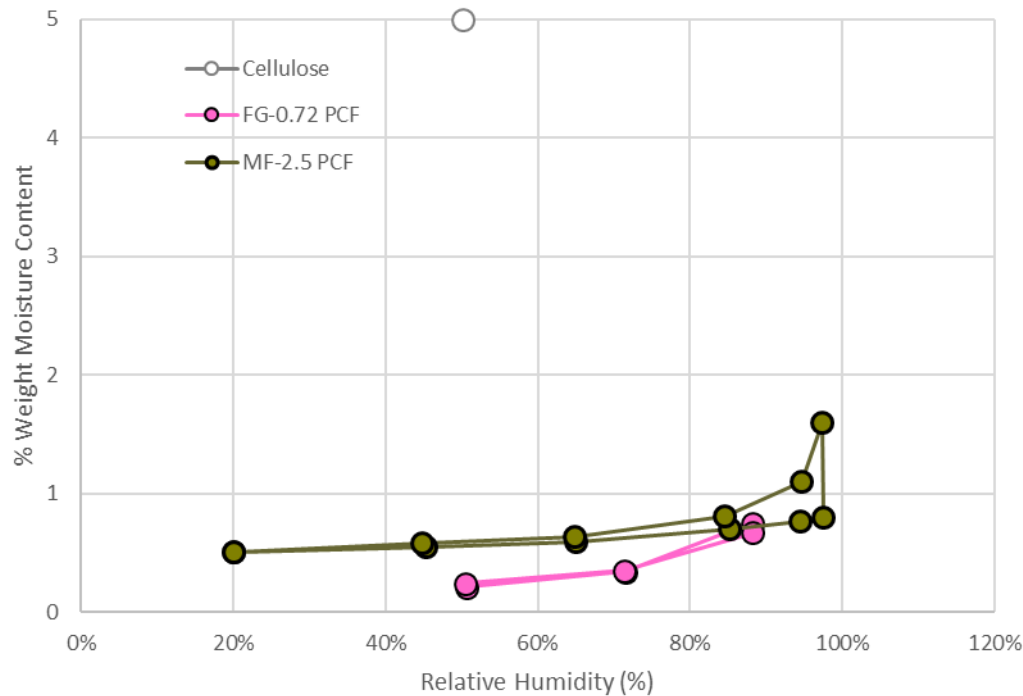
- ASHRAE Fundamentals data (Kumaran, Burch)
- Moisture buffering/storage ability of cellulose
- Raw data, shown by weight, not volume (2.5x diff)

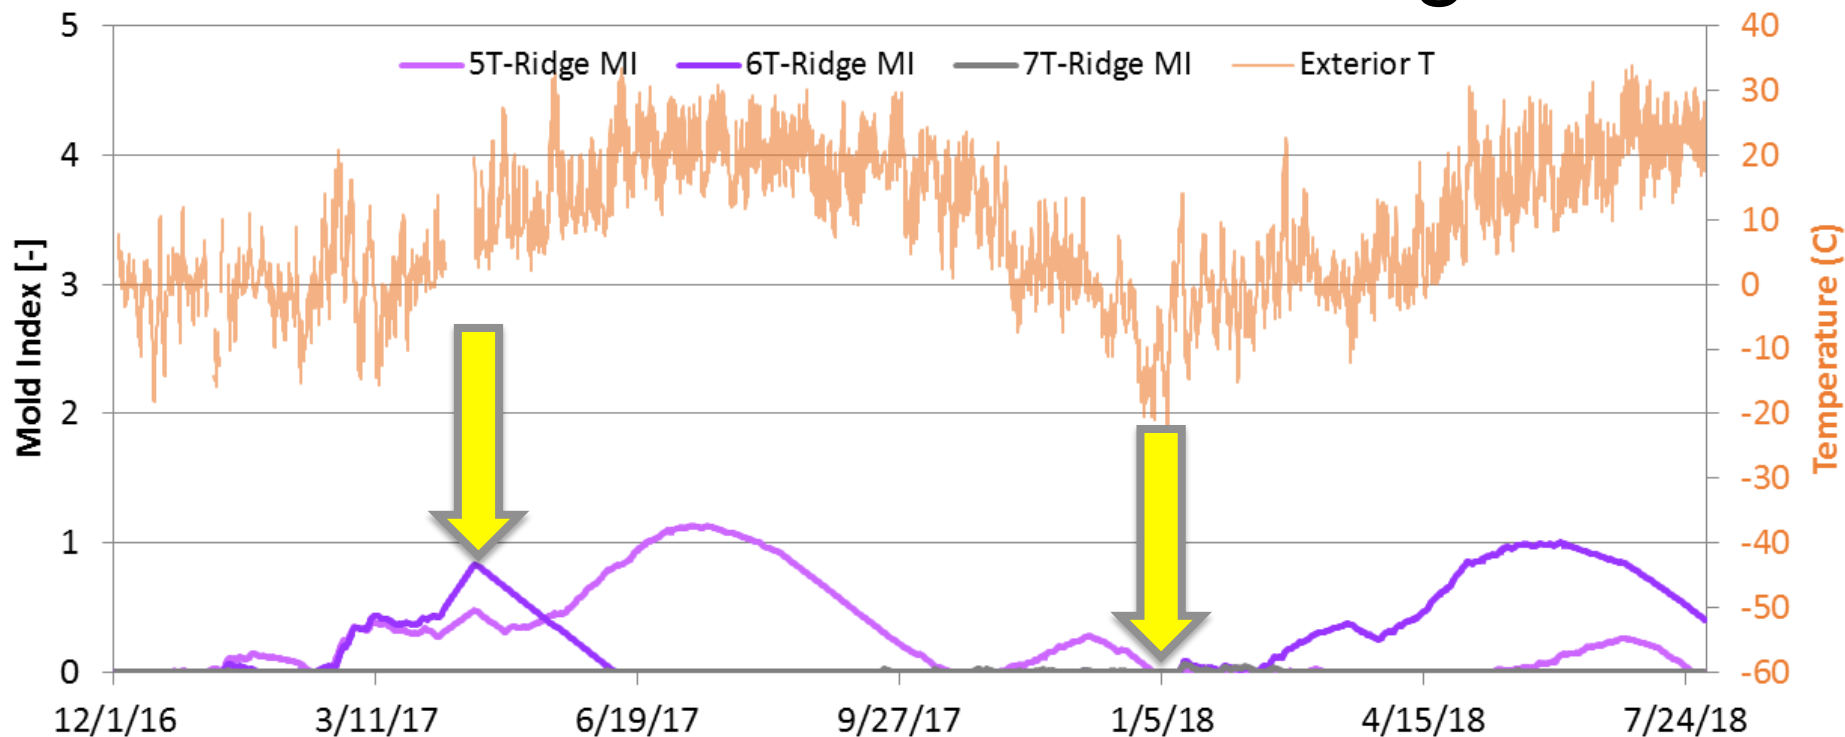
- **Roof 5-Roof 6** RH 90-100% most of winter
- **Roof 6** RH sensor failed mid 4/2017
- **Roof 5** bad data 1/2018
- All mold index values below 2

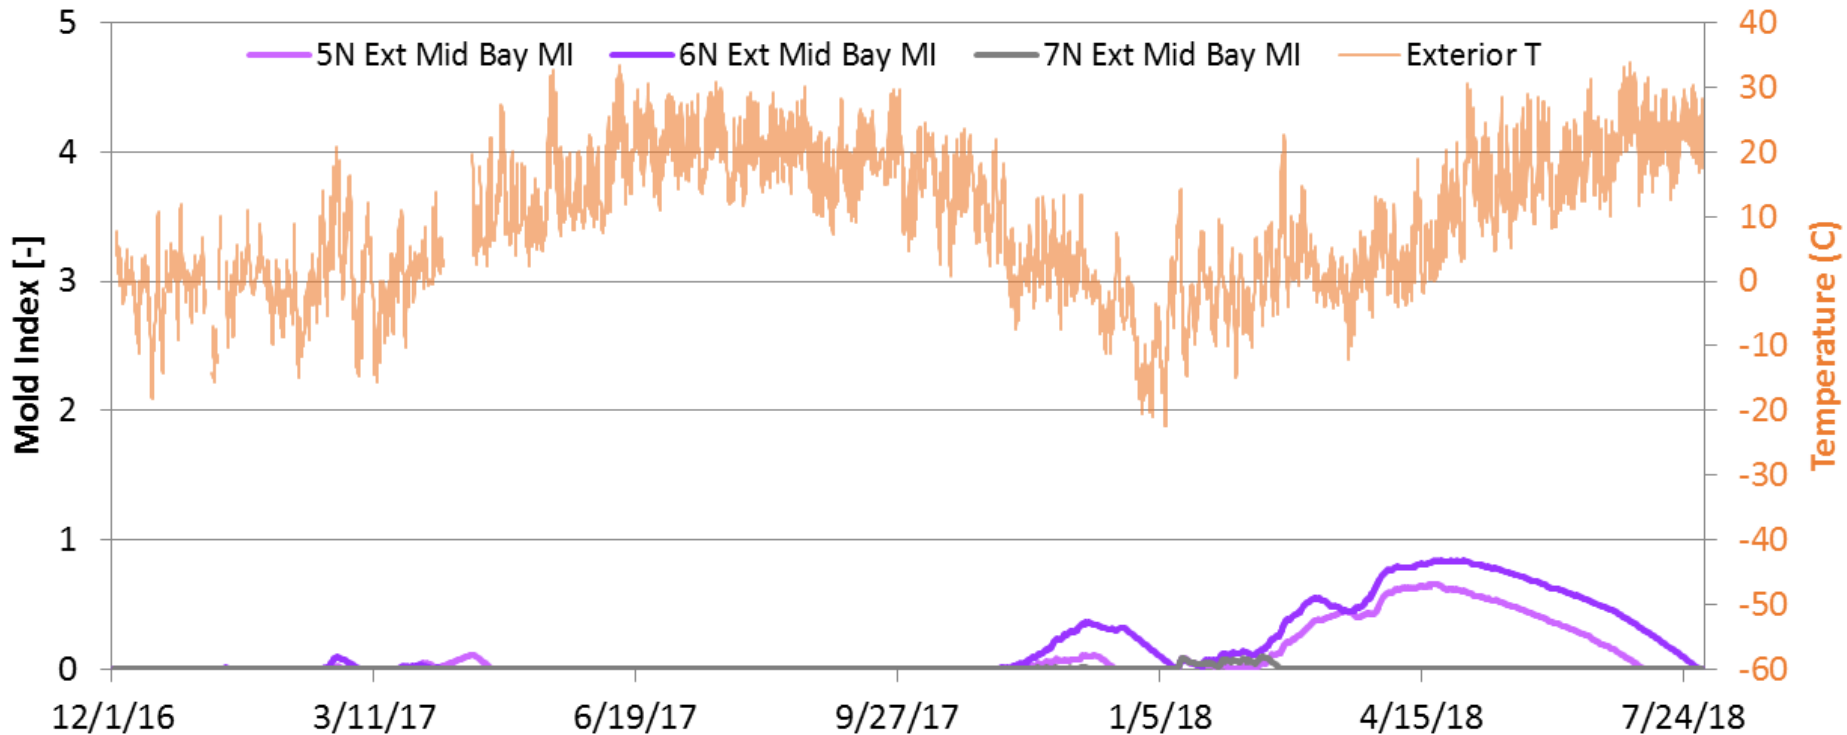
- RH peaks 90-100% much of winter
- Winter 2 worse than Winter 1
- Mold indices all below 1
- South even drier-lower risk (MI=0 typ.)

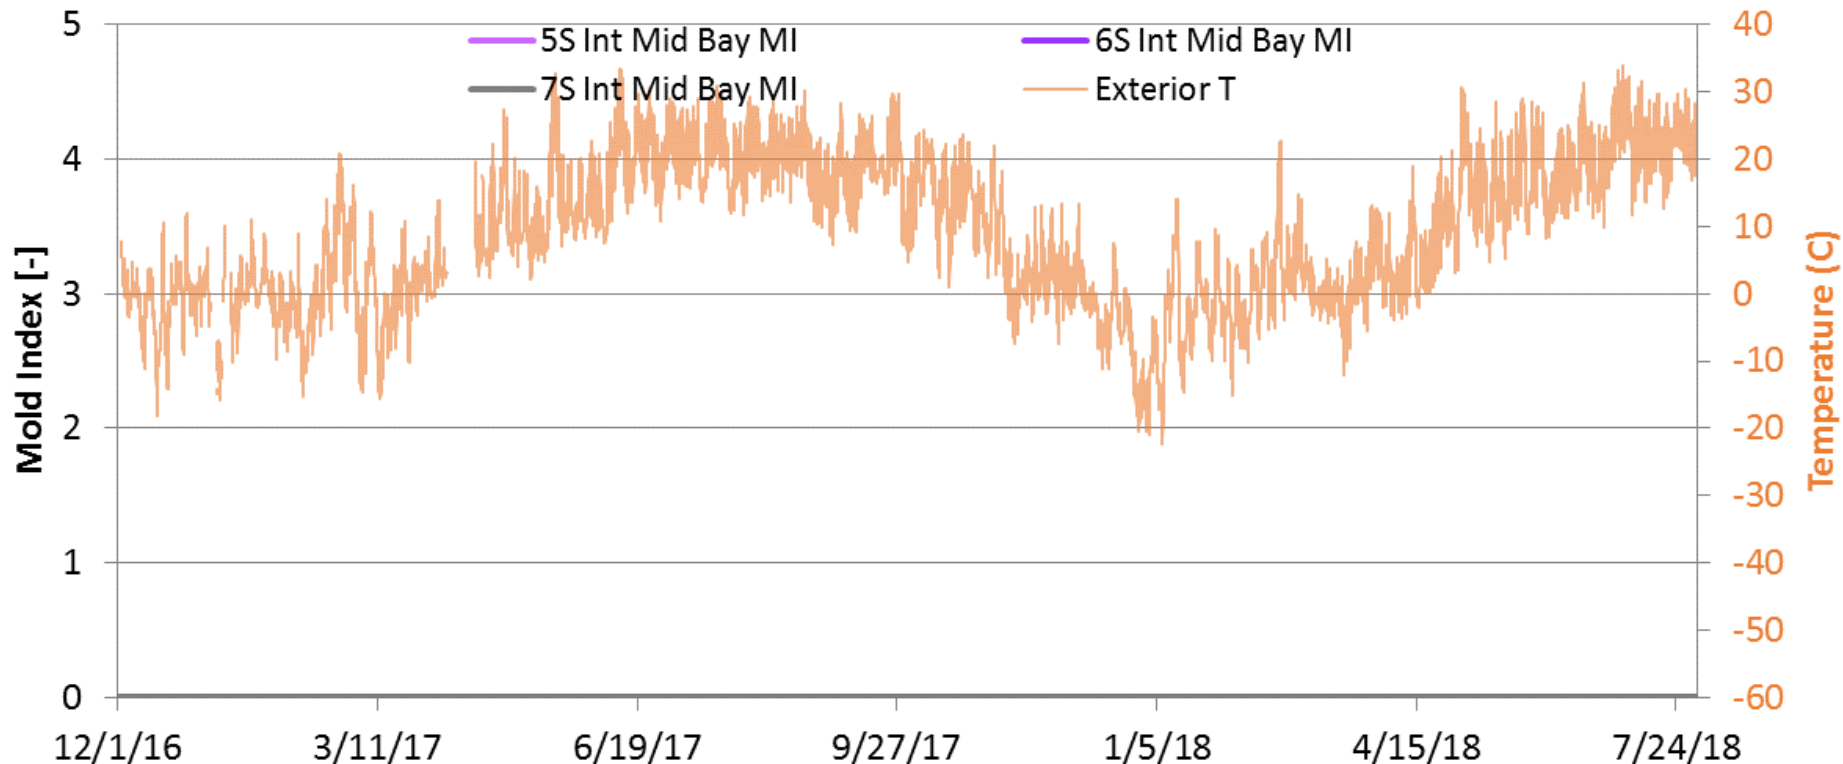
- RH south side inward drive
- Not mis-plotted: max mold index 0.004

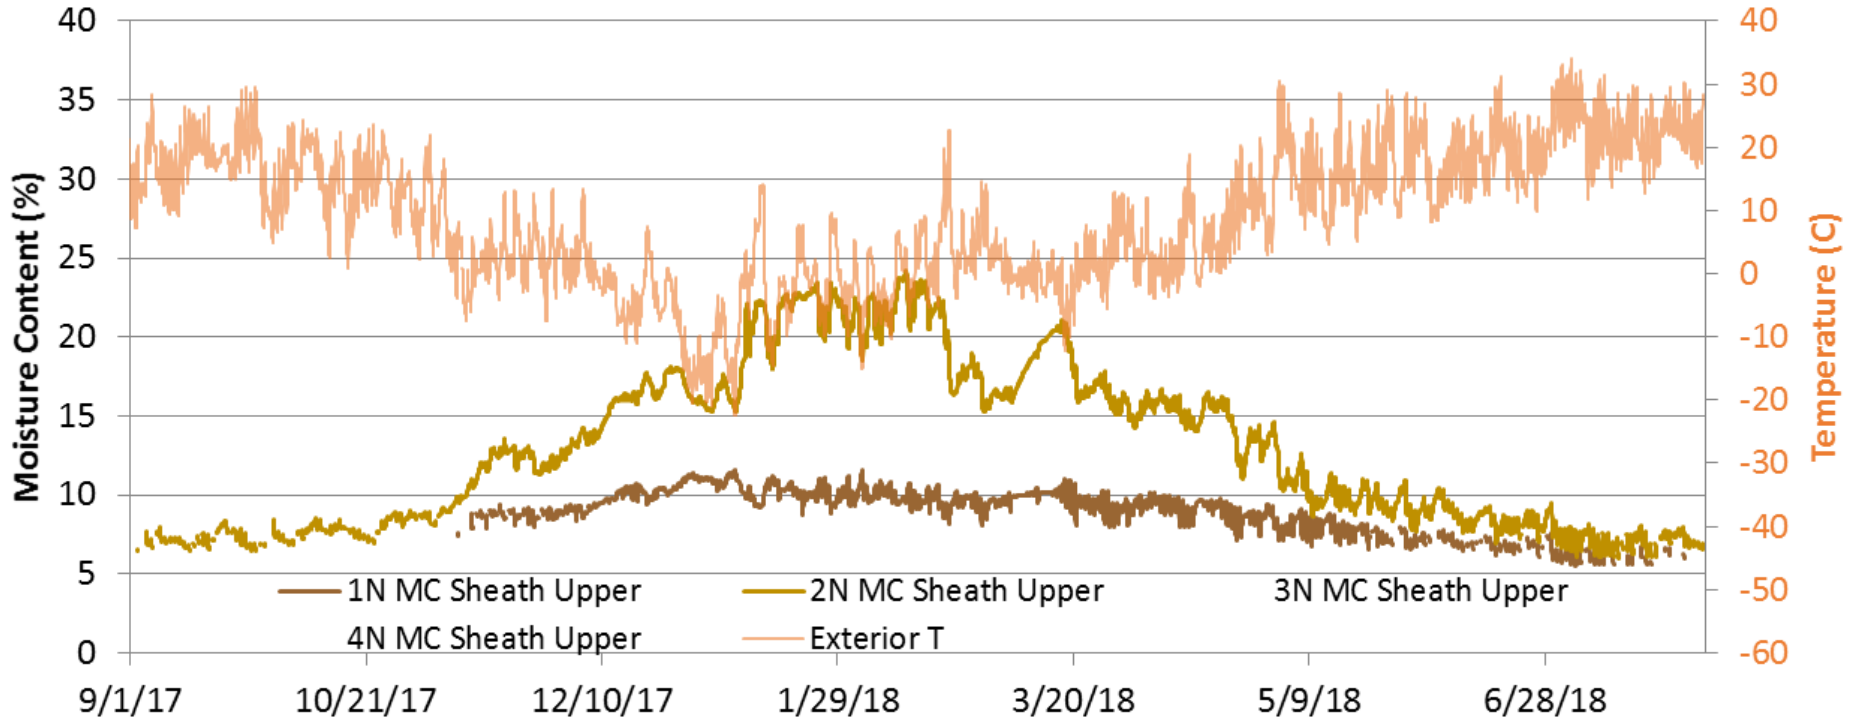
- FG North upper sheathing MC data
- **Roof 3** “tight” **Roof 4** “small”
- Why **Roofs 1** vs. **Roof 2**? VB vs. SVR
- SVR possibly opening up at 50% interior RH?
