Kohta Ueno and Joseph Lstiburek

# Unvented Roof Without Spray Foam:

## The Latest Building America Research

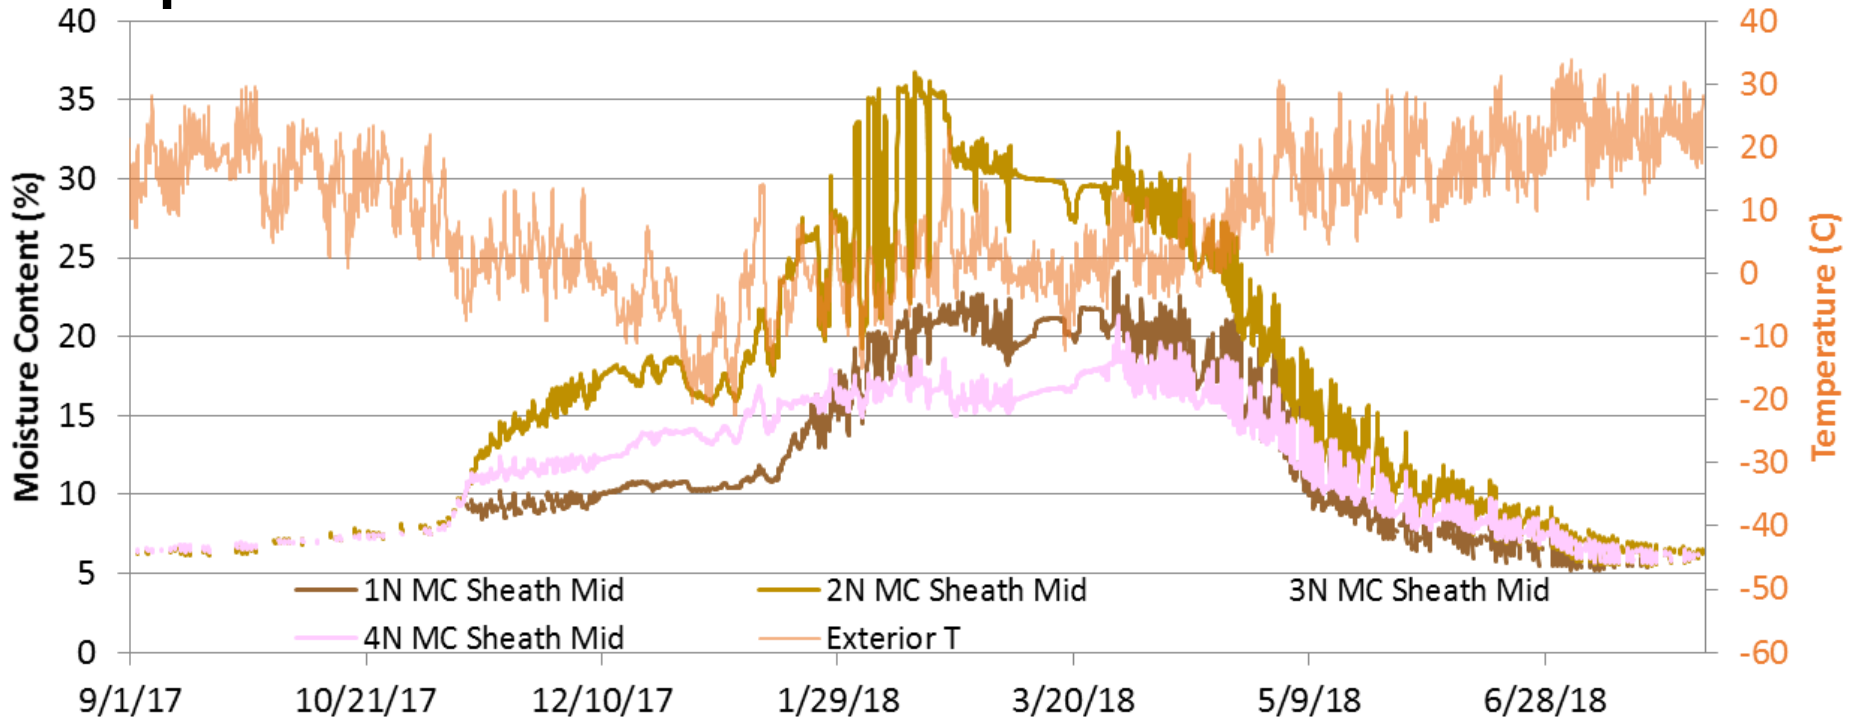
- FG North mid-height sheathing MC
- Consistent pattern **Roofs 1** vs. **Roof 2**

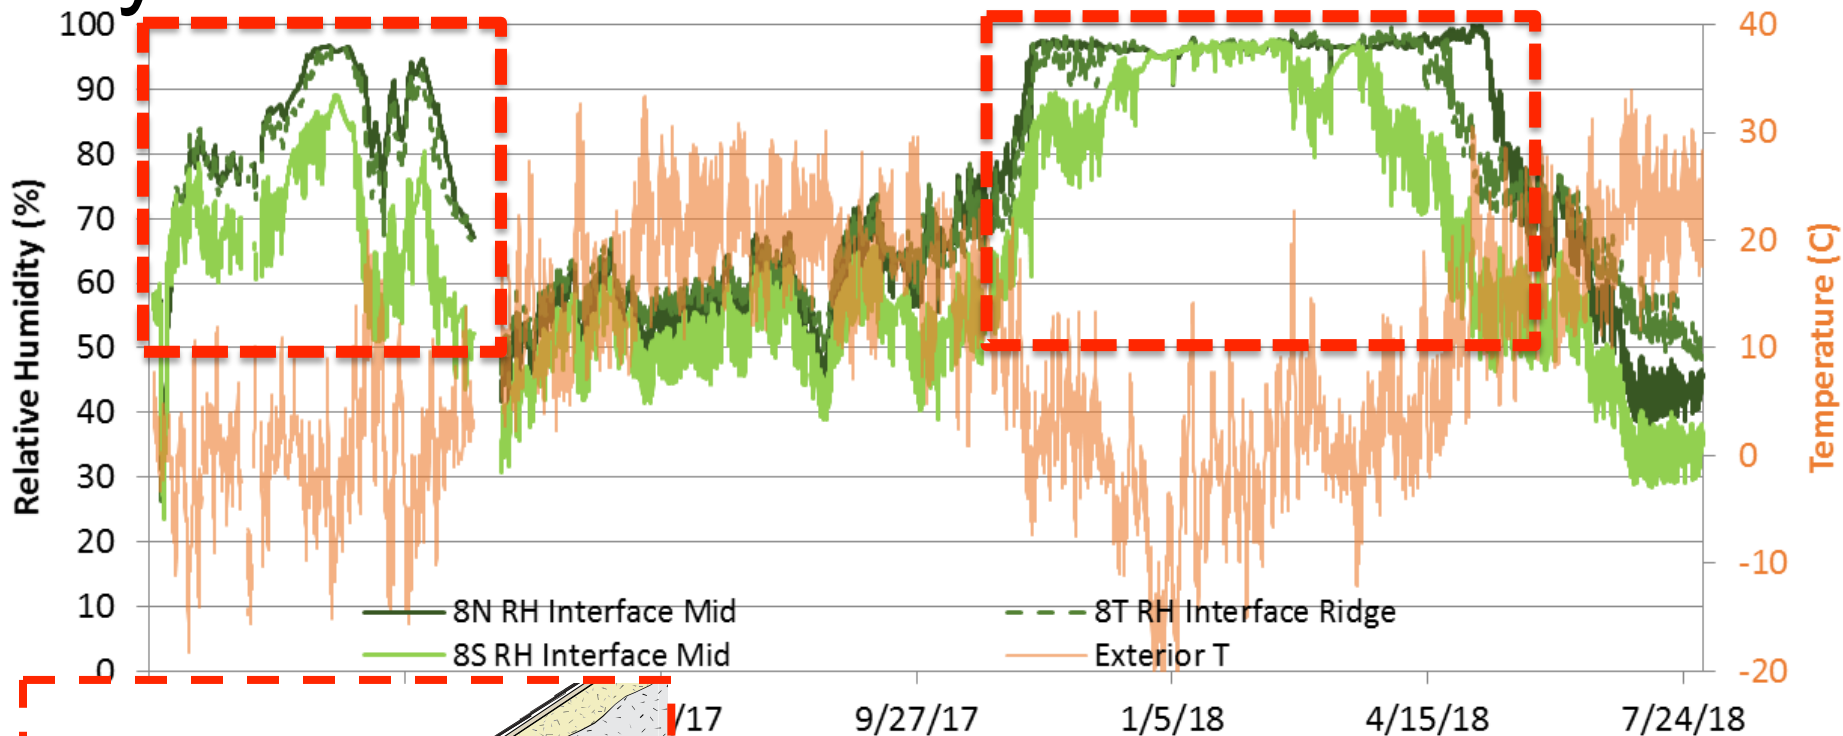
ons to 90-95% RH  
 (interior RH): 95-100% RH all winter  
 from interior (cellulose storage)

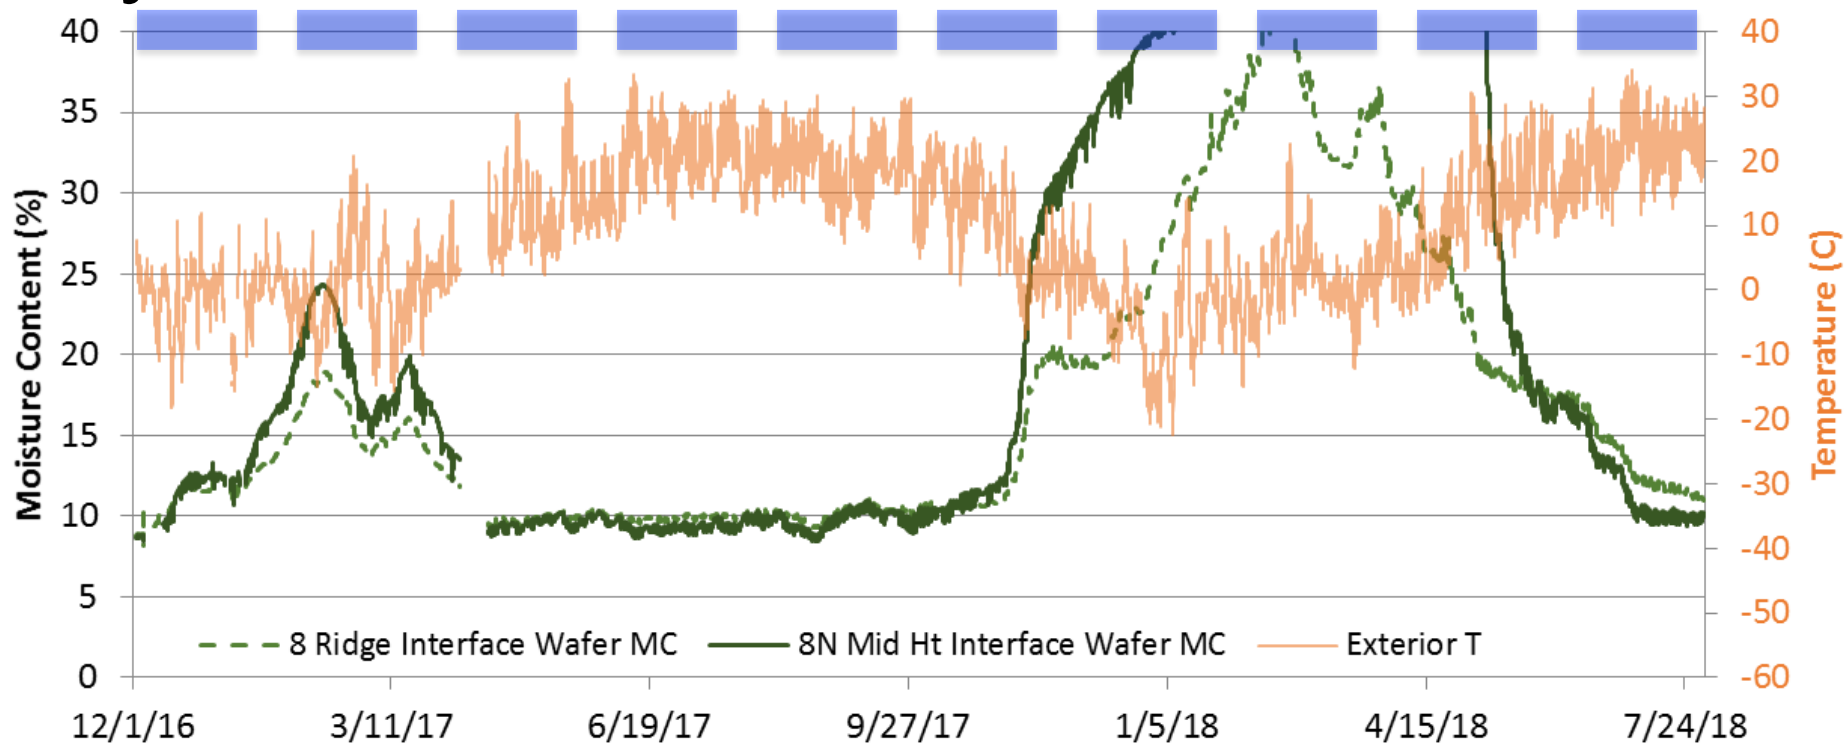
- Winter 2 interface possibly in condensation range
- But also possibly borate contamination

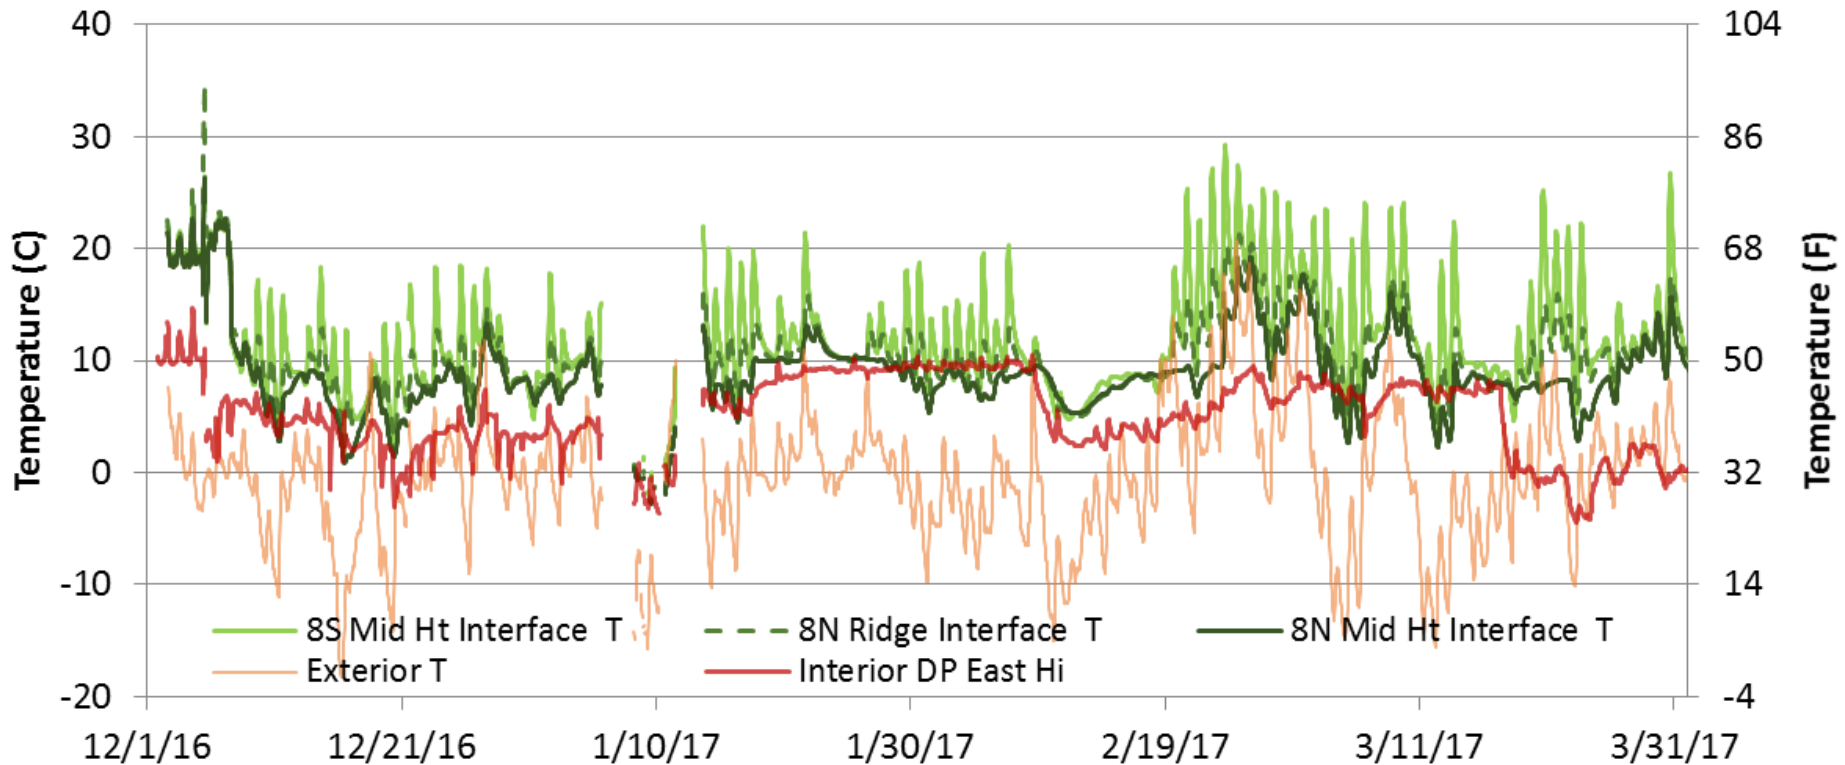
- **Interface T** (greens) & **interior DP** (red)
- DP is typically below interface temperature in Winter 1

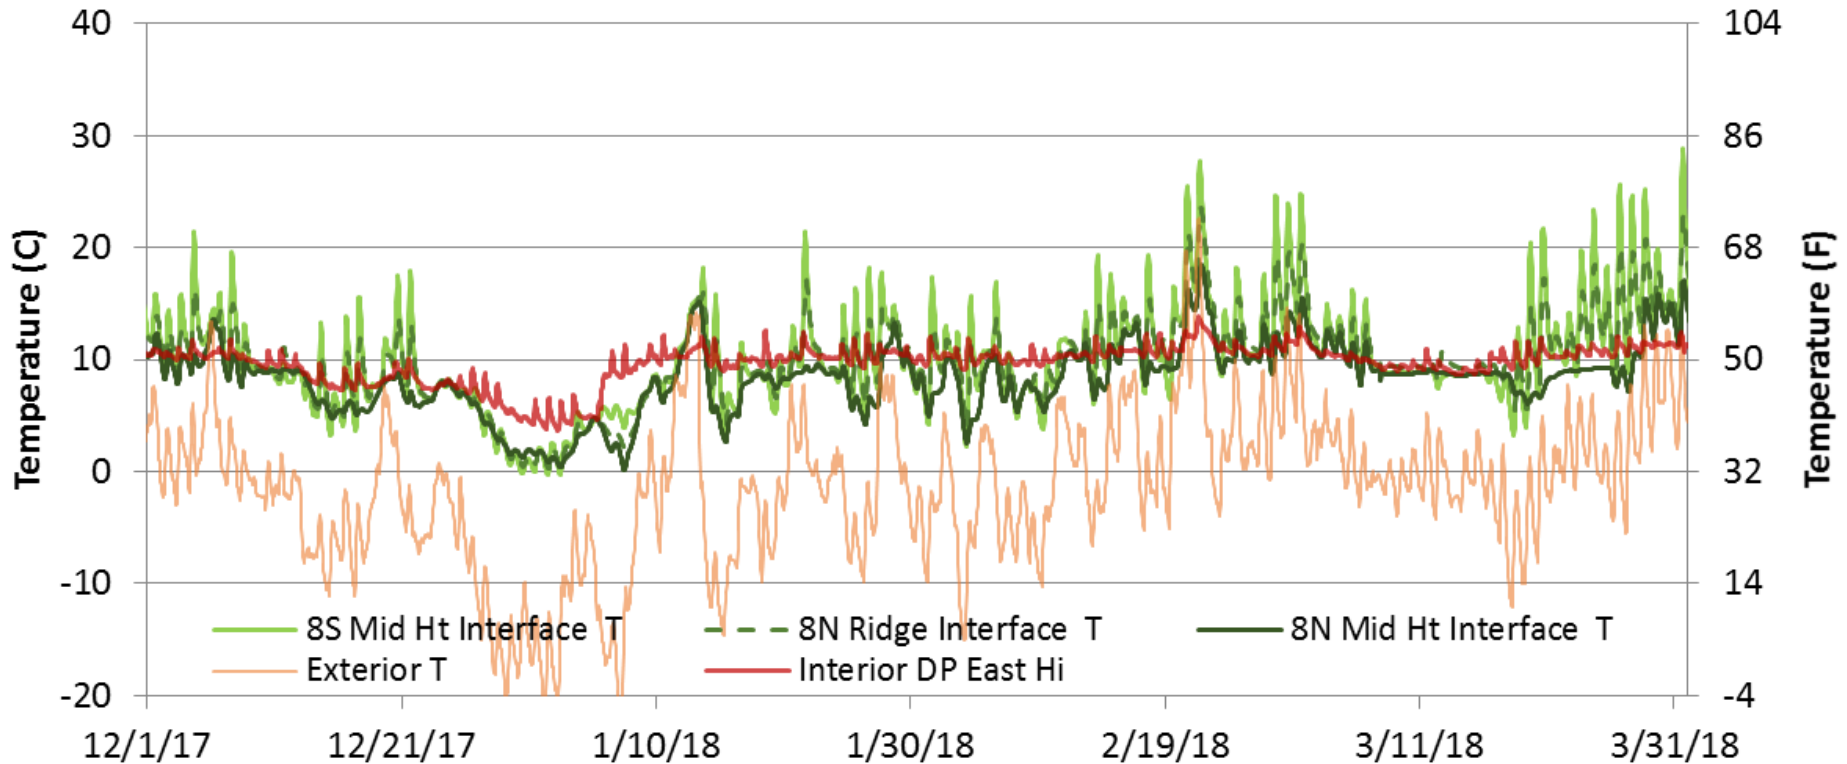
- **Interface T** (greens) & **interior DP** (red)
- **Interior DP** is often greater than interface temperature in Winter 2
