1722 PINE STREET: FROM MAZE TO MATRIX

1722 PINE STREET PHILADELPHIA PA
4 story, 4 unit rowhouse, built 1845
Brick front and rear

1722 PINE STREET RENOVATION PROJECT GOALS

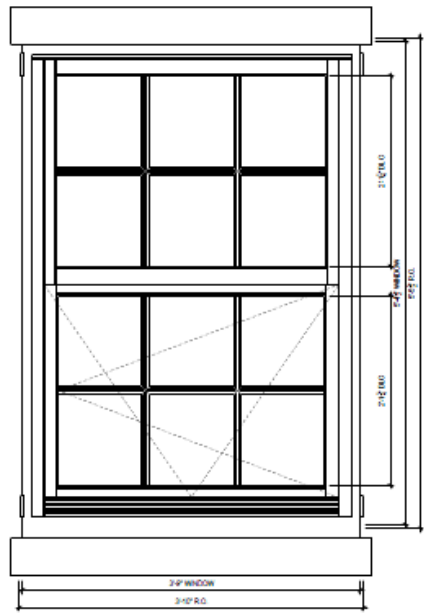
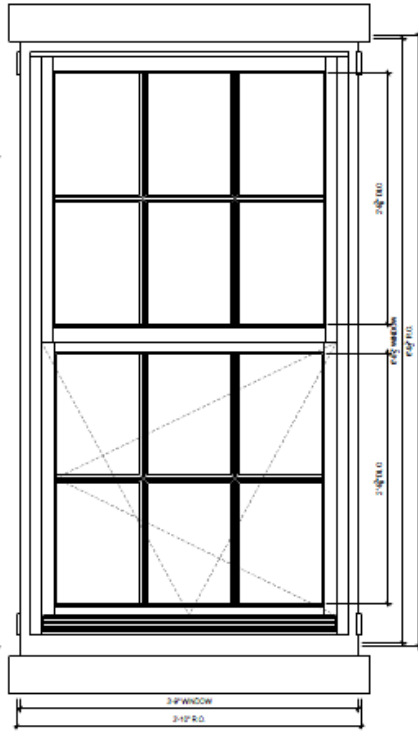
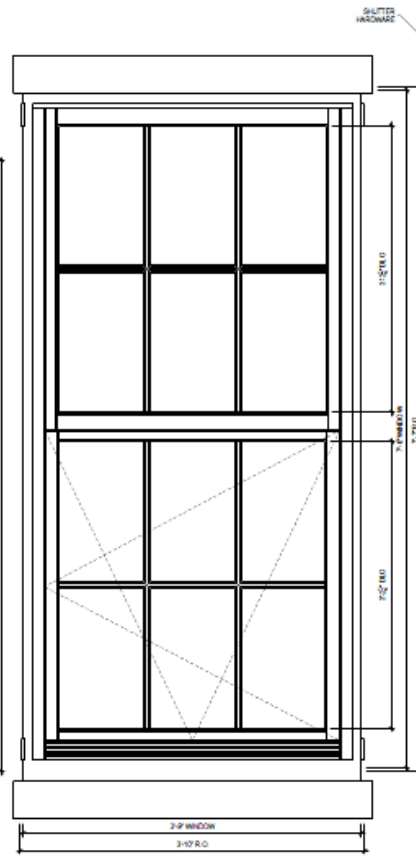
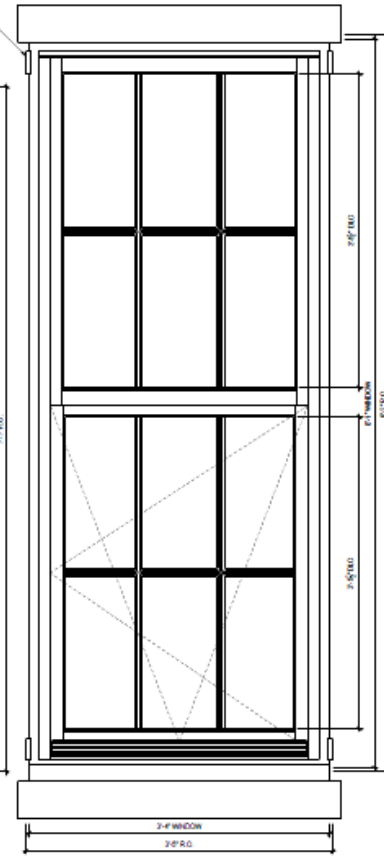
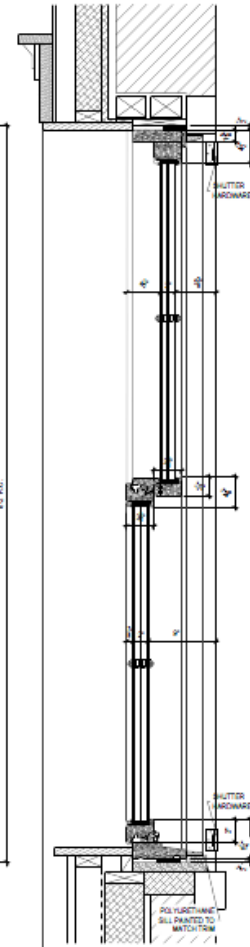
Historical Commission Window Submission

- NEW FRAME TO MATCH ORIGINAL WINDOW FRAME MATERIAL: WOOD
 - WINDOW FRAME COLOR: RAL 5011 - STEEL BLUE
 - POLYURETHANE SILL: ARMATHERM 500-150
 - ARMATHERM 500-150: PAINTED RAL-5011-STEEL BLUE
- NOTE:
R.O. IS NOT EQUAL TO M.O.

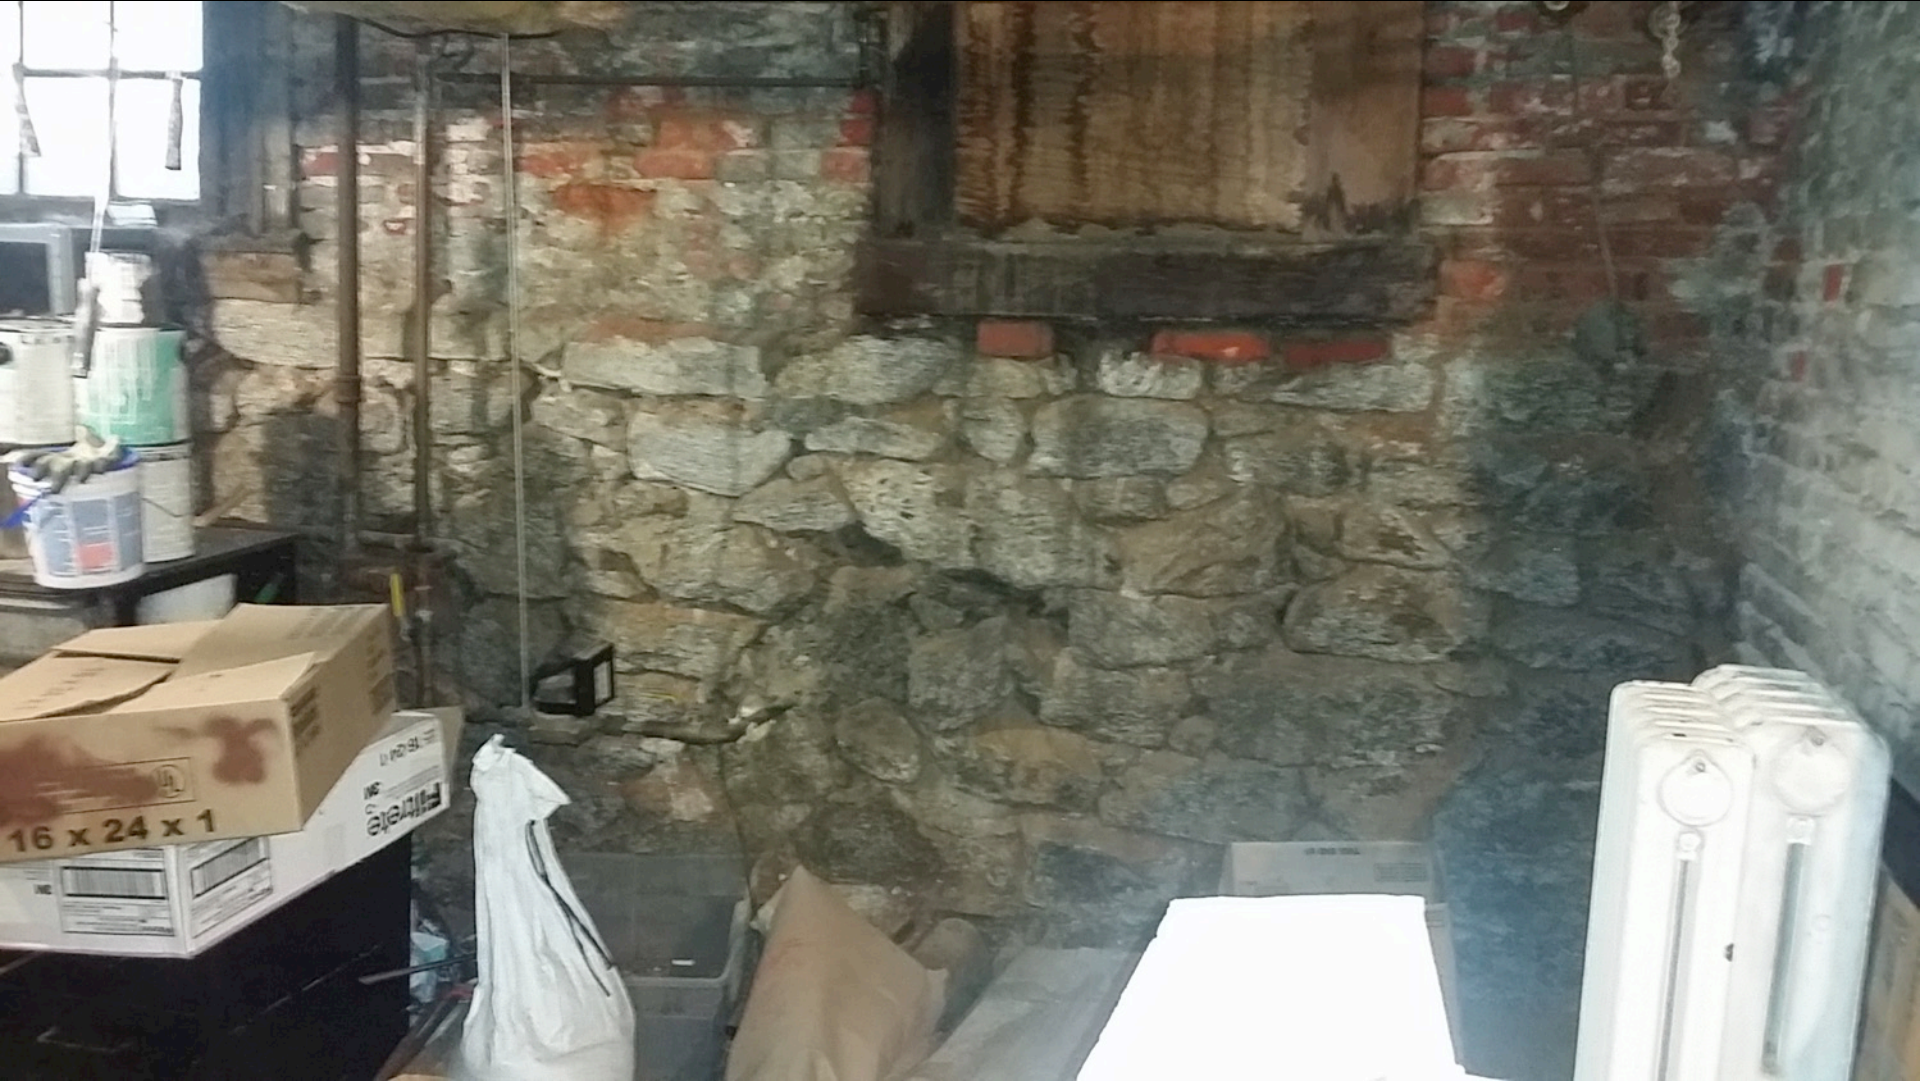
Deteriorating Stone Walls

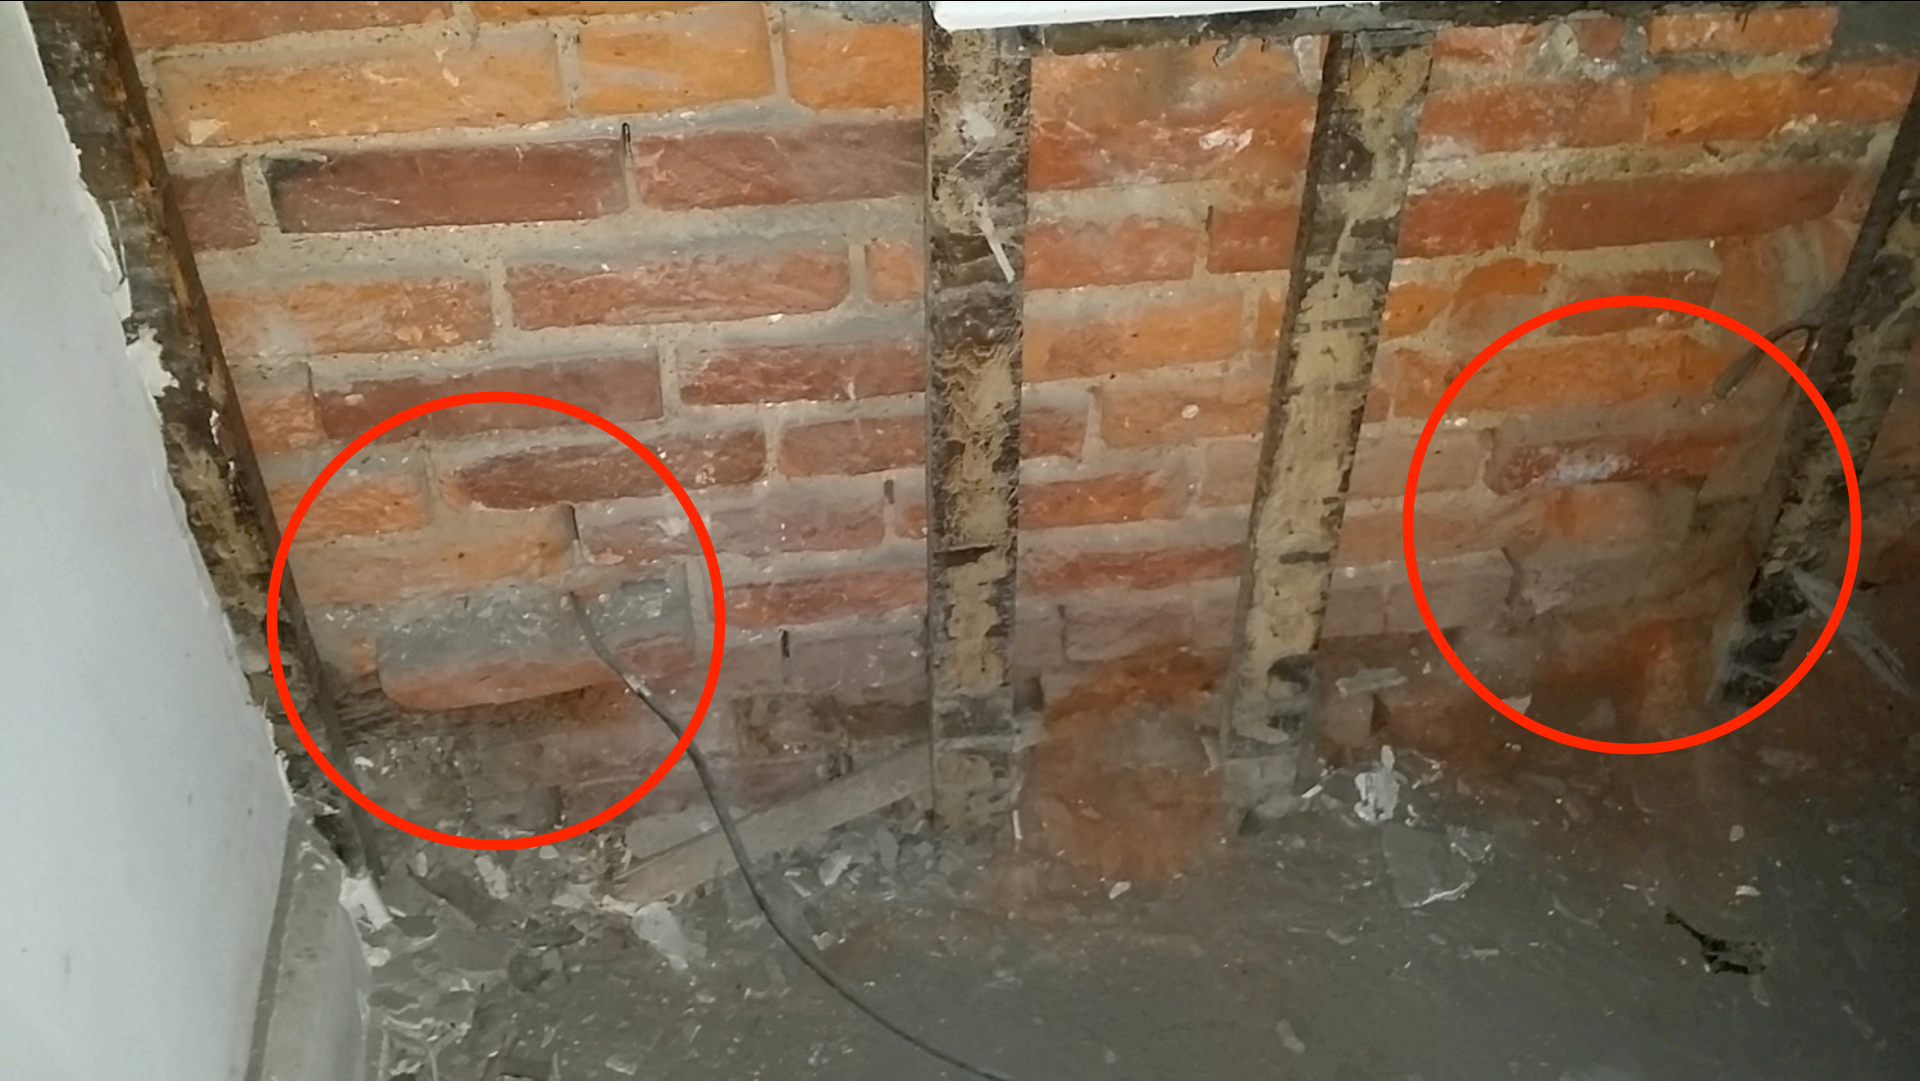
Deteriorating Brick Walls

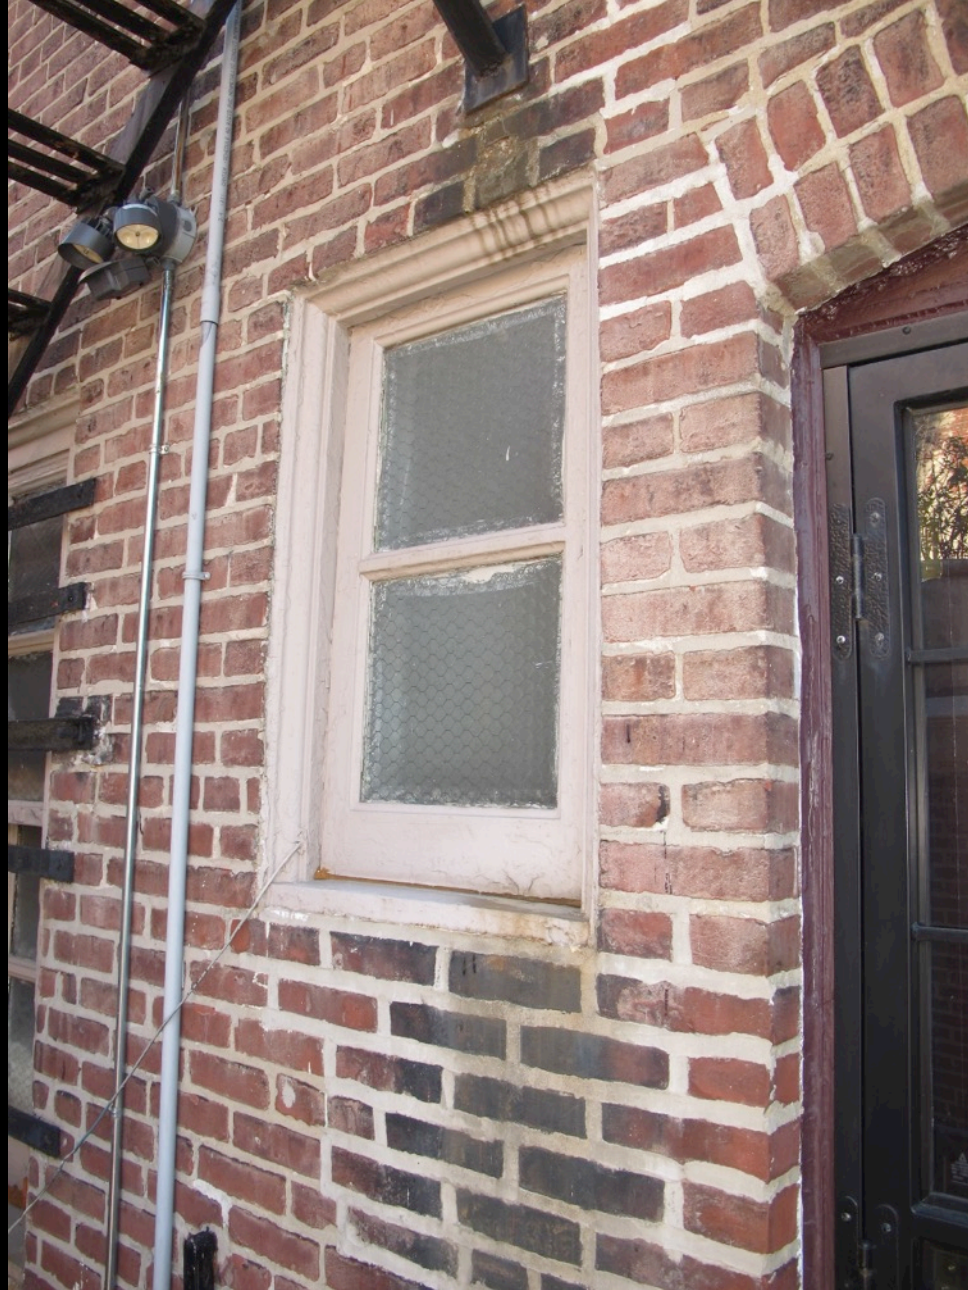
Deteriorating Brick Walls

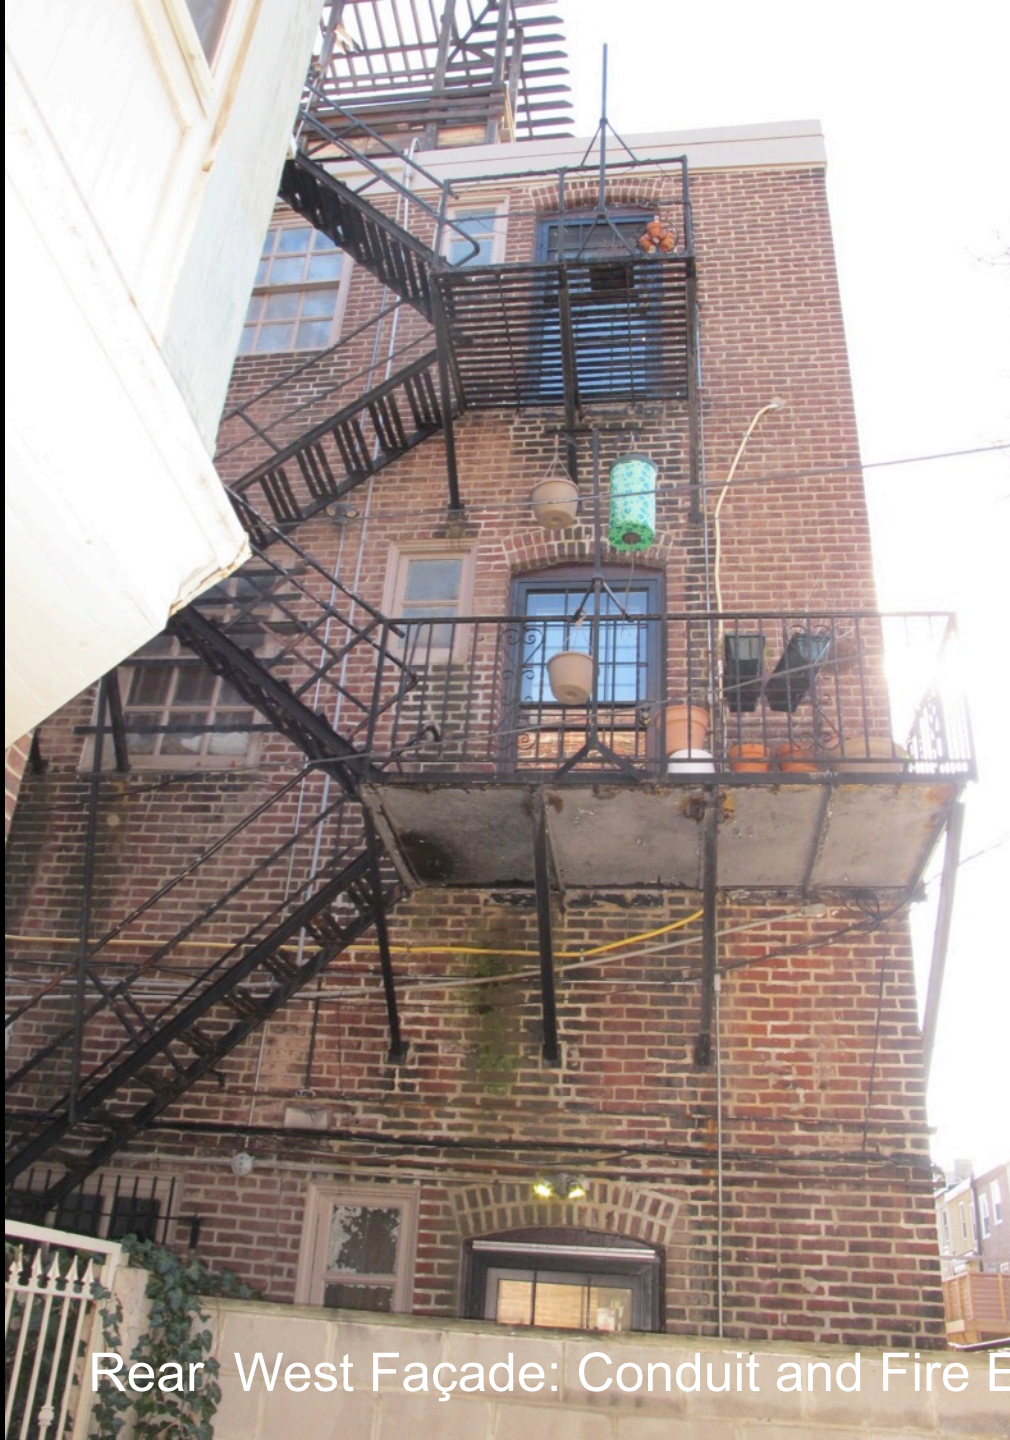
Rear West Façade: Conduit and Fire Escape

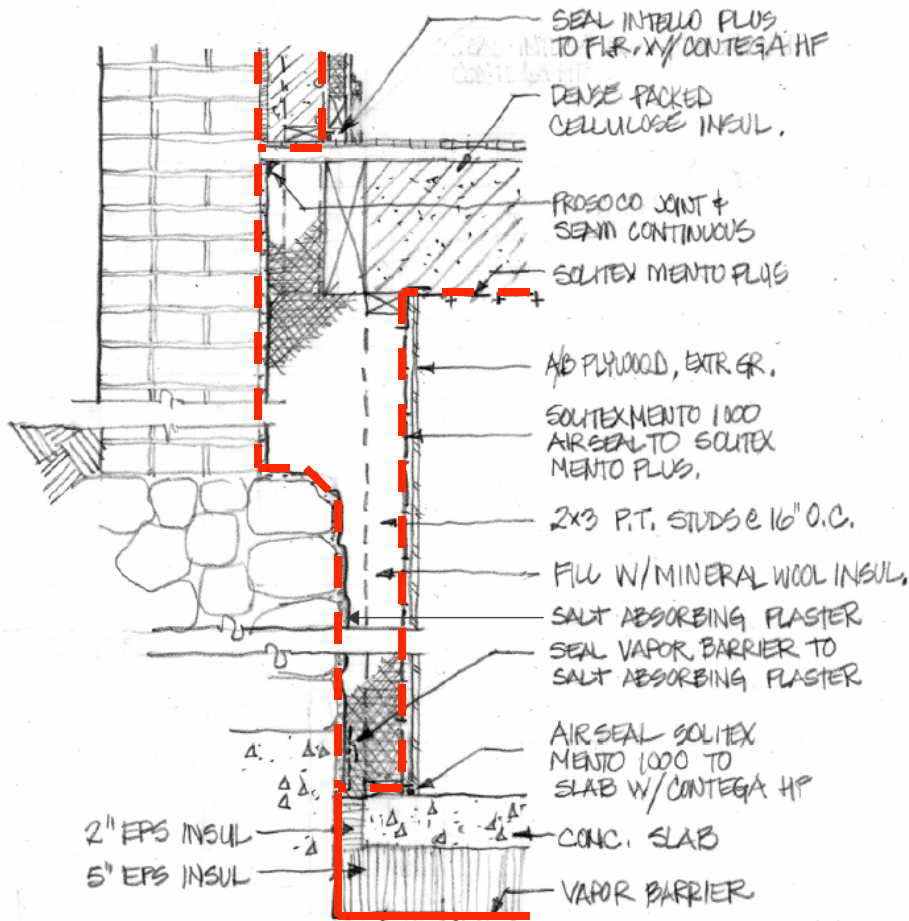
W1 SECTION @ N. BASEMENT WALL
 1/2" = 1'-0"

Basement Party Wall

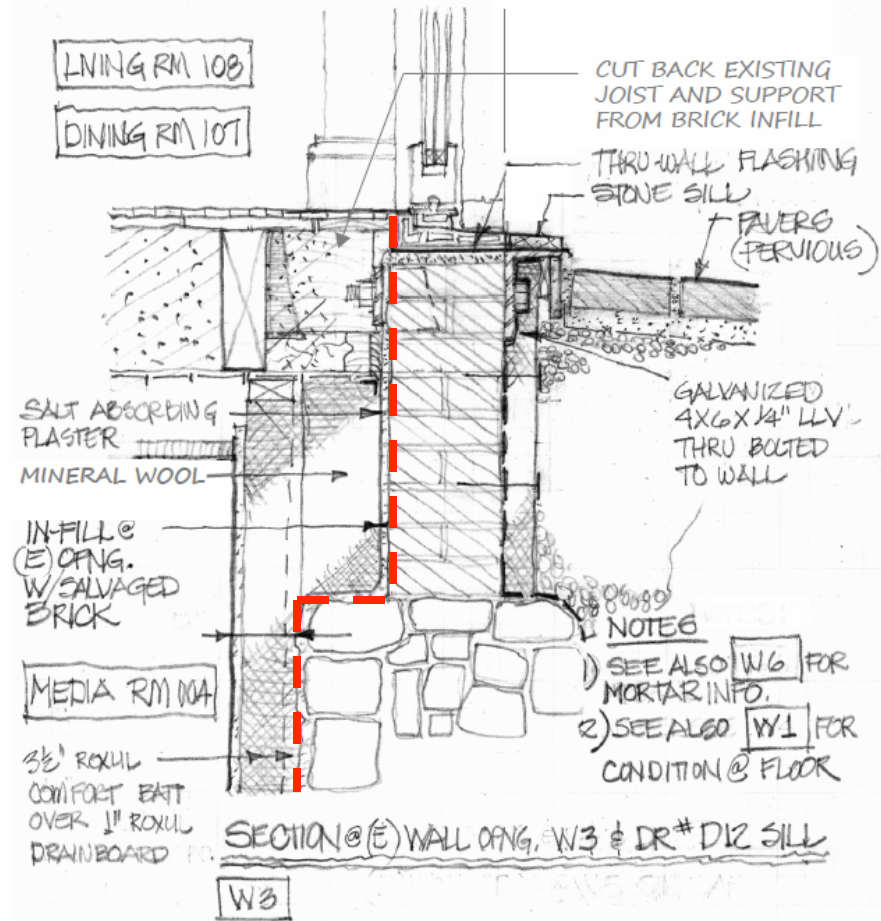
SECTION @ (E) WALL OF NG. W3 @ DR# D12 SILL
W3

NOTES
 1) SEE ALSO **W6** FOR MORTAR INFO.
 2) SEE ALSO **W1** FOR CONDITION @ FLOOR

Basement Exterior Wall

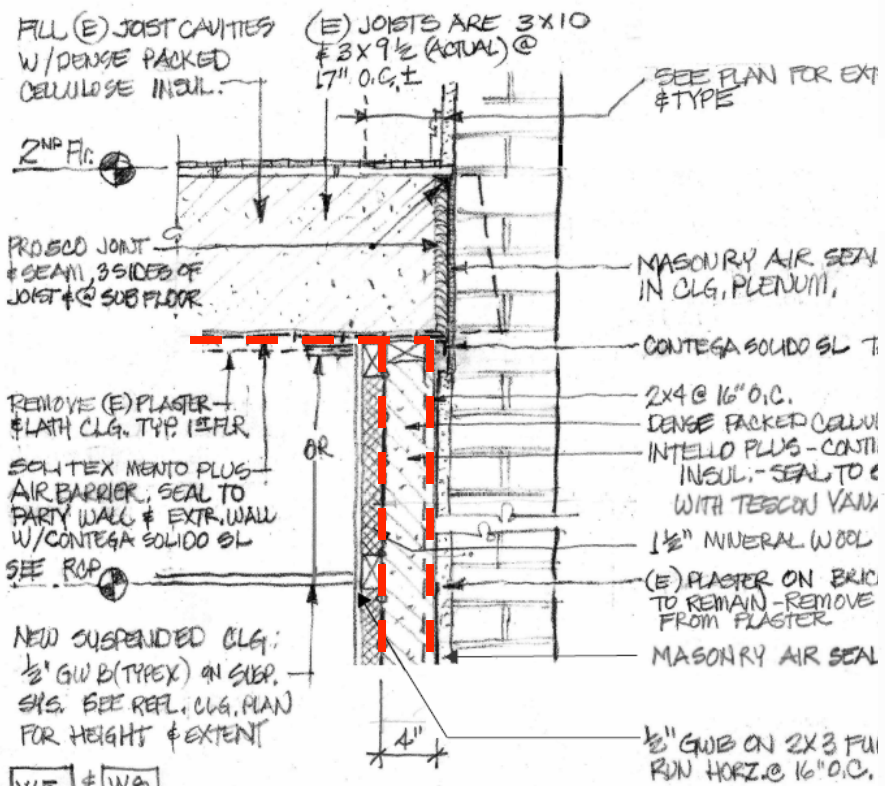
W5 # W6
1ST FLR. E.W.#S EXTERIOR WALL

NOTE 1) NEW CLG TO FORM 1 HR. FIRE SEPARATION @ 1ST FLR. CLG.

Unit 1 Ceiling

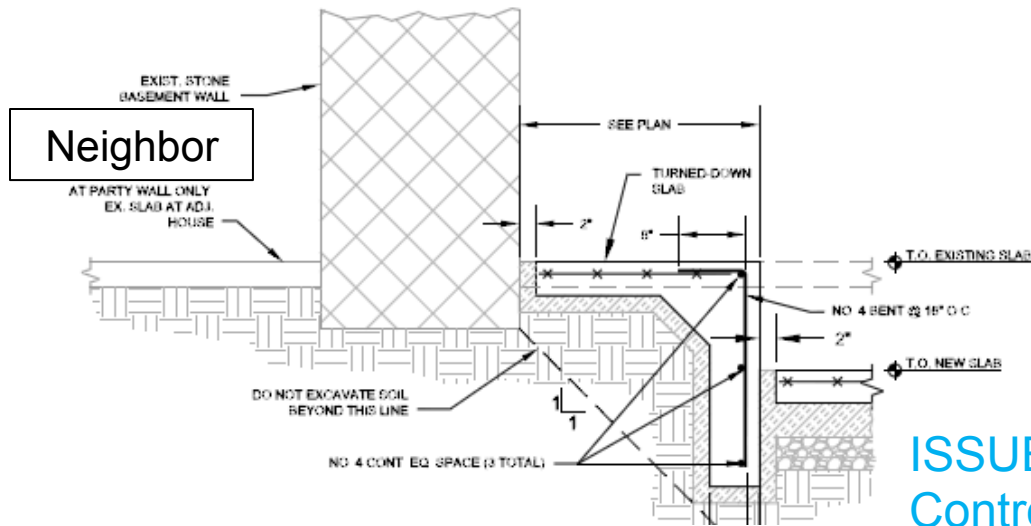
Turned Down Slab

ISSUE:
Control Rising Damp

1. Admixture in concrete
2. Admixture in dry pack
3. Surface applied water proofing

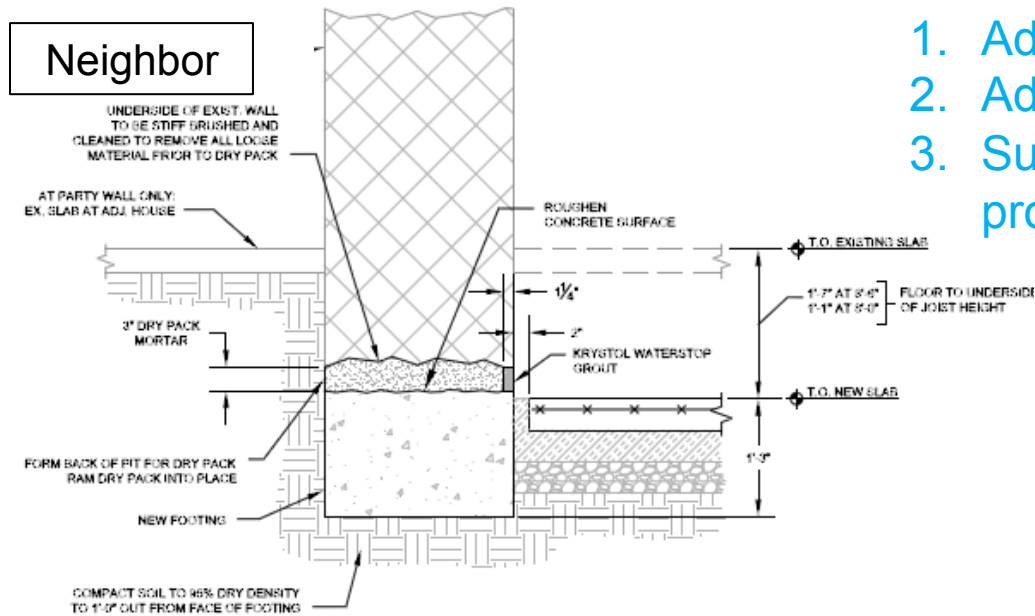
Underpinned Party Wall

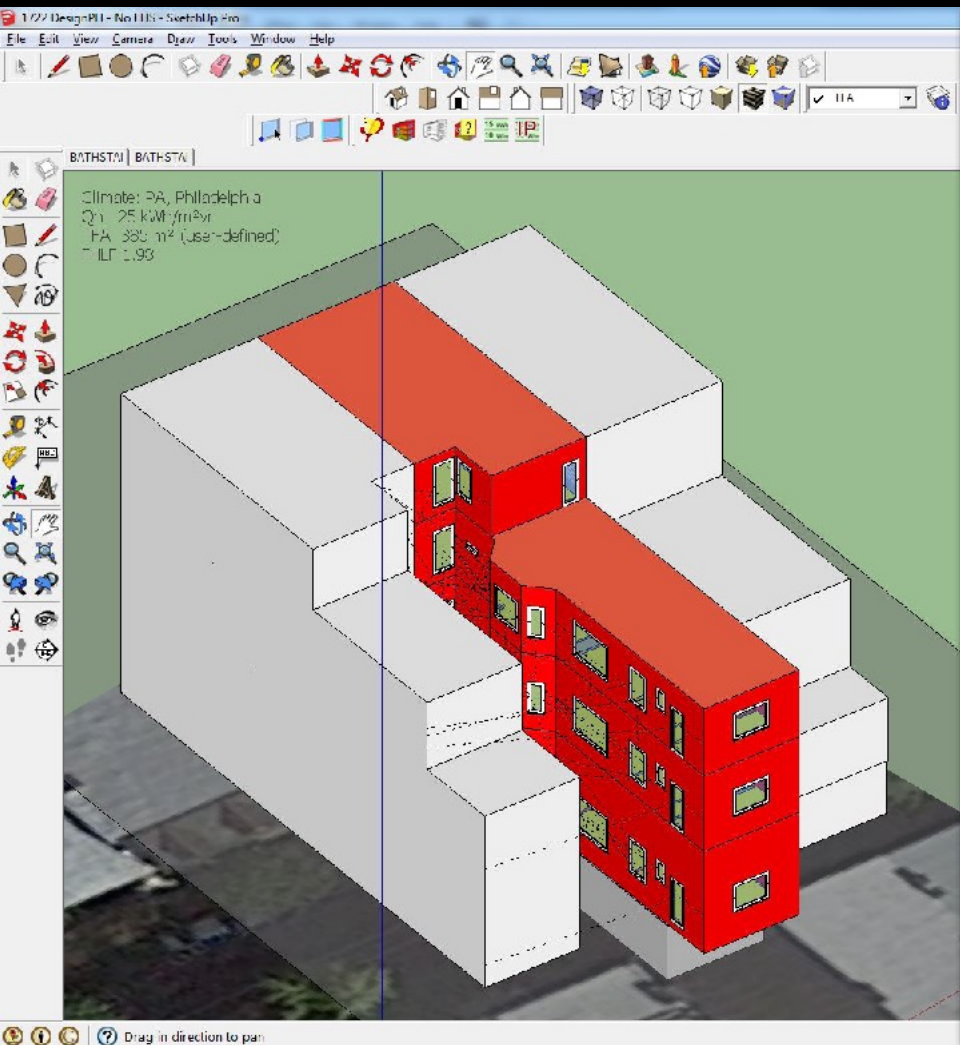
DesignPH Results

Total heat losses (kWh/a)	Total free heat gains (kWh/a)	Utilisation factor	Treated Floor Area (m²)	Ann. Heat Demand (kWh/a)	Specific Ann. Heat Demand, Q_h (kWh/m²a)
24825.60	7825.21	1.00	384.51	17011.04	44.26

Total Heat Loss Area (m²)	Area Weighted U-value (W/m²K)	Air Temp. Factor	Ann. Htg. Degree Hours (kWh)	Transmission Heat Loss (kWh/a)	Q_t (kWh/m²a)
761.00	0.41	1.00	7020	21852.60	56.31

Treated Floor Area (m²)	Ventilation volume (m³)	1 lit. air exchange rate	Heat capacity of air	Ann. Htg. Degree Hours (kWh)	Ventilation heat loss (kWh/a)	Q_v (kWh/m²a)
384.51	951.27	0.14	0.33	70.20	3073.08	7.99

Group nr.	Area Group	Win. area (m²)	Glazing area (m²)	g-value	Reduction factor	Radiation, G_s	Solar heat gain (kWh/a)	Q_s (kWh/m²a)
2	North Windows	24.05	14.85	0.50	0.37	114.41	510.57	1.33
3	East Windows	0.00	0.00				0.00	0.00
4	South Windows	18.90	10.73	0.50	0.38	570.81	1884.26	4.90
5	West Windows	37.82	24.19	0.50	0.30	251.23	2034.41	5.29
6	Horizontal Windows	0.00	0.00				0.00	0.00
		76.77	49.76				4479.24	11.57

Treated Floor Area (m²)	Internal heat gain rate (W/m²)	Heating period (days/a)	Heating period (kWh)	Internal heat gain (kWh/a)	Q_i (kWh/m²a)
384.51	2.10	160.40	4.33	1648.00	4.29

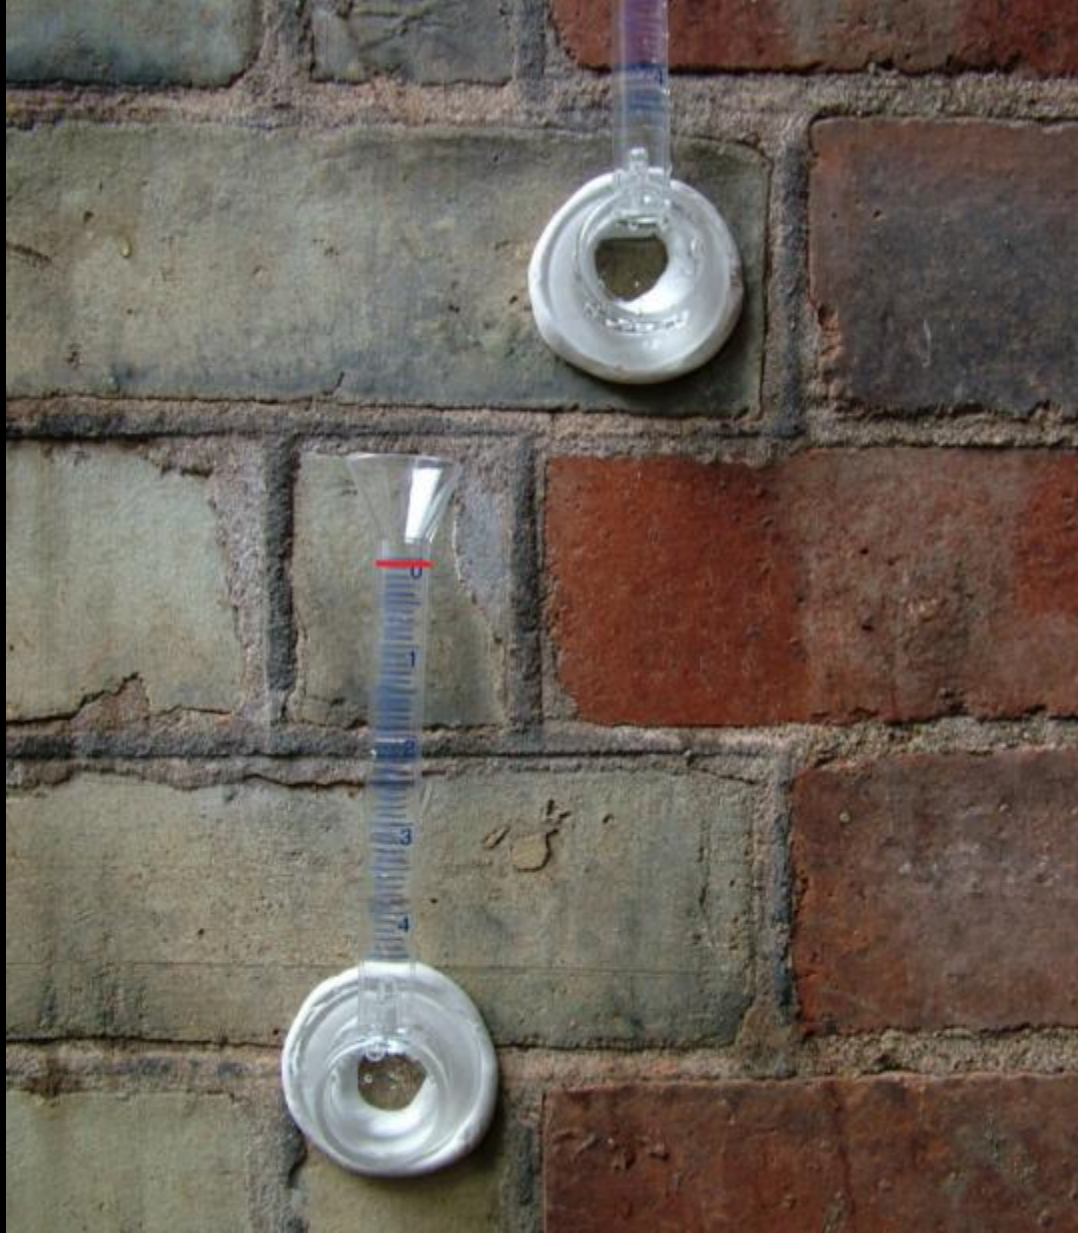
RILEM moisture absorption test

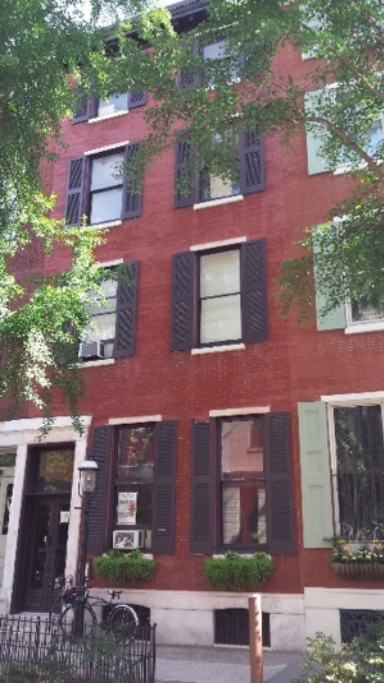
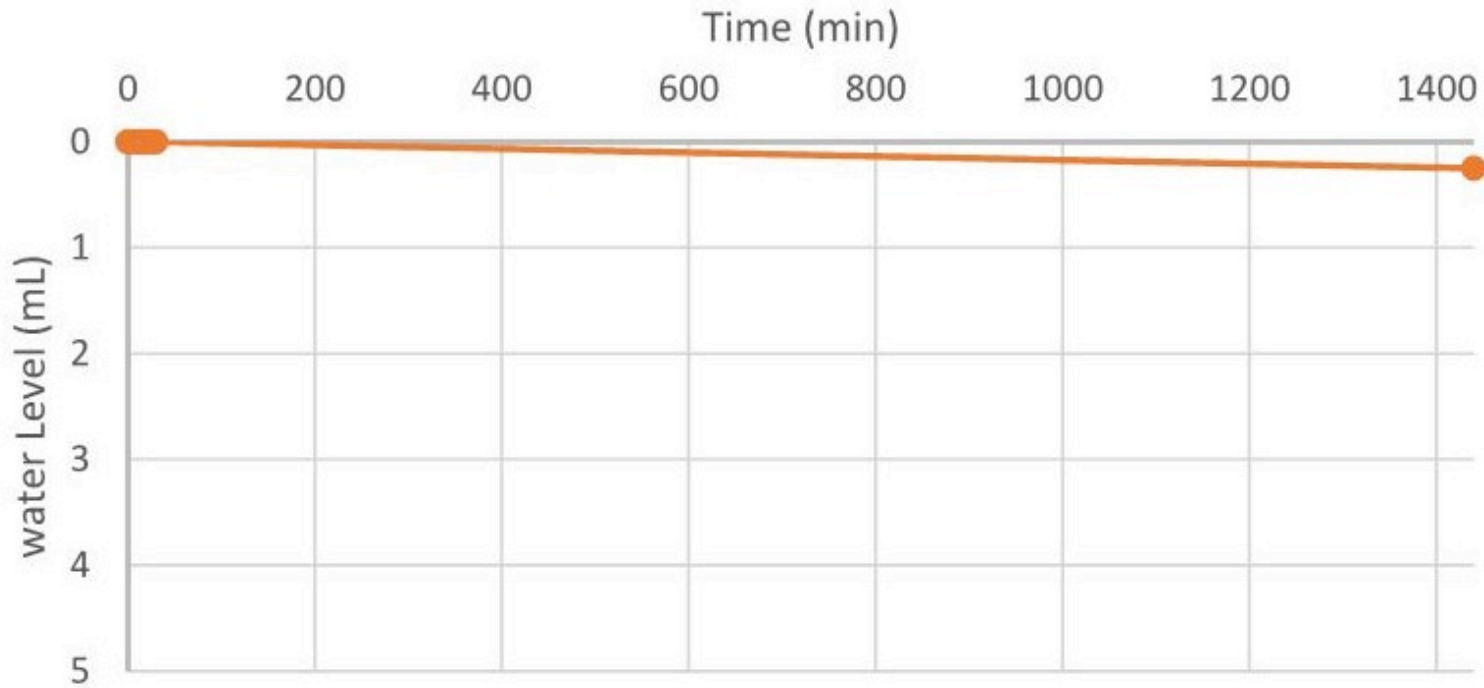
Rilem Tube Moisture Absorption Test – Pine Street
Result - Low Absorption Rate

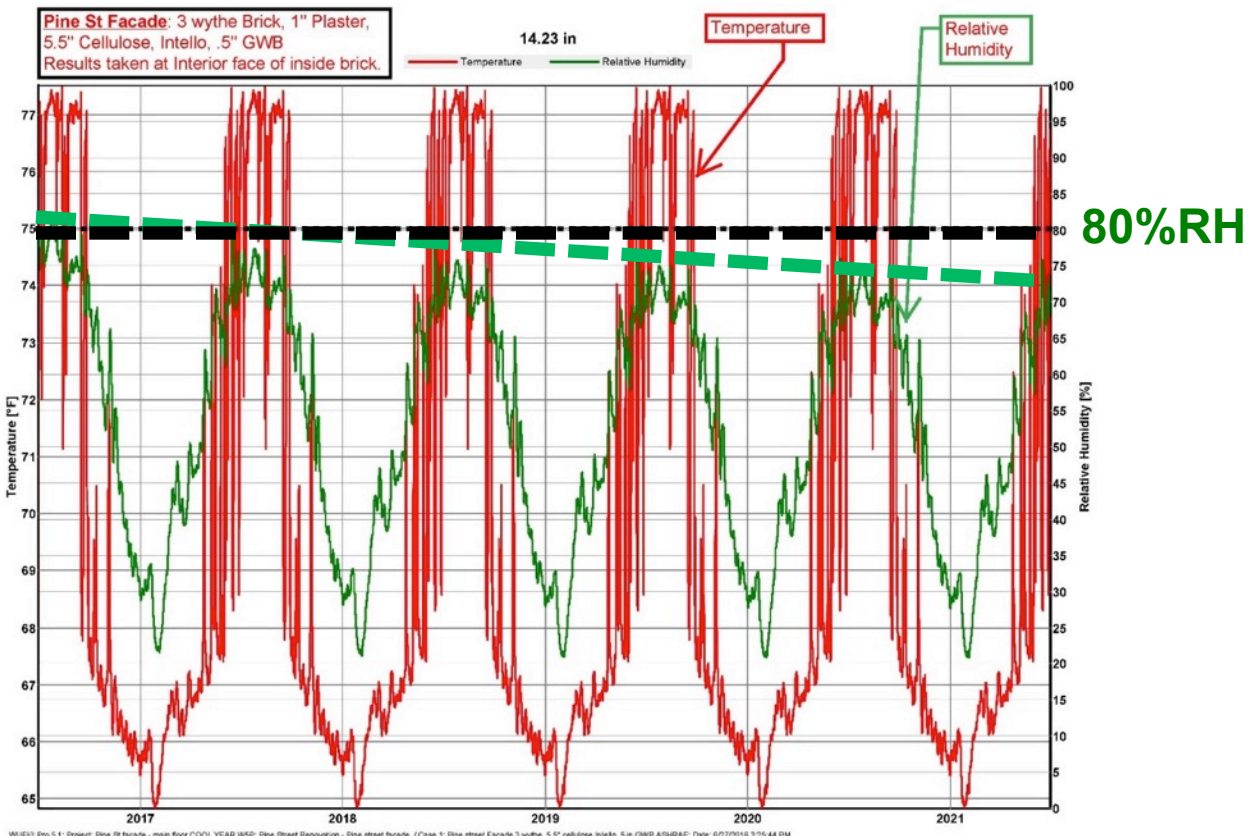
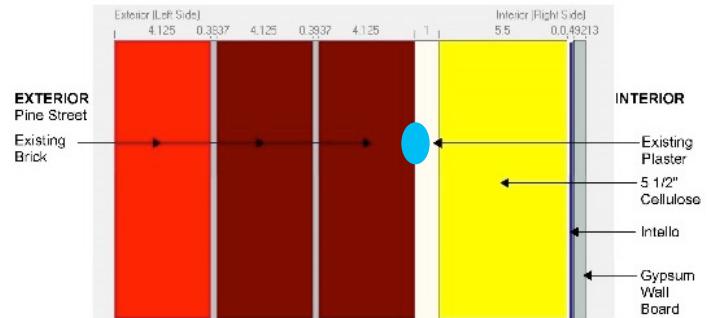
Add 5.5" Cellulose with Smart Vapor Control (R19)

Acceptable Mold Risk

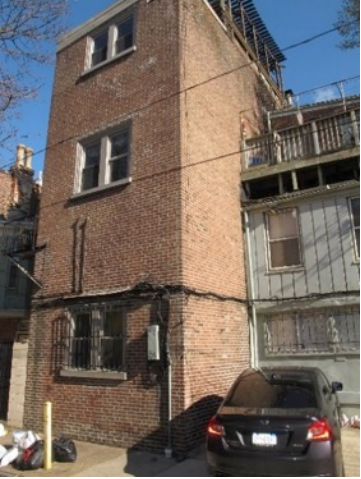
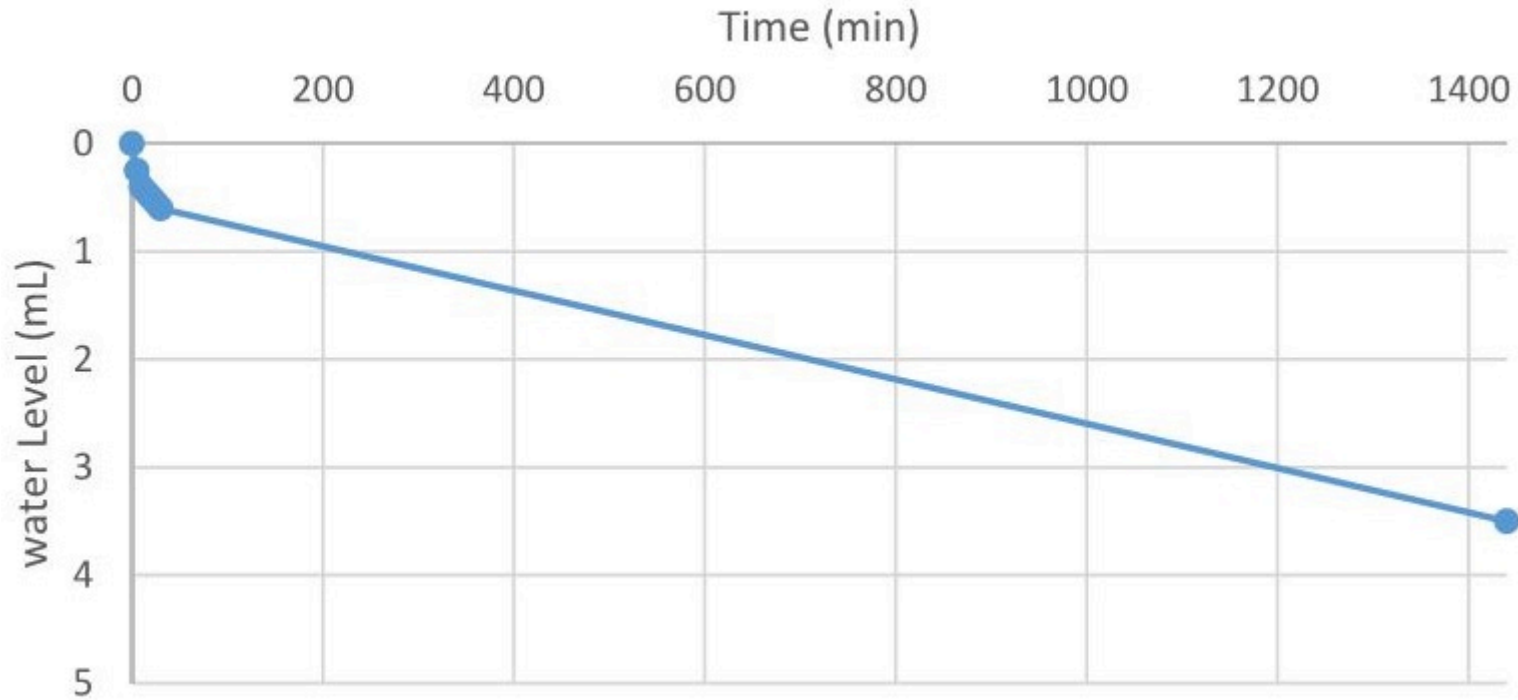
Rilem Tube Moisture Absorption Test – Waverly Street
Result - High Absorption Rate

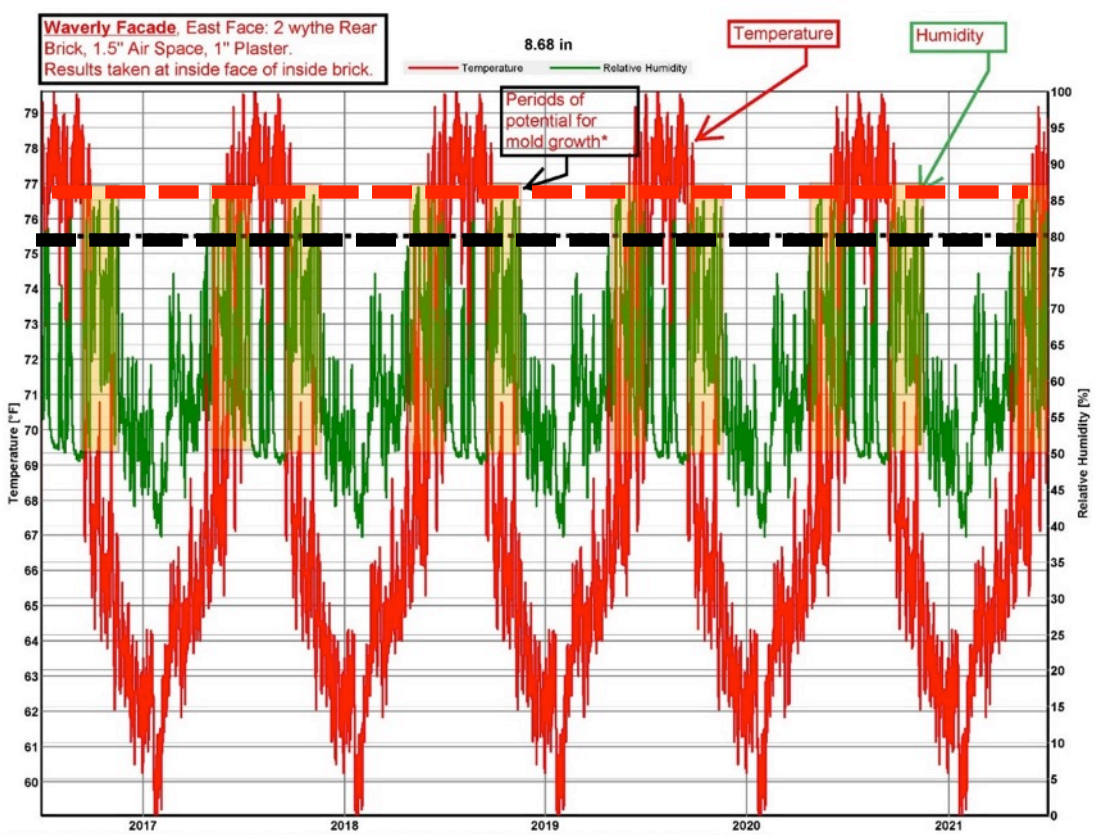
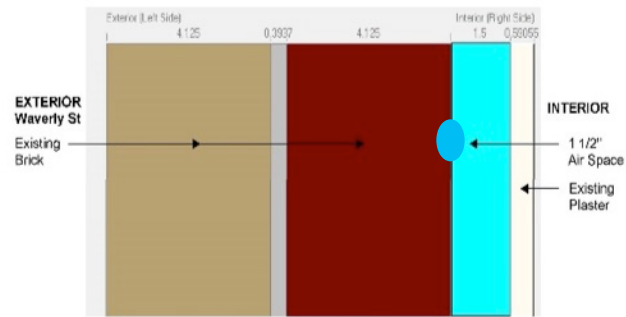
Existing Conditions
Unacceptable Mold Risk

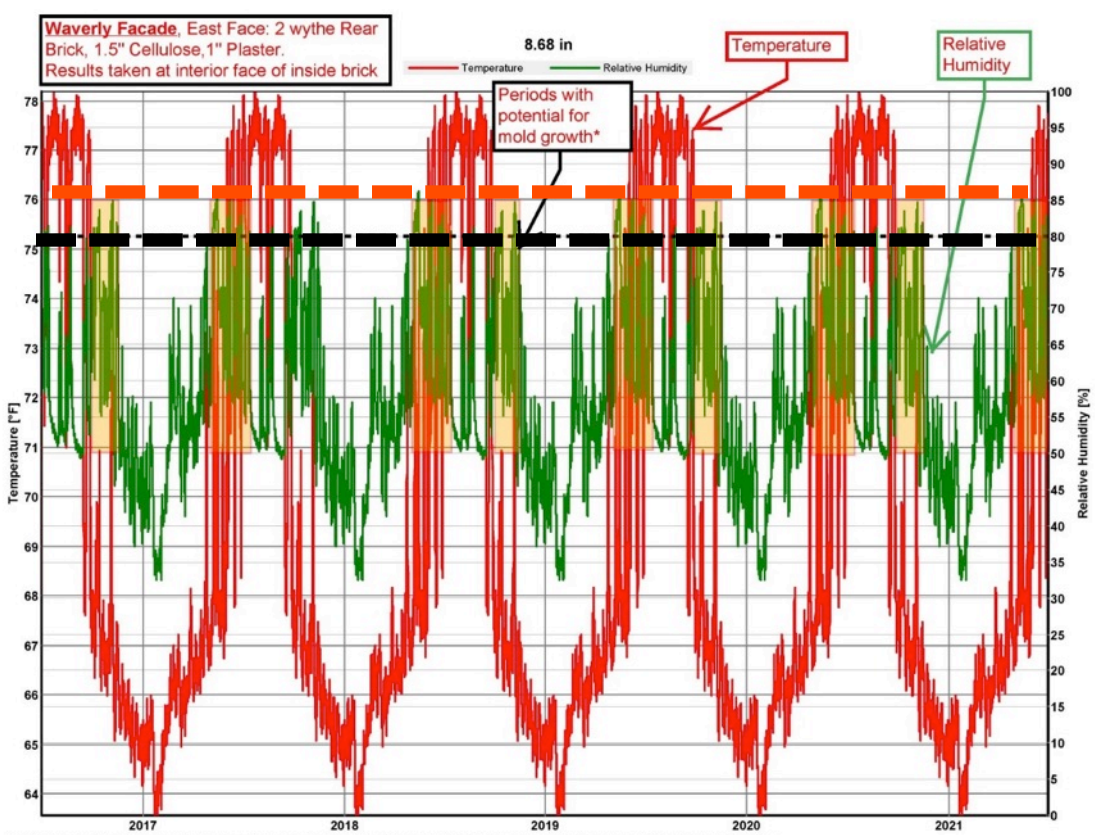
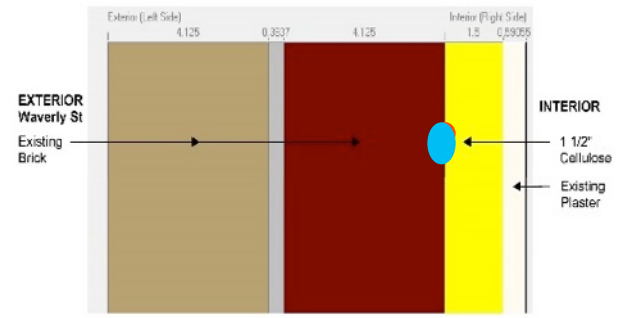
WUFI Pro 5.1; Project: Pine St facade - main floor SEAW walls poor brick WSP; Pine Street Renovation - Pine street facade; / Case 1: 2 wythe rear brick 1.5" cells 1 in plaster ASHRAE160P; Date: 6/27/2016 2:32:14 PM

1.5" Cellulose in Existing Wall Cavity
 Unacceptable Mold Risk

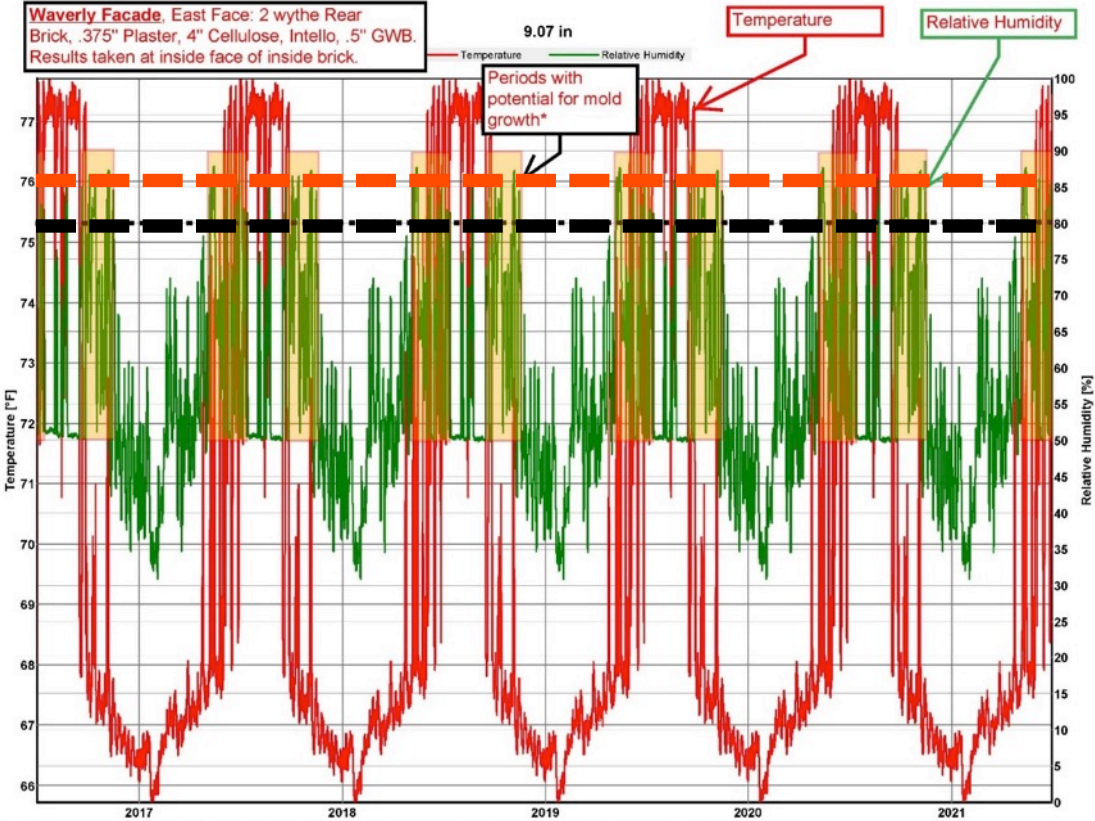
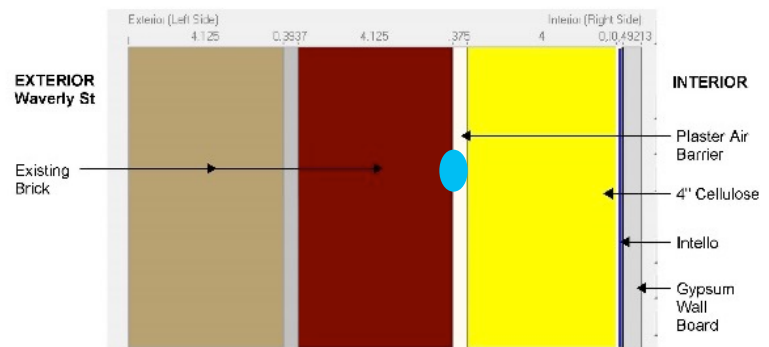
* over 50F and 80% RH

New 4" cellulose, smart air vapor barrier

Unacceptable Mold Risk

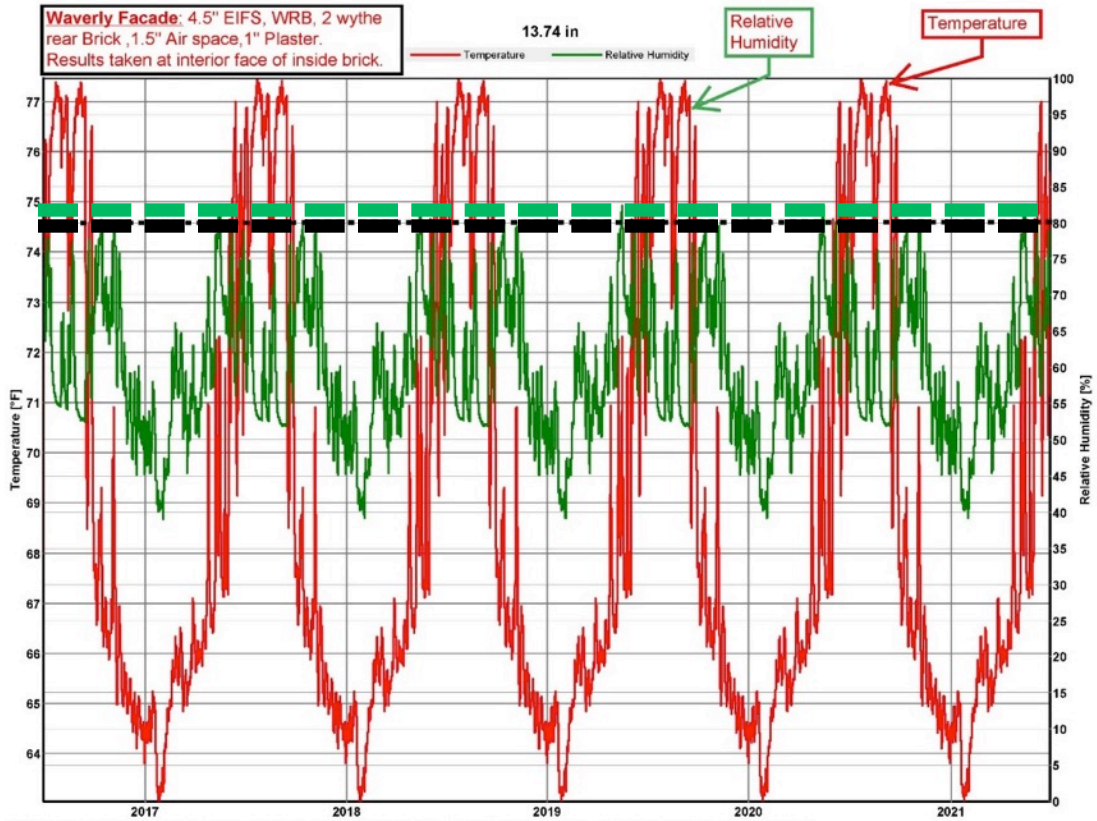
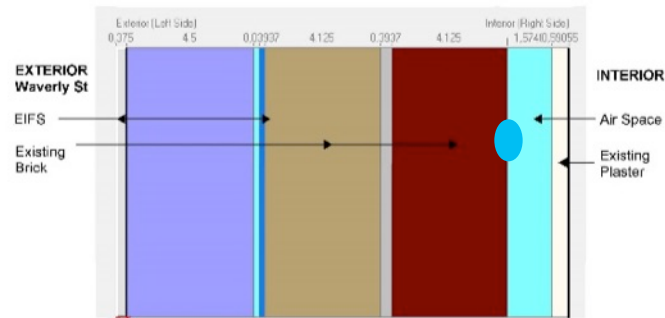
EIFS with Drainage Plane, 4" EPS
Acceptable Mold Risk
