1722 PINE STREET: FROM MAZE TO MATRIX

1722 PINE STREET PHILADELPHIA PA
4 story, 4 unit rowhouse, built 1845
Brick front and rear

1722 PINE STREET RENOVATION PROJECT GOALS

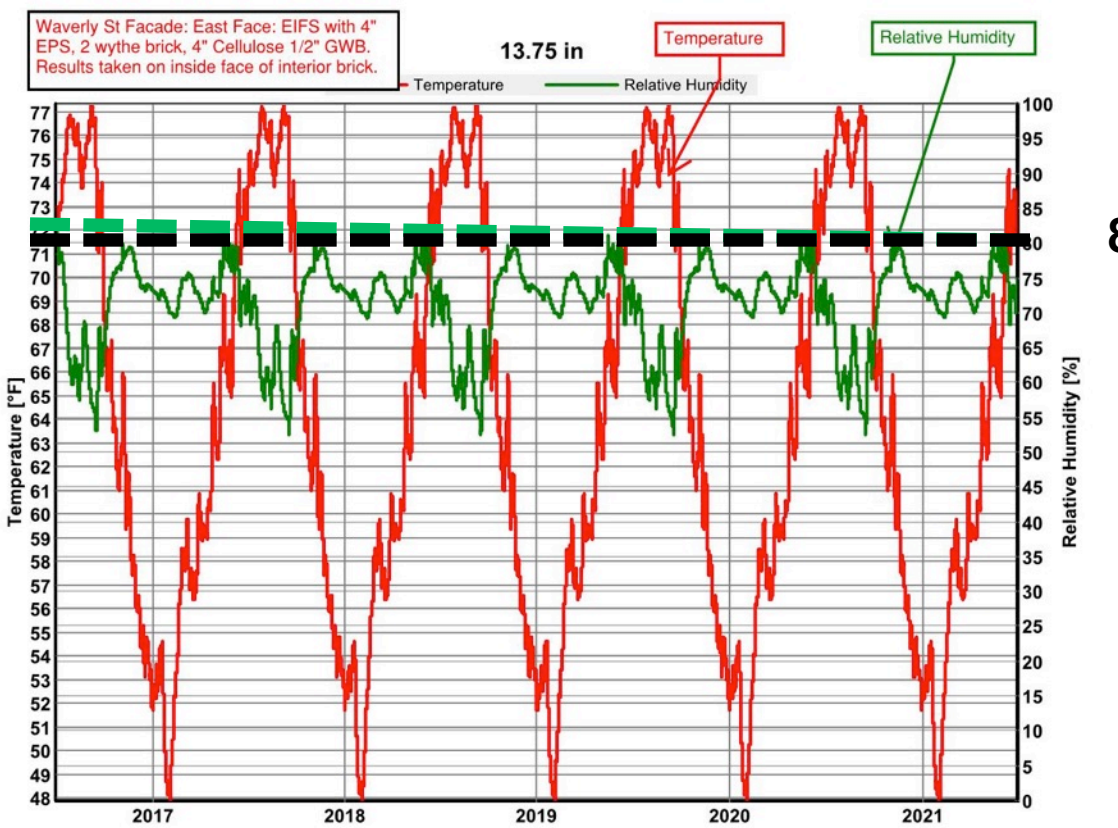
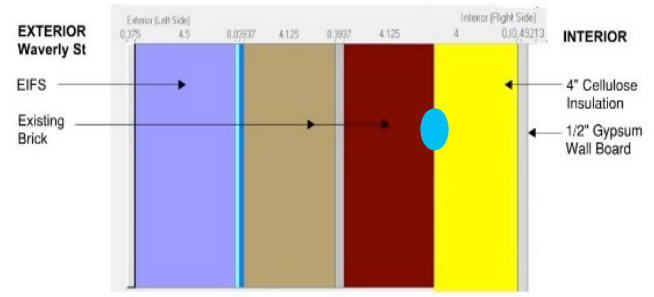
80%RH

WUFI® Pro 5.1; Project: Waverly St East facade - main floor SE&W walls poor brick.WSP: Pine Street Renovation - Pine street facade, / Case 6: EIFI & WRB 2 wyth rear brick 4" Cellulose NO Intello .5 in GWB; Date: 6

EIFS with 4" EPS + 4" Cellulose
Acceptable Mold Risk
