# FOUR COMPLETED COMMERCIAL PASSIVE BUILDING PROJECTS — LESSONS LEARNED

Presented by Adam J. Cohen, Architect, CPHC NA & EU, LEED AP

The First US public school building built to Passivhaus Standards

The First US assembly building built to Passivhaus Standards

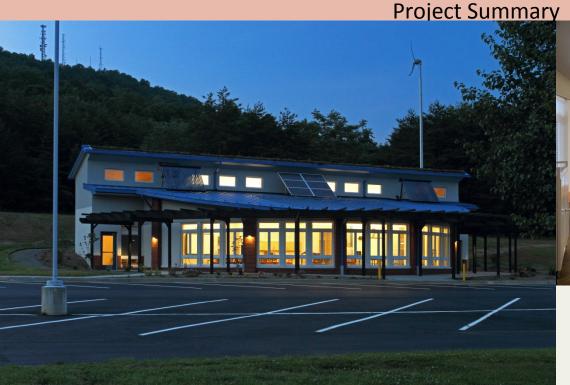
Size: 3,600 GSF ~ 3,053 TFA

Construction: 5B, non-sprinkled

Final air test: 0.59 ACH<sub>50</sub>

Modeled heat demand: 3.69 kBTU/(ft²yr) (TFA)

Modeled Specific Primary Energy Demand: 32.2 kBTU/(ft2yr) (TFA)

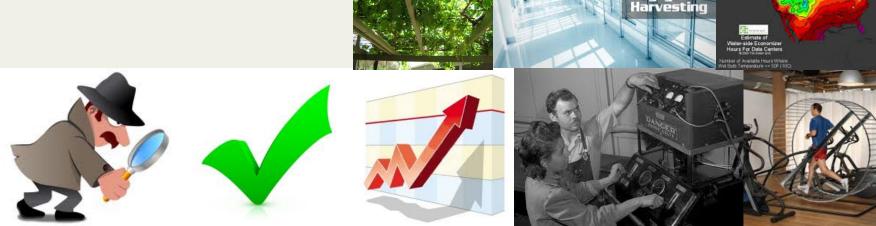
#### **Energy Sleuth**

- After the first year, the school administration doubled the number of classes in the building.
- When the PHPP was adjusted for the new occupancy periods, it was very close to the actual increase of approximately 100 kWh per month in energy for the first three months of occupancy.
- Over the course of the following six months, though, we observed a steady increase in the energy usage.
- When examined through remote energy observation, we saw that the building's systems including ERV control and lighting control were not operating as designed.
- The ERV was designed to be off when non-occupied and come on for a flush out 1 hour prior to occupancy. The energy readings showed that the ERV was running continuously.

• The summer economizer function was operating in the fall and winter.

The daylight harvesting controls were not operating as designed.

The shading system was not in use during the summer.

- When we investigated at the site, we found that at some point, the building power had been lost and no one had reset the timers on the ERV system.
- The economizer function which was to be manually engaged at the start of the cooling season and manually disengaged when the season was over was never disengaged.

- It was through the remote monitoring system that we were able to detect the problems, but the causes of the issues required site investigation.
- We recommended in November 2012 that the administration re-commission the building, as was recommended in the O&M manual and retrain the new occupants.

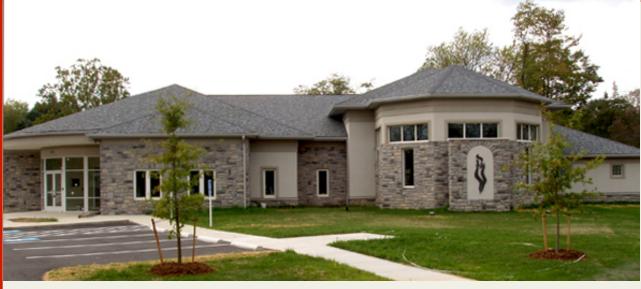
Location: Blacksburg, Virginia Client: Hillel @ Virginia Tech

- Light timber construction
- Complex usage pattern
- Significantly different zoning requirements
- Two commercial kitchen exhaust hoods
- Mixed humid climate
- Restricted budget of a nonprofit organization
- Slab R 17.8
- Wall (Stone) R 40.6
- Wall (EIFS) R 46.7
- Ceiling R 67.0
- Window Average R 6.5, SHGC 0.6

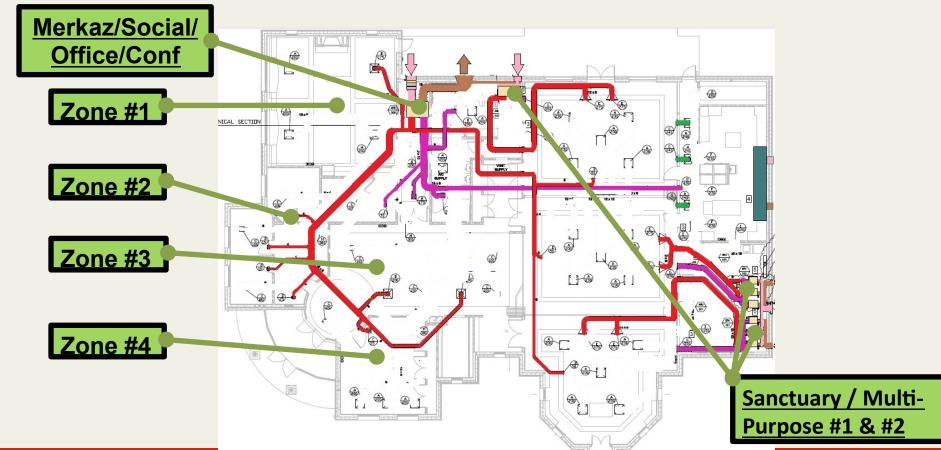
Ventilation Learning Opportunities – THE CONCEPT

- Initially designed three single zone demand control systems (CO2 based)
- A Single four zone demand control system that would be maintained through static duct pressure.

- In practice we found getting this instrumentation correct proved very difficult.
- Because we had four zones each with a multi-point damper, there was in essence an almost unlimited series of damper combination settings and we found after many attempts to reprogram the control algorithms, that we were unable to find a group of settings that would not end up with a "hang up" point.
- We reverted to a simpler proportional control of the ERV ECM motor. This system while not as elegant as a static pressure controlled system does the job very well and is simple to design and install.

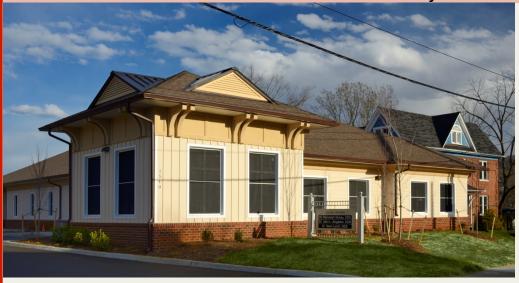
Location: Roanoke, Virginia Client: Drs. Lynch, Dickey and Singleton

- Light timber construction
- Simple usage pattern
- Significant thermal comfort requirements
- Mixed humid climate
- Slab R 18.0
- Wall (Brick) R 37.3
- Wall (Siding) R 36.5
- Wall (EIFS) R 42.4
- Ceiling R 66.3
- Window Average R 6.8, SHGC 0.6
  - Glass Block Assem. R 4.9, SHGC 0.66

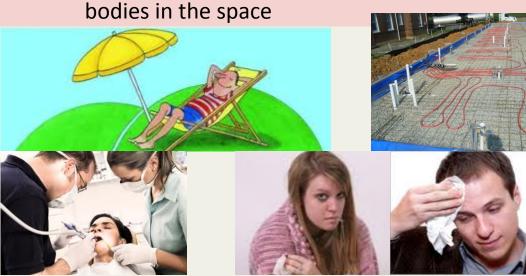
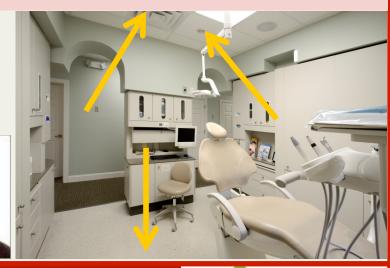
#### **#1 Focus THERMAL COMFORT**

- One consistent area of concern in all clinics is the thermal comfort of the doctor and patient
- Doctors generally complain of being too hot and often patients complain of being too cold
- When one has a dental procedure, one typically has a nervous patient, a working doctor, an
  assistant and a dental light. When calculating the heat load in the small work area it
  becomes clear that the heat generated by the people and light is significant
- Three Pronged Strategy:
  - Preconditioned fresh air along the ceiling of each operatory space at a very low velocity
  - Separate low velocity forced air conditioning system directed behind the dental chair

100 ft2 passive cooling loops around each dental chair to take radiant heat from the

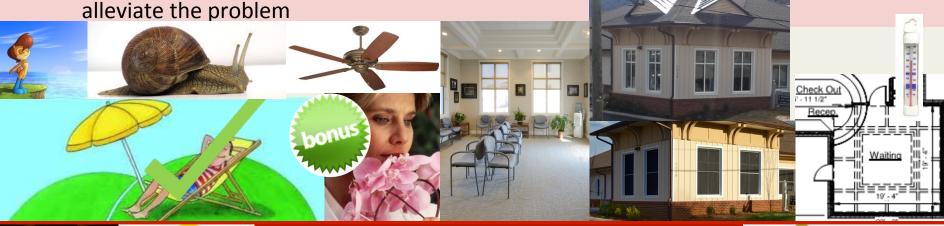
Results – Intended and Unintended

- The doctors report that the operatory thermal comfort is exceptional
- The doctors report that the fresh air exchange has eliminated the "dental clinic smell"
- The waiting room was overheating in the summer
  - West facing reception room rose as high as 76°F, well above the 72°F set point
  - The 80% reduction solar screens that we designed for the glazing in the waiting room were not being used
    - The doctors said that they did not like the look of the screens
  - Good amount of fresh air supply to this space (60 CFM)
    - The very low velocity the warm air felt stagnant
  - The ceiling in this area is 14 ft. while the balance of the space is 9 ft.

A ceiling fan was installed in the waiting room which sufficiently mixed the air to

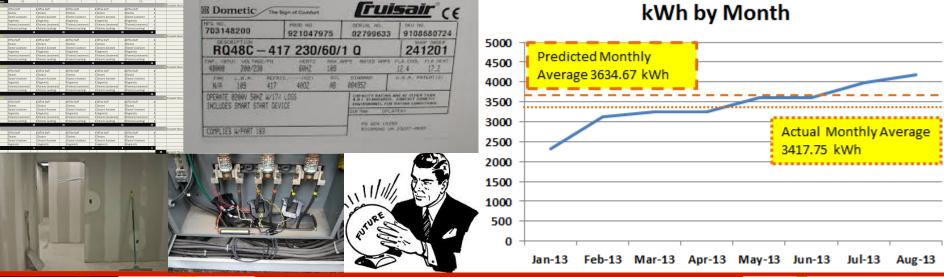
#### Energy

- Building energy use is approximately 5% 10% below predicted
- Expected results, as 3 of the 14 operatories were left unfinished with the anticipation of adding a fourth partner in the future.
- Fairly easy building to predict the energy use
  - Existing practice and we were able to set up energy monitoring on the existing dental equipment prior to running our models.
  - Did not have to depend on the plate rated energy usage of the equipment for our models.
  - Very consistent occupant usage

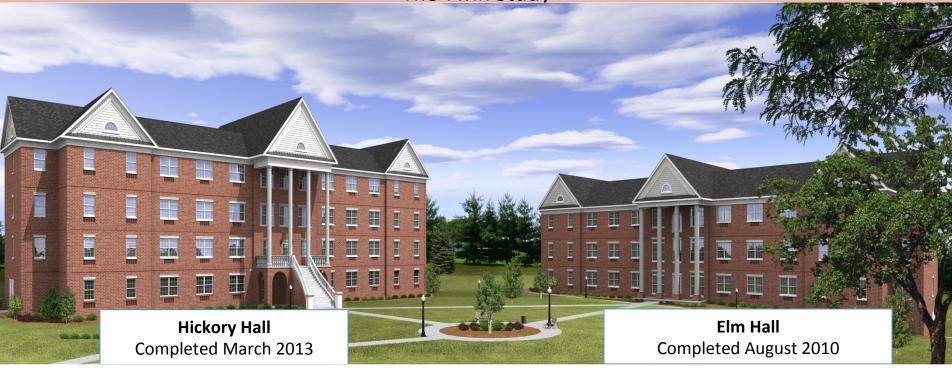
The Twin Study

- 40,000 sq ft
- 117 beds
- Modular wooden construction (3 floors)
- Full concrete basement
- Passivhaus & LEED

- 36,000 sq ft
- 116 beds
- Modular wooden construction (3 floors)
- Partial CMU basement (balance crawl space)
- LEED

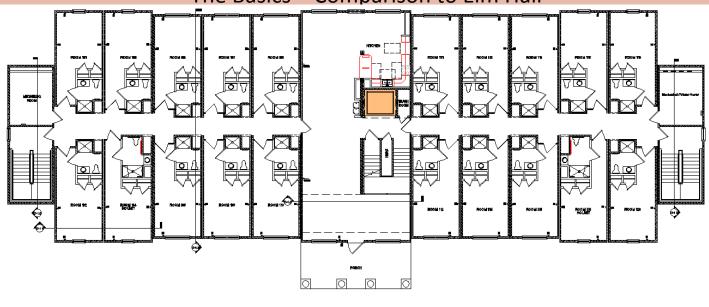
#### The Basics – Comparison to Elm Hall

System	Elm Hall	Hickory Hall
Ventilation	Raw Outside Air	Passivhaus Compliant ERVs
HVAC System	PTAC & Ducted Heat Pumps	Integrated Hydronic Geothermal System with Fan Coil Units
Design Heating Load	570,000 BTU/Hr	50,000 BTU/Hr
Installed Heating Capacity	818,430 BTU/ <u>Hr</u>	142,000 BTU/Hr (includes 50% DHW load)
Design Cooling Load	32 Tons	14 Tons
Installed Cooling Capacity	68 Tons	14 Tons
Elevator	Hydraulic	Traction

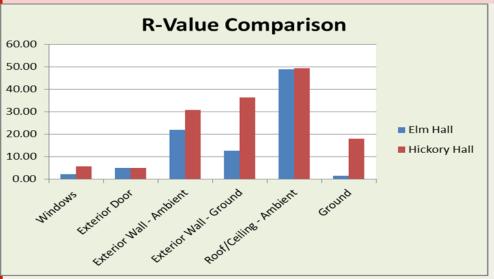
- Airtightness:
  - Hickory Hall current test .30 ACH50
  - Elm Hall measured 3.20 ACH75 (Army Corp protocol)
- Slab Added 4" termite treated EPS
- Walls:
  - Concrete Changed to insulated precast with interior insulated wire chase (2x4)
  - Walls added 2 ½" Roxul Cavity Rock exterior insulation
- Roof Added 2" cellulose
- Windows Changed to PH certified windows (25% reduction in heat demand!)

R- Value Co	mparisor	1
	Elm	Hickory
	Hall	Hall
Windows	2.28	5.66
Exterior Door	5.00	5.00
Exterior Wall -		
Ambient	21.97	30.70
Exterior Wall -		
Ground	12.56	36.45
Roof/Ceiling -		
Ambient	48.83	49.45
Ground	1.53	18.03
