# Interior Insulation of Mass Masonry Walls: A Pittsburgh-Area PH Case Study

8th Annual North American Passive  
House Conference

# McKeesport, PA YMCA Building

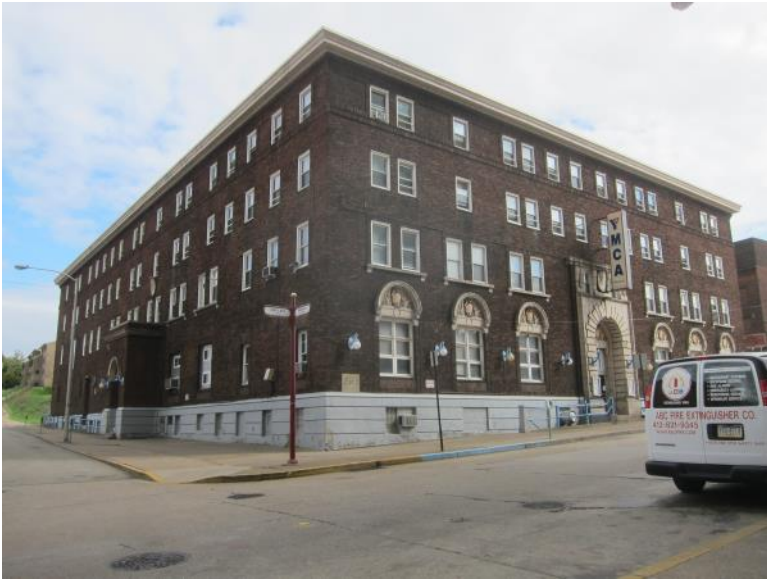
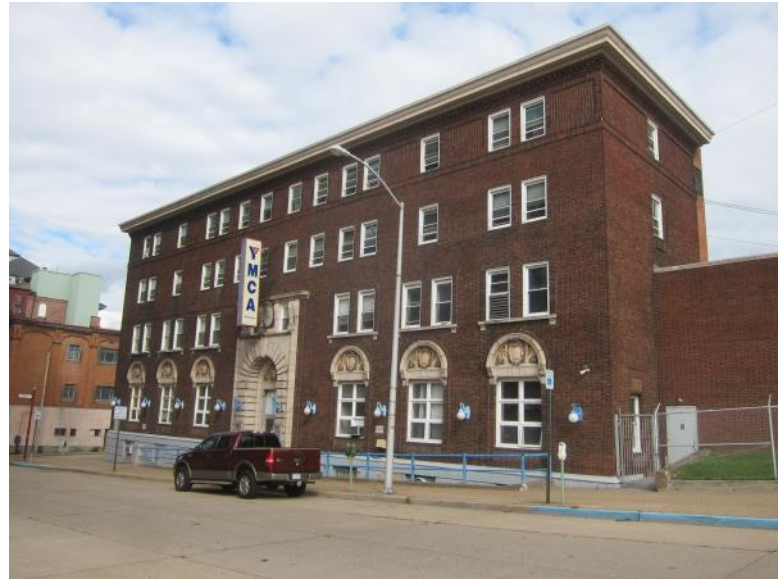
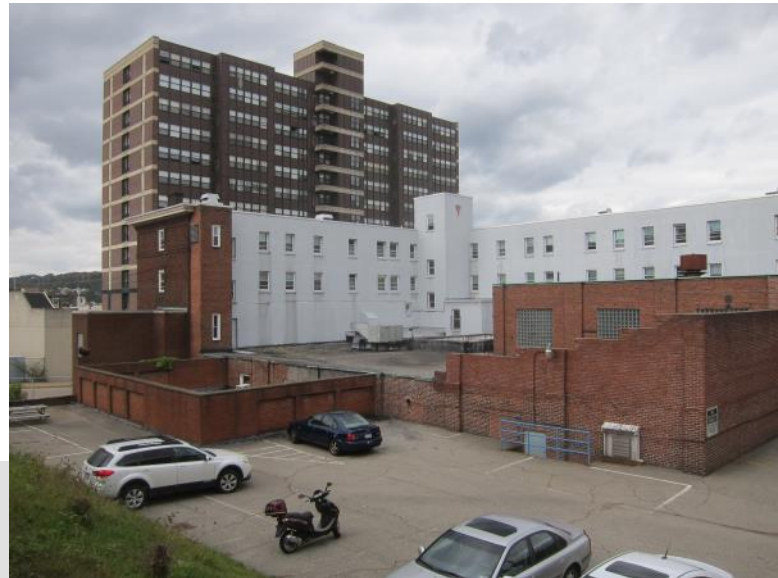
- Former YMCA building, circa 1923 construction
- Action Housing Inc. - Downtown Housing facility
- ~65,000 sf; ~75 units (rental, shelter rooms)

- Former YMCA building, circa 1923 construction
- Action Housing Inc. - Downtown Housing facility
- ~65,000 sf; ~75 units (rental, shelter rooms)
- Major energy efficiency retrofit project underway
  - PH target; occupied rehab project
- Thoughtful Balance Inc. (architecture firm)
  - Laura Nettleton, Michael Whartnaby
- BSC acting as sub-consultant
  - Masonry interior insulation retrofit; other energy issues

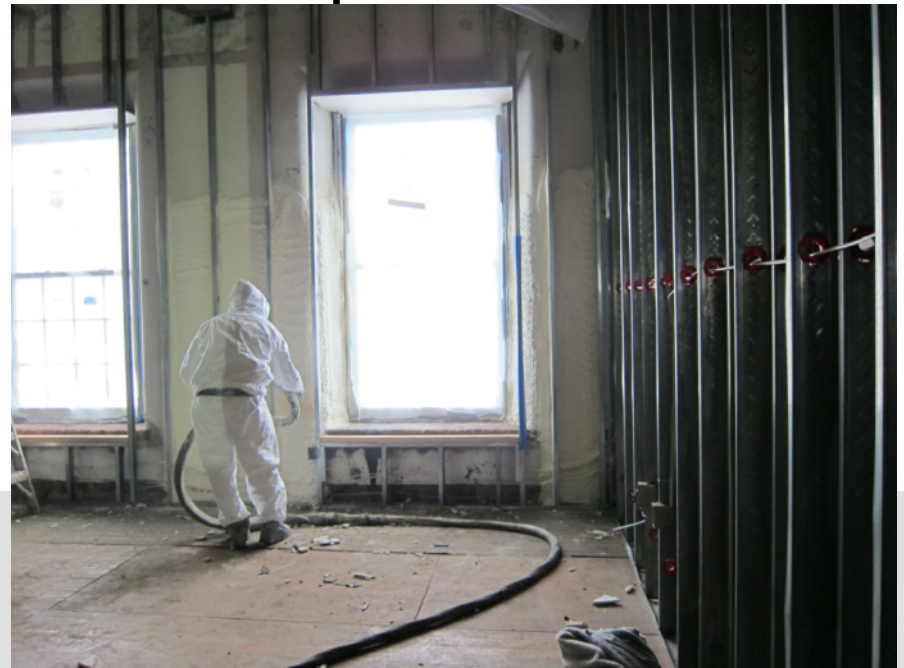
# Recommended Approaches

- Spray foam against masonry
- Open cell (0.5 PCF)? Closed cell (2.0 PCF)? Intermediate (1.0 PCF)?
- Air seal at joist pockets
- Montreal experience

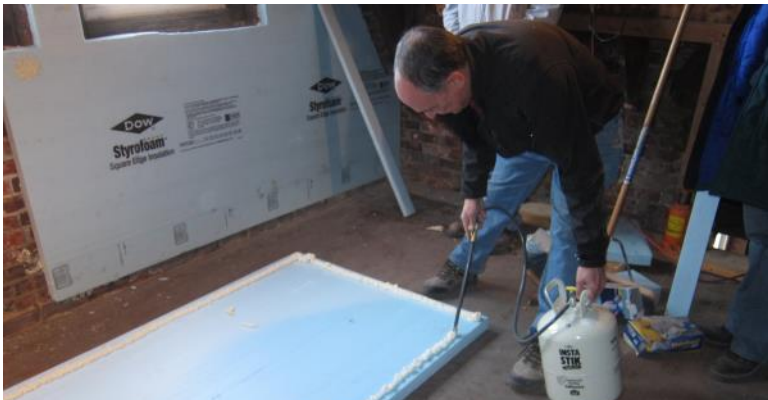
- Rigid board foams, adhered to wall—air barrier
- Expanded polystyrene/EPS (non-GWP foam)

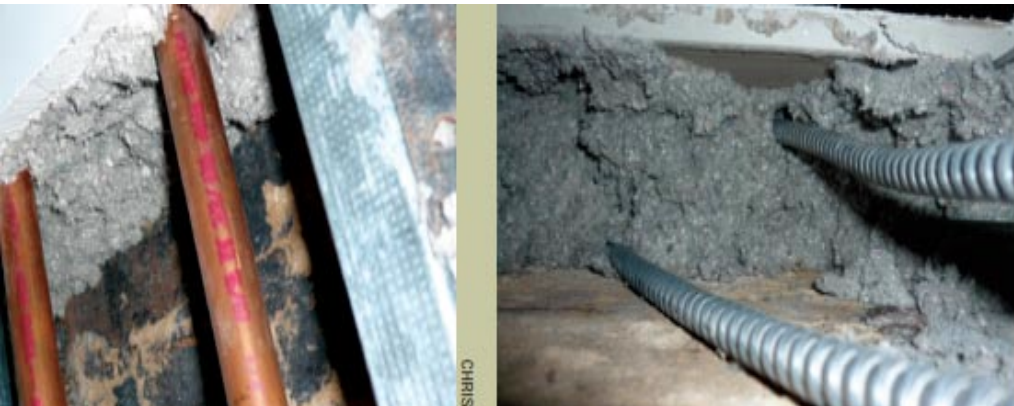
# Non-Foam Options?

- Dense pack cellulose against brick
- High-density mineral fiber/glass fiber & variable permeability vapor retarder
- Requires meticulous workmanship/air barrier—air barrier outboard of framing & services

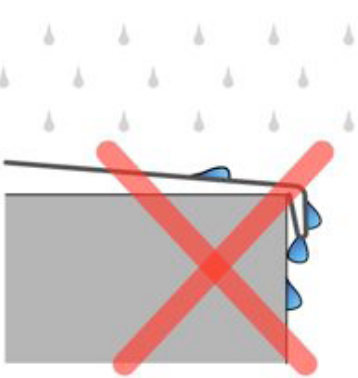
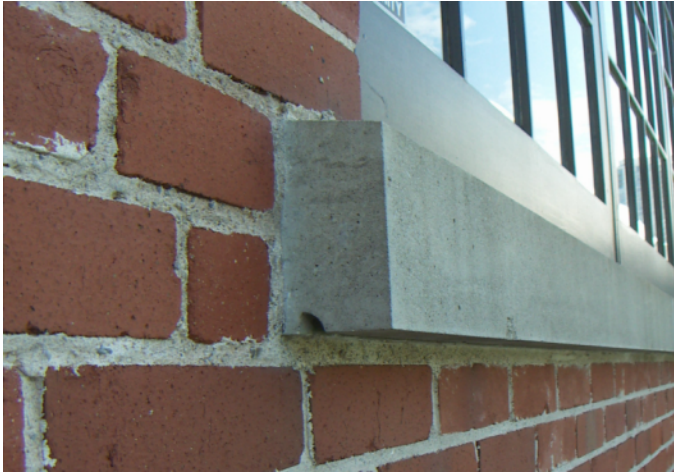
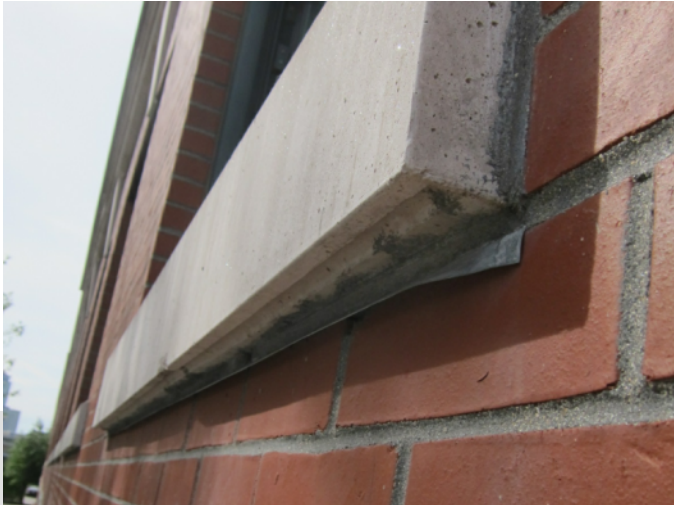
# Drip Edges

- Minimum projection of drip edge

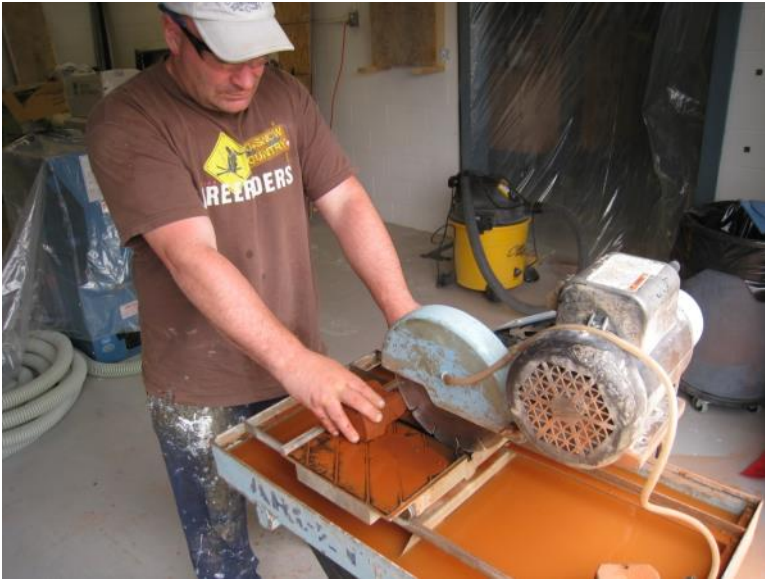
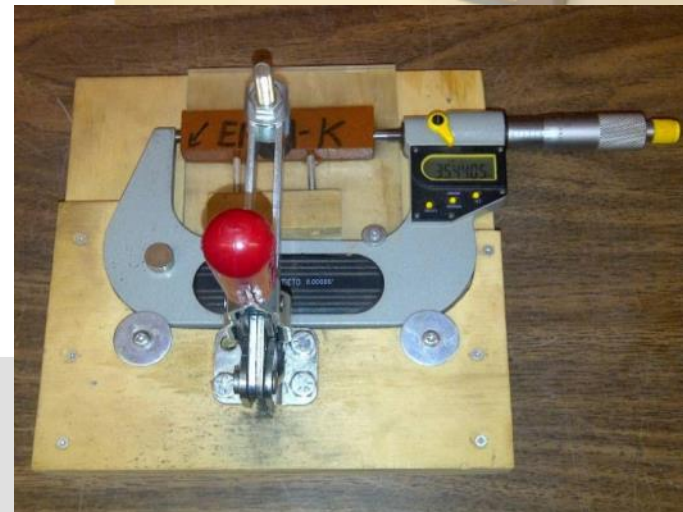
# Laboratory Measurement of $S_{crit}$

- Critical Degree of Saturation ( $S_{crit}$ )
  - European research on stone and masonry
  - Below this moisture content: no damage w. F/T
  - Above this moisture content: damage occurs quickly
- Cut brick samples; measurements
- Vacuum saturate to range of moisture contents
- Subject to freeze-thaw cycles
- Measure dilation (growth) of samples (very small!)
- “Hook” in graph signifies  $S_{crit}$

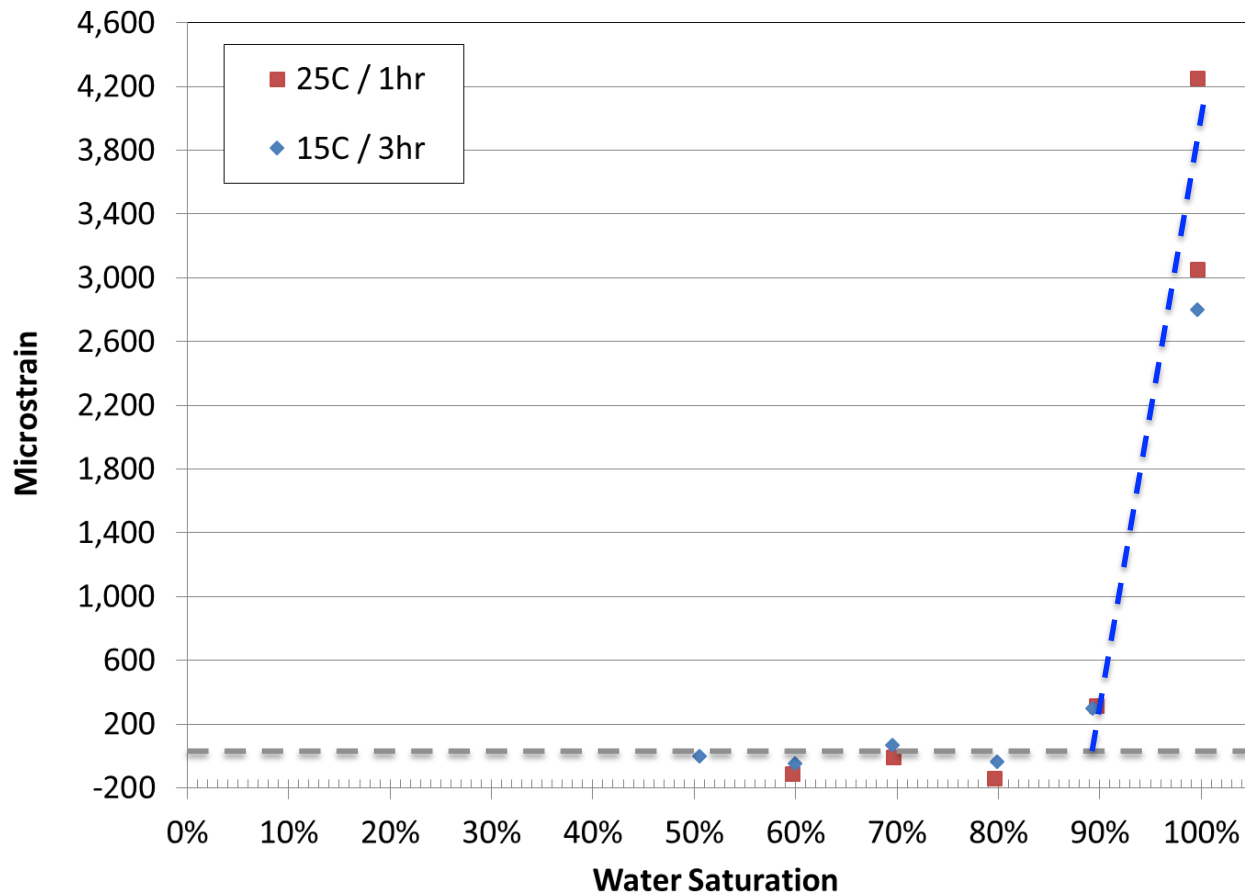
# Dilation (Growth) of Samples

- “Hook” in graph signifies  $S_{crit}$

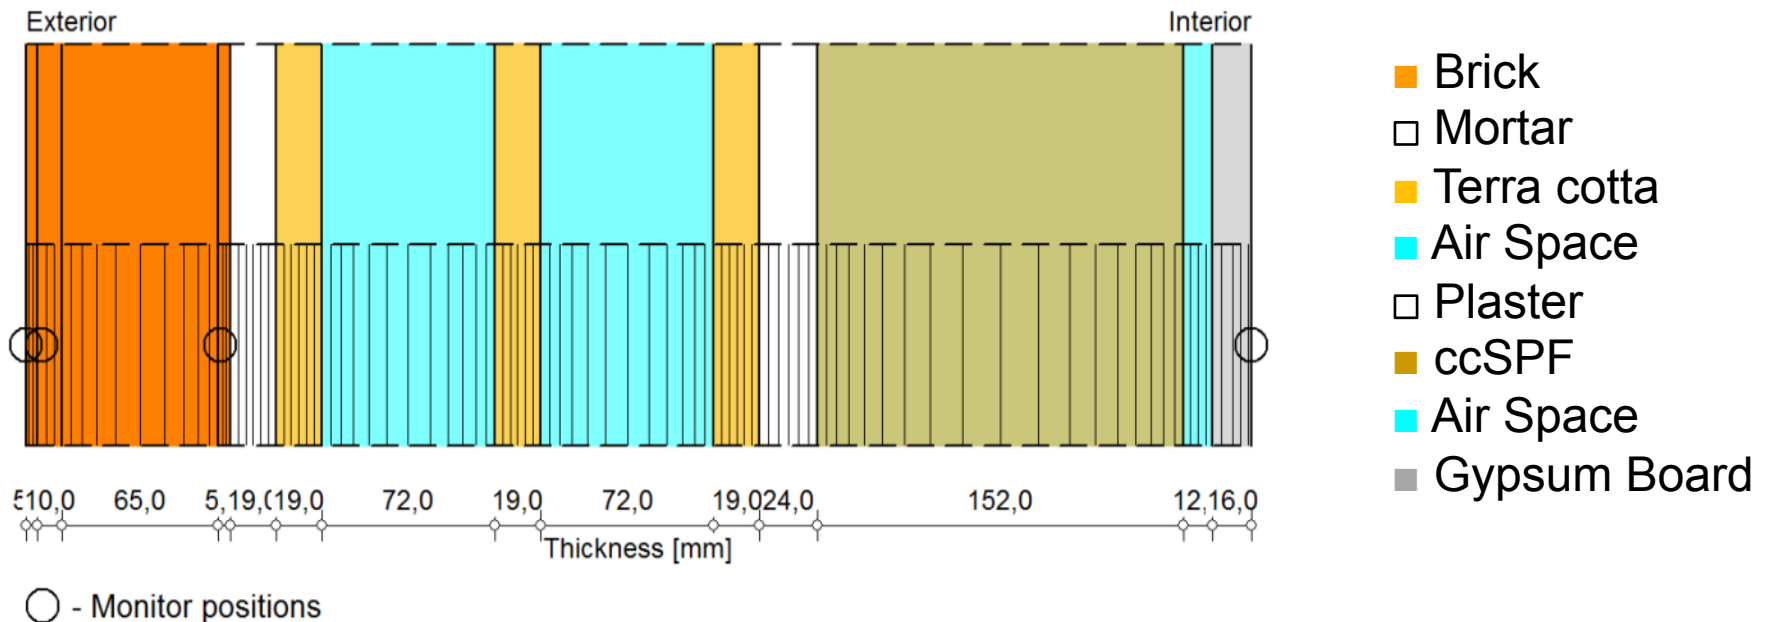
# Hygrothermal Simulations

- Simulate existing (uninsulated) wall
- Simulate retrofitted (insulated) wall
- Vary rain loading—sensitivity analysis

- Low risks at low rain exposures—both existing and insulated (below  $S_{crit}$ )
- Extreme rain loads:
  - Existing wall medium-to-high risks
  - Insulated wall medium-to-high risks
  - Insulated vs. uninsulated—less effect than rain load
  - Even at high insulation levels (8" ccSPF)
- Danger of putting wood-based materials on “cold and wet” side of wall
  - Showed rising moisture contents
